Noise from Cargo Cover

F36 (4-Series Gran Coupe)

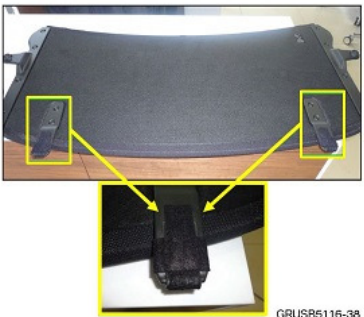
A rattling sound may be heard from the rear cargo cover.

Excessive clearance on mounting tabs.

| <p>A</p> <p>GRUSB5116-38</p> | <ol style="list-style-type: none"> 1. Remove rear cargo cover. 2. Install felt tape on locating tabs as shown in Figure A. |
