SI B51 21 16
Body Equipment

WIND NOISE FROM KIDNEY GRILL

F10 (5-Series) (LCI) from June 2013

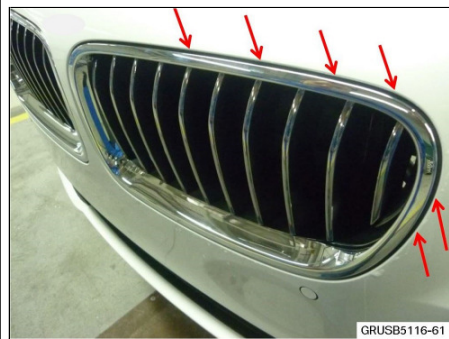
Air passing through the gap between the front kidney grill and the body on LCI vehicles only.

Install foam strips between kidney grills and body
