INTERMITTENT DISTORTION IN AUDIO SYSTEM, DRIVER'S SIDE

F30 (3-Series Sedan)	F31 (3-Series Sport Wagon)
----------------------	----------------------------

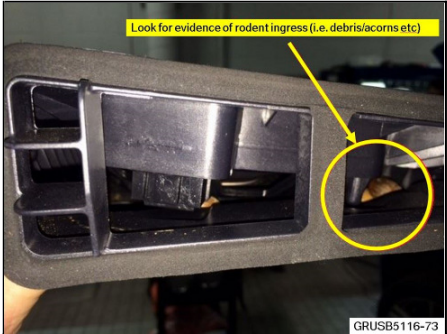
Note: Perform this repair on the driver's side only. If rodent ingress is suspected on the passenger's side subwoofer, create a PUMA case and provide photos showing evidence of rodent ingress.</p> <ol style="list-style-type: none"> 1. Remove Driver's side seat and subwoofer enclosure and inspect for signs of rodent ingress into subwoofer enclosure. <p>Was evidence of rodent ingress found? YES – remove debris discovered in the subwoofer enclosure. Go to next step. NO – continue diagnosing distortion with ISTA.</p>
	<ol style="list-style-type: none"> 2. Inspect subwoofer for damage.

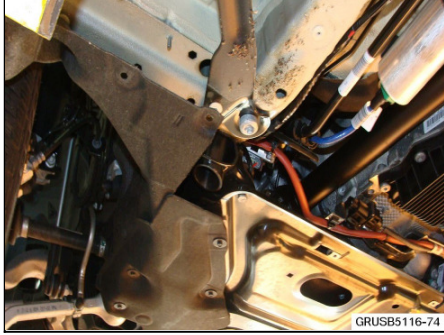
Was subwoofer damaged by rodent ingress?

YES – replace subwoofer. Go to next step.

Note: Do not replace subwoofer unless debris

cannot be removed, or subwoofer is damaged. Create an info only PUMA case showing subwoofer damage.
