ACSM AND ICM WARNING LAMPS ILLUMINATED

This Service Information bulletin supersedes SI B61 15 13 **dated October 2013**

F30 (3 Series) Produced to April 2013

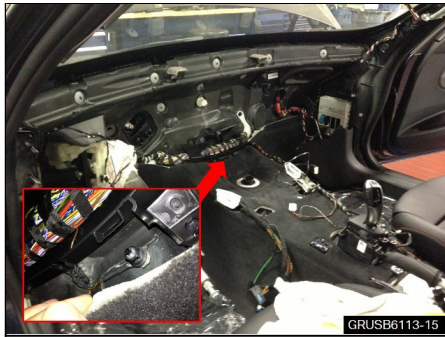
Ground point Z10*10B is loose.

Diagnose vehicle and tighten loose ground point.

1. Perform a vehicle test using ISTA and complete all test modules related to the stored faults.
2. Check the ground circuit of the ACSM (Advanced Crash Safety Module) and ICM (Integrated Chassis Management) modules for a voltage drop or high resistance, as recommended by the test module.
3. If the ground circuit check indicates high resistance or a high voltage drop, check the ground point Z10*10B, located under the dash, behind the heater box as indicated below. Tighten to 8Nm and clear the faults. Refer to Repair Manual instructions "6411206 Remove and install the heating and air-conditioning unit" in order to gain access to the ground point.
4. The wiring harness installation process at the factory has been improved as of April 2013.
