KAFAS CAMERA: CCM DISPLAYED ADVISING OF FRONT CAMERA MALFUNCTION

F16 (X6), Produced in January 2016

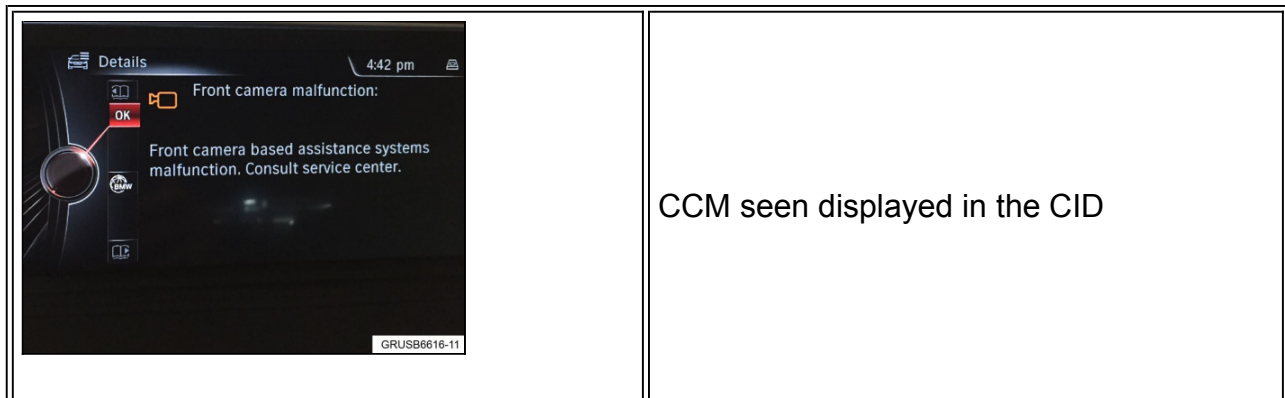
A CCM (Check Control Message) advising of a front camera malfunction is displayed in the CID when the vehicle is parked in the sun and the ambient outside temperature is high.

Fault code 800AC0 is stored in the KAFAS

Replace the KAFAS camera

Replace the KAFAS camera as per repair instructions REP 66 51 030.
