N63R Map Thermostat Faults

This Service Information bulletin supersedes SI 12 13 16 dated May 2016

G12 (750i sedan)

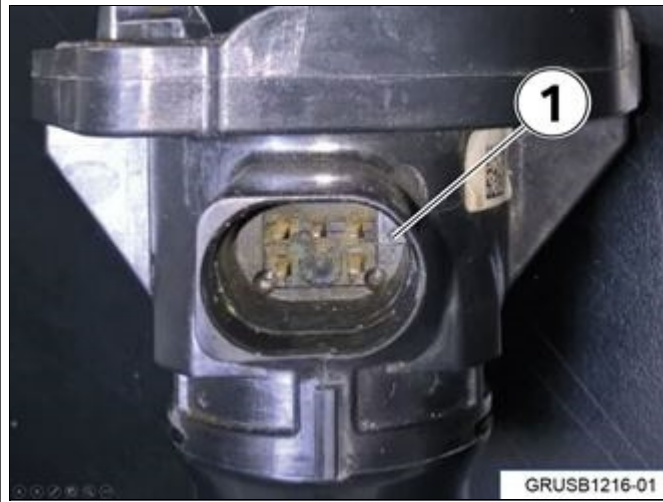
Coolant is leaking past the map thermostat electrical connector.

<ol style="list-style-type: none"> 1. Remove the connector for the map thermostat (1) and check for coolant. <p>Is coolant present in the engine wiring sensor harness for cylinders 1-4?</p>
--	---

YES - replace the map sensor thermostat (PN 11 53 8 602 282) and the sensor harness (PN 12 51 8 654 414). Go to step 2.

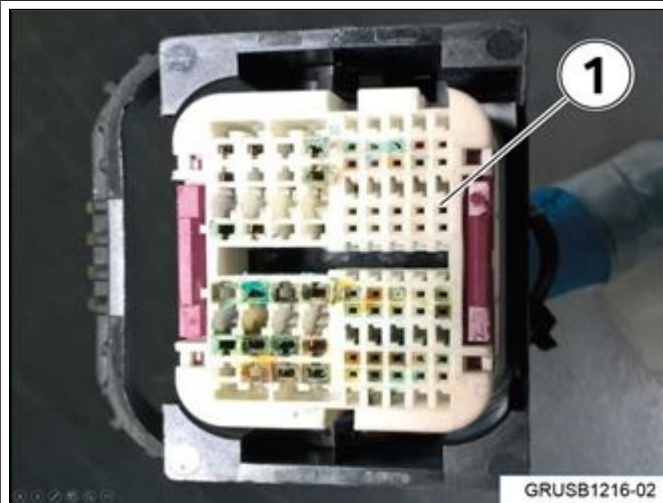
2. Check the wiring harness connector at the DME for coolant (1).

Is there any coolant at the DME harness connector?

YES – Continue to step 3.

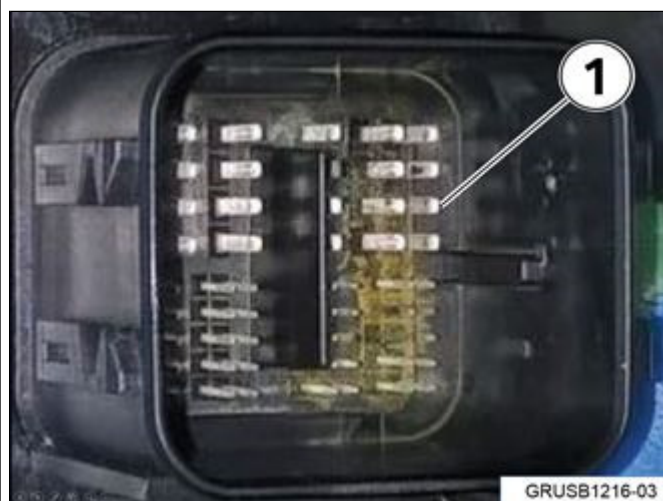
3. Check the DME and PDM connector sockets for coolant contamination (1).

Is there any contamination at the electrical connectors for the DME or PDM?

YES- Submit a TC case to the TC DME group for DME and PDM parts replacement approval.
