SI B24 04 16
Automatic Transmission

G12 N63R -Ticking Noises From Transmission Cooler Lines Area

G12 (750i/750ix)	Vehicles produced up to 11/15/2015
------------------	------------------------------------

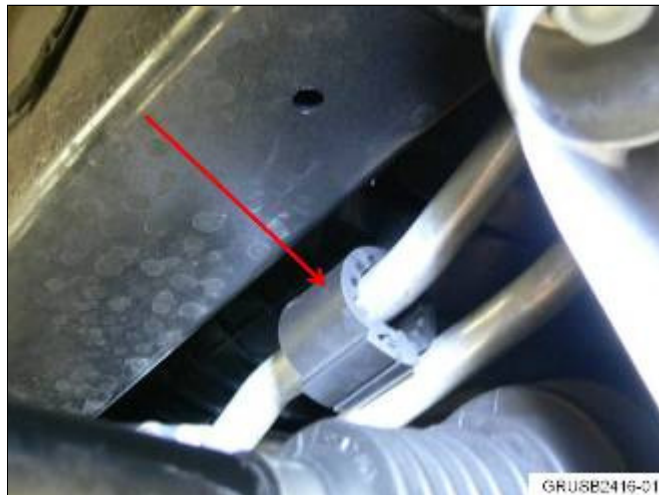
Customer reports an audible clicking noise in the driver's footwell area, heard directly after the transmission shifts.

Interference between the transmission cooling lines and engine support mounts.

1. Remove front, left wheel.
2. Remove the left front wheel arch cover according to Repair Instruction REP 5171 038.
3. Install the rubber protection ring (PN 64 53 7 578 706) on the return transmission cooler line, where shown in the illustration.

Note: Applying a small amount of water on the rubber protection ring, helps to place it at the correct position on the cooler line.
