SI B51 20 16
Body Equipment

June 2016
Technical Service

Door Will Not Go Up All The Way

I12 (i8)

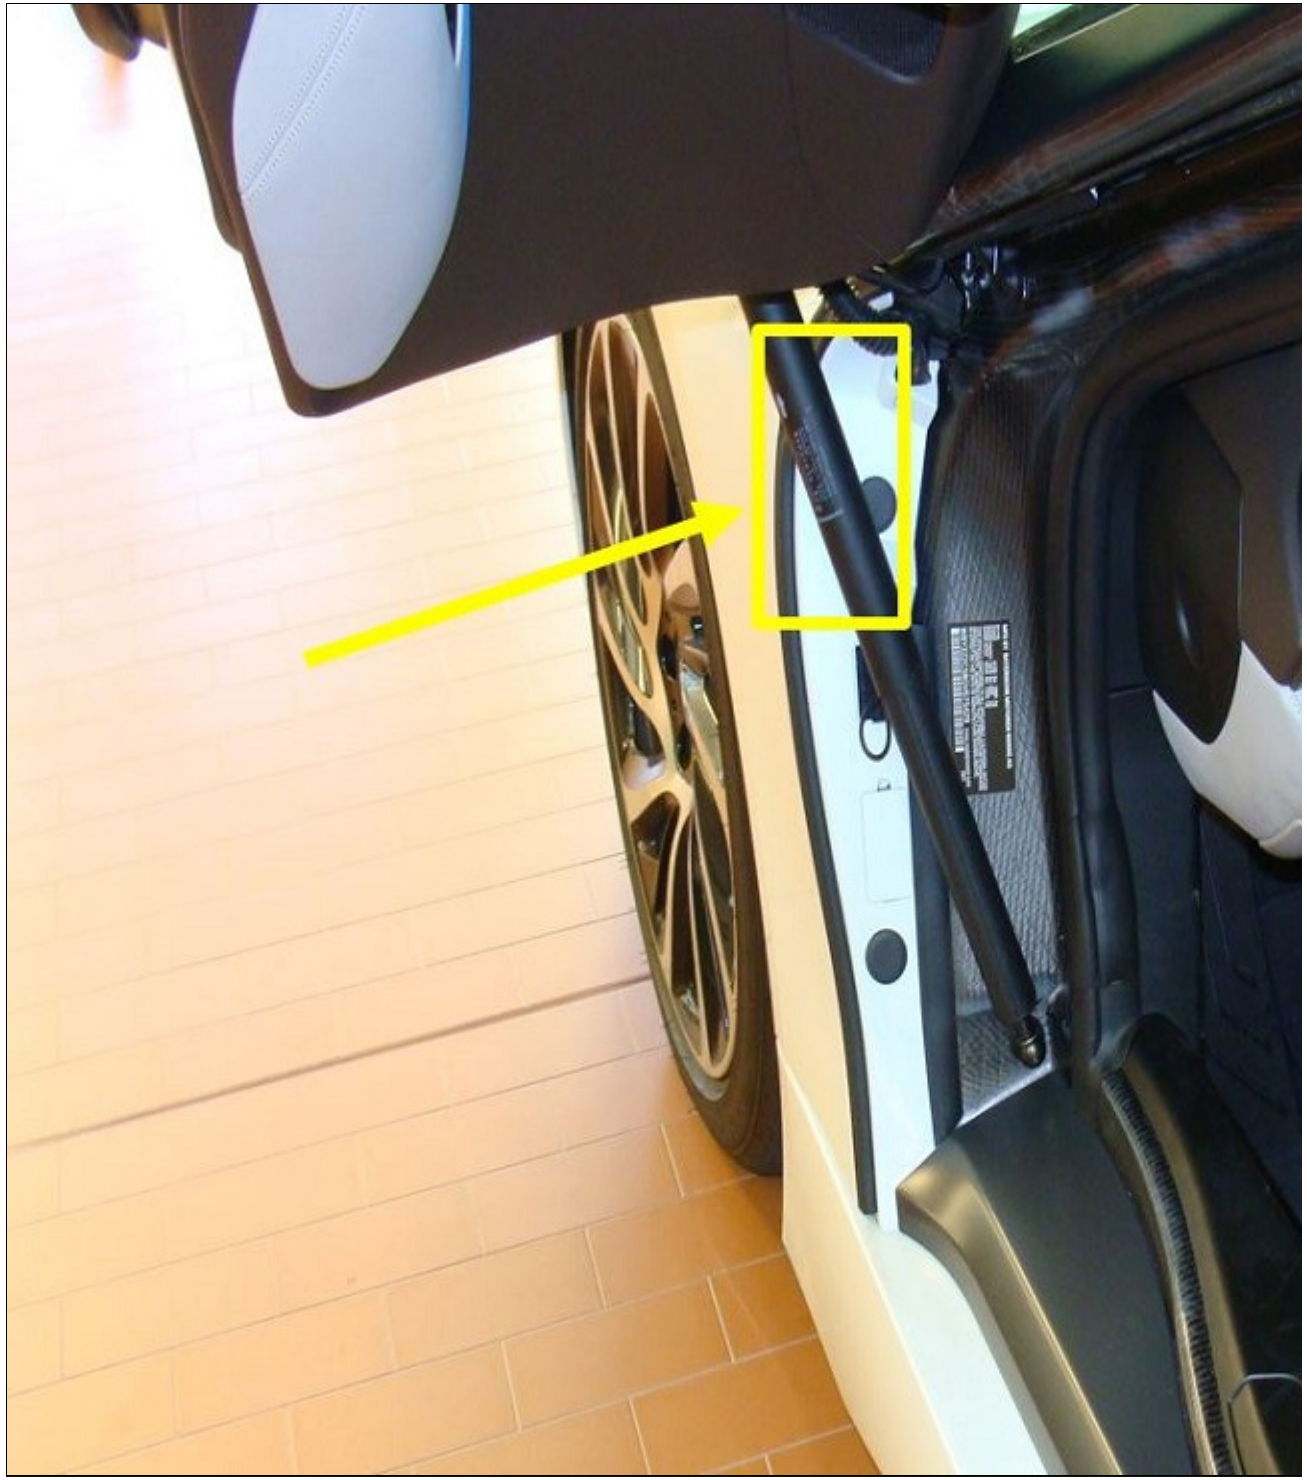
PROCEDURE

The driver's side or passenger's side door may not open to the highest position.

Insufficient lifting force from gas pressurized damper spring.

Replace gas pressurized damper spring with the next highest opening force level.
