SI B51 23 16
Body Equipment

SNOW IN ENTRANCE AREA

I12 (i8) Vehicles produced until August 2015.

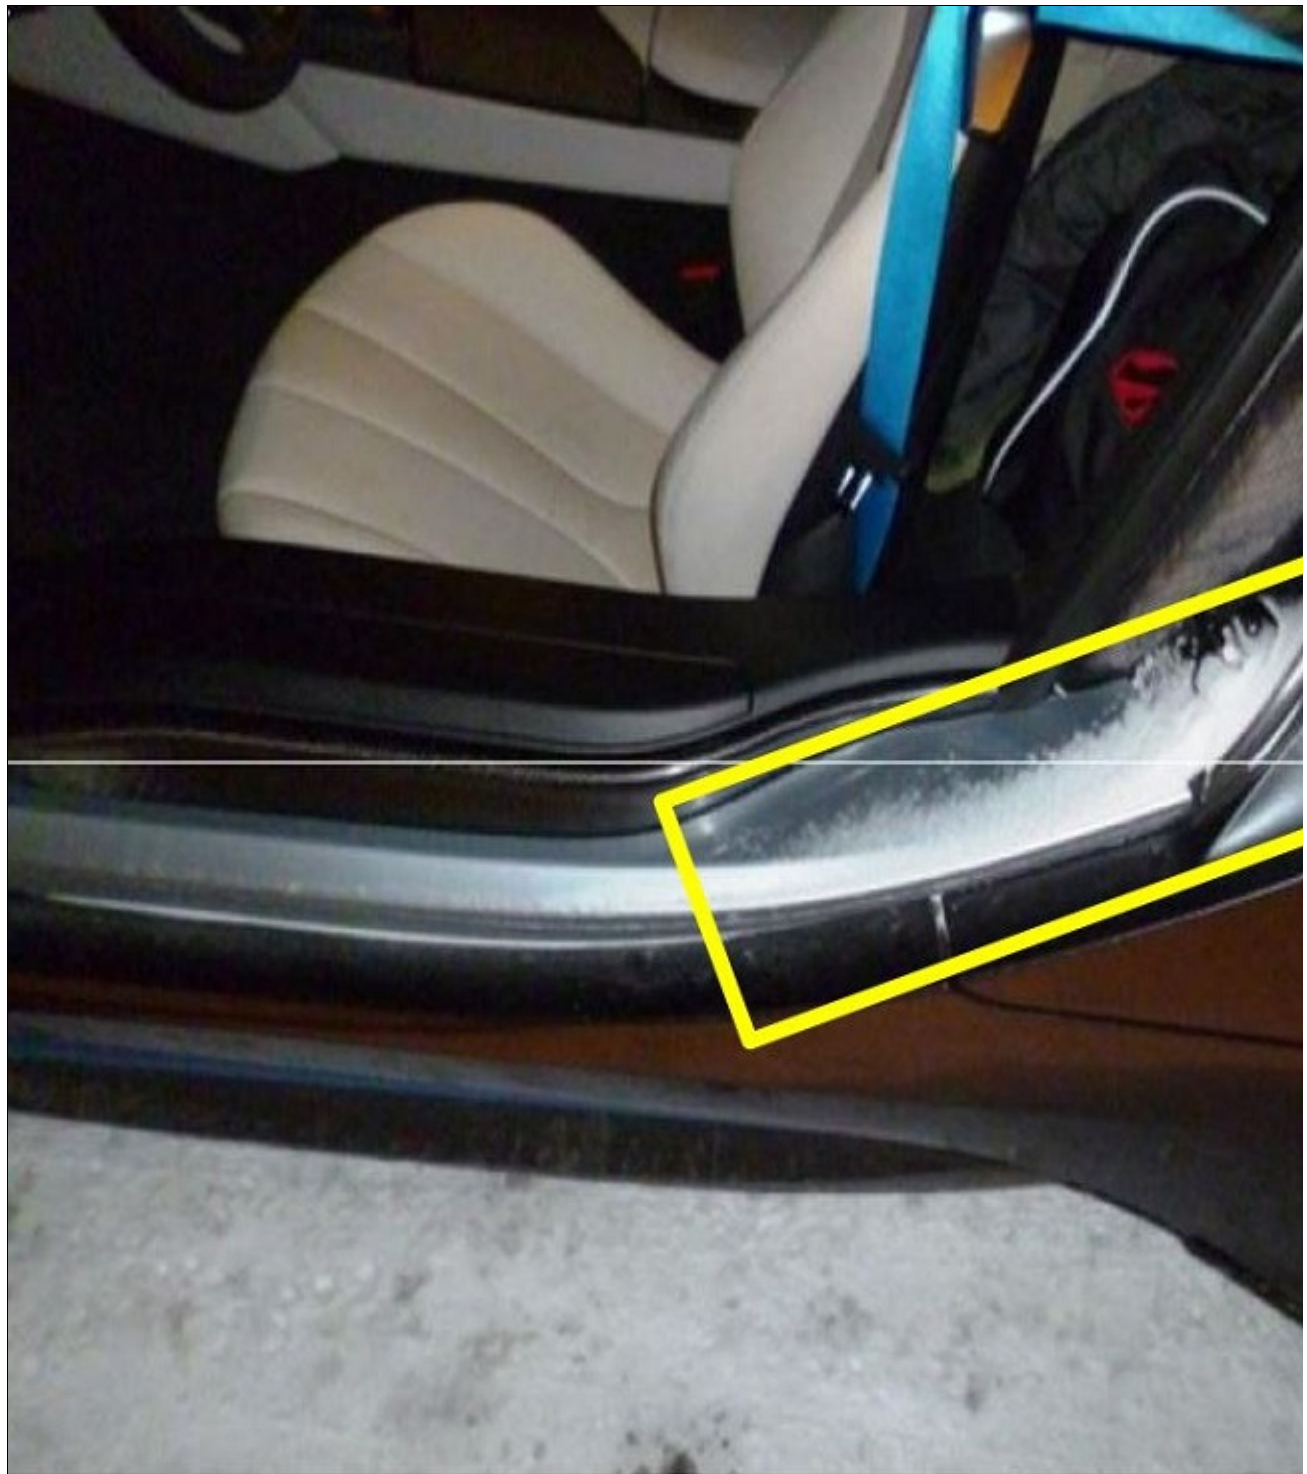
Snow or dust may accumulate in entrance area

Excessive clearance in door sill area.

Replace entrance cover and entrance molding on both sides.
