SI B54 02 16  
Special Roofs

## GAP VISIBLE BETWEEN UPPER A-PILLAR COWL PANEL SEAL AND CONVERTIBLE TOP SEAL.

F33 (4 Series Convertible)	F83 (M4 Convertible)
Produced to April 2015

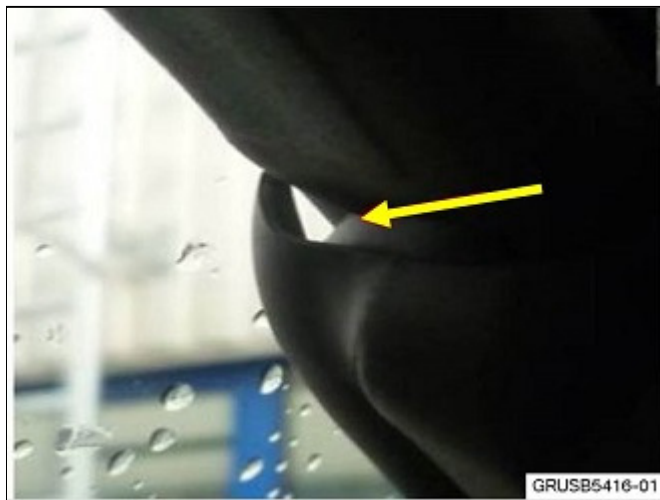
Photo at left shows gap between A-pillar seal and cowl panel seal (inside view).

Design of upper A-pillar cowl panel seal to convertible top seal.

Replace A-pillar cowl panel seal.

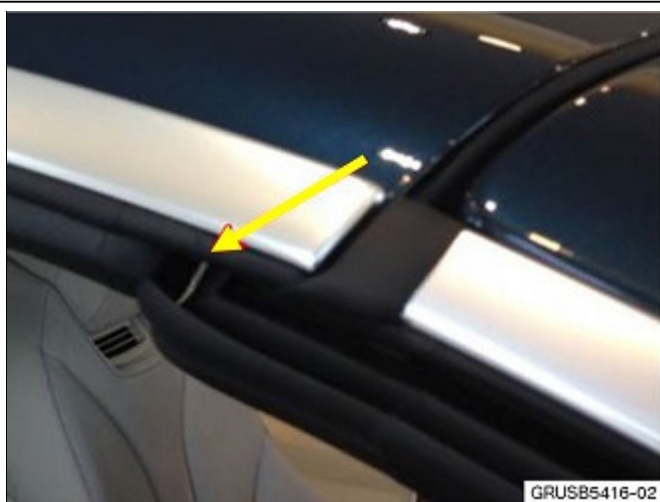
Photo at left shows gap between A-pillar seal and cowl panel seal (outside view).
