Various Electrical Faults Caused by Shorted K-CAN2

This Service Information bulletin supersedes SI B61 18 14 **dated July 2014**

F25 (X3)

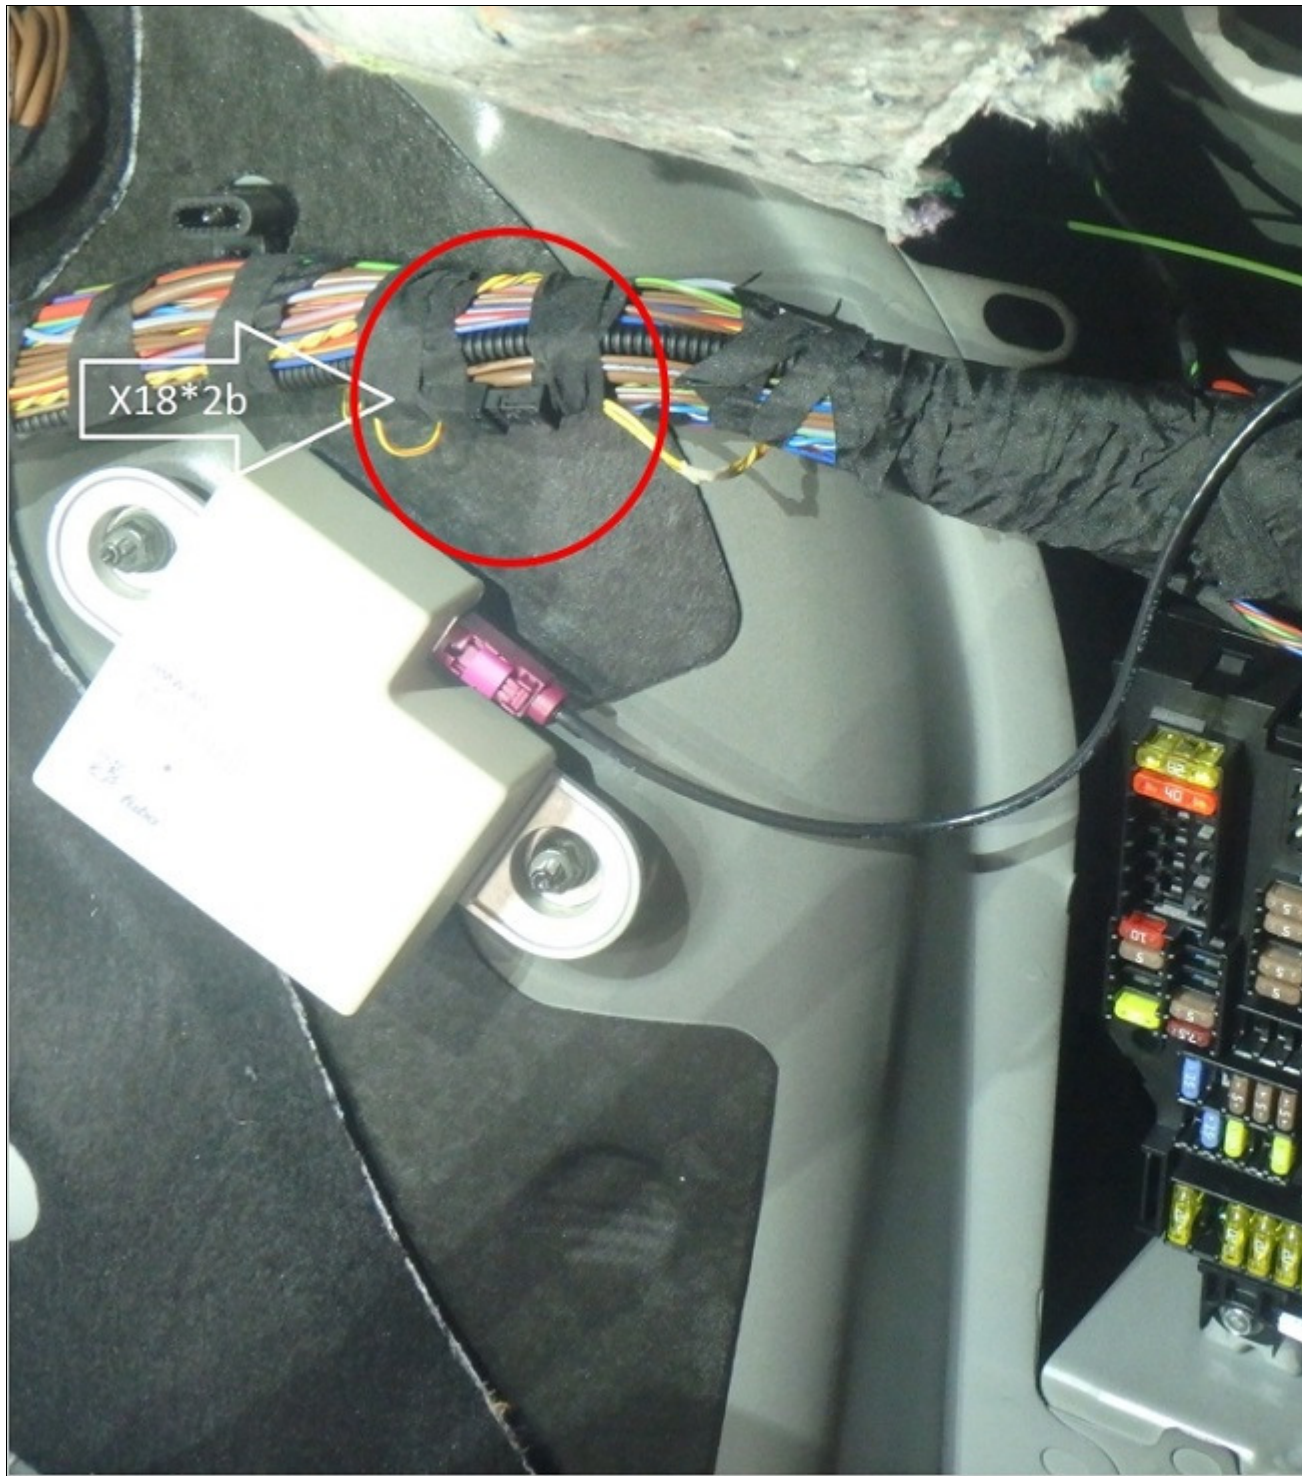
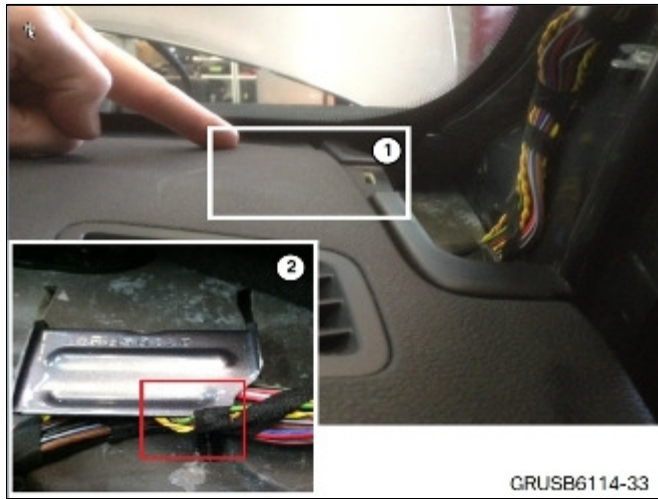
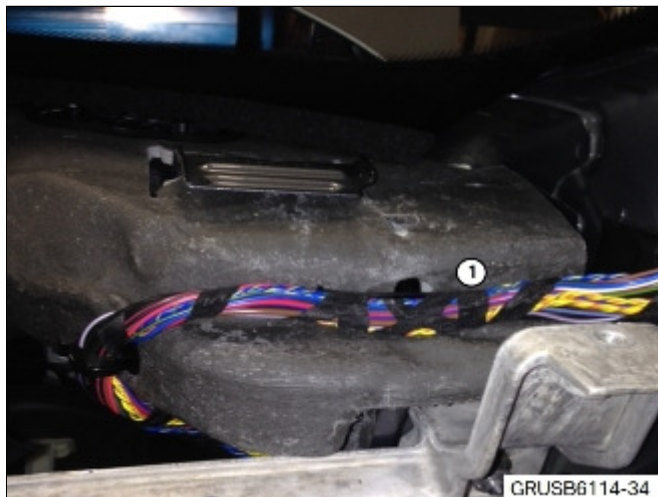
- The wiring harness gets pinched between the instrument panel and the locating tab on the passenger side of the instrument panel.
- Connector X18*2b not fully connected (located above rear distribution box in trunk)

K-CAN2 High – GE/RT (Yellow/Red)

K-CAN2 Low – GE/BR (Yellow/Brown)

- Locate and repair the shorted wires. Reposition the harness.
- Fully connect X18*2b
