AIRBAG WARNING LAMP ILLUMINATED

I01 (i3)

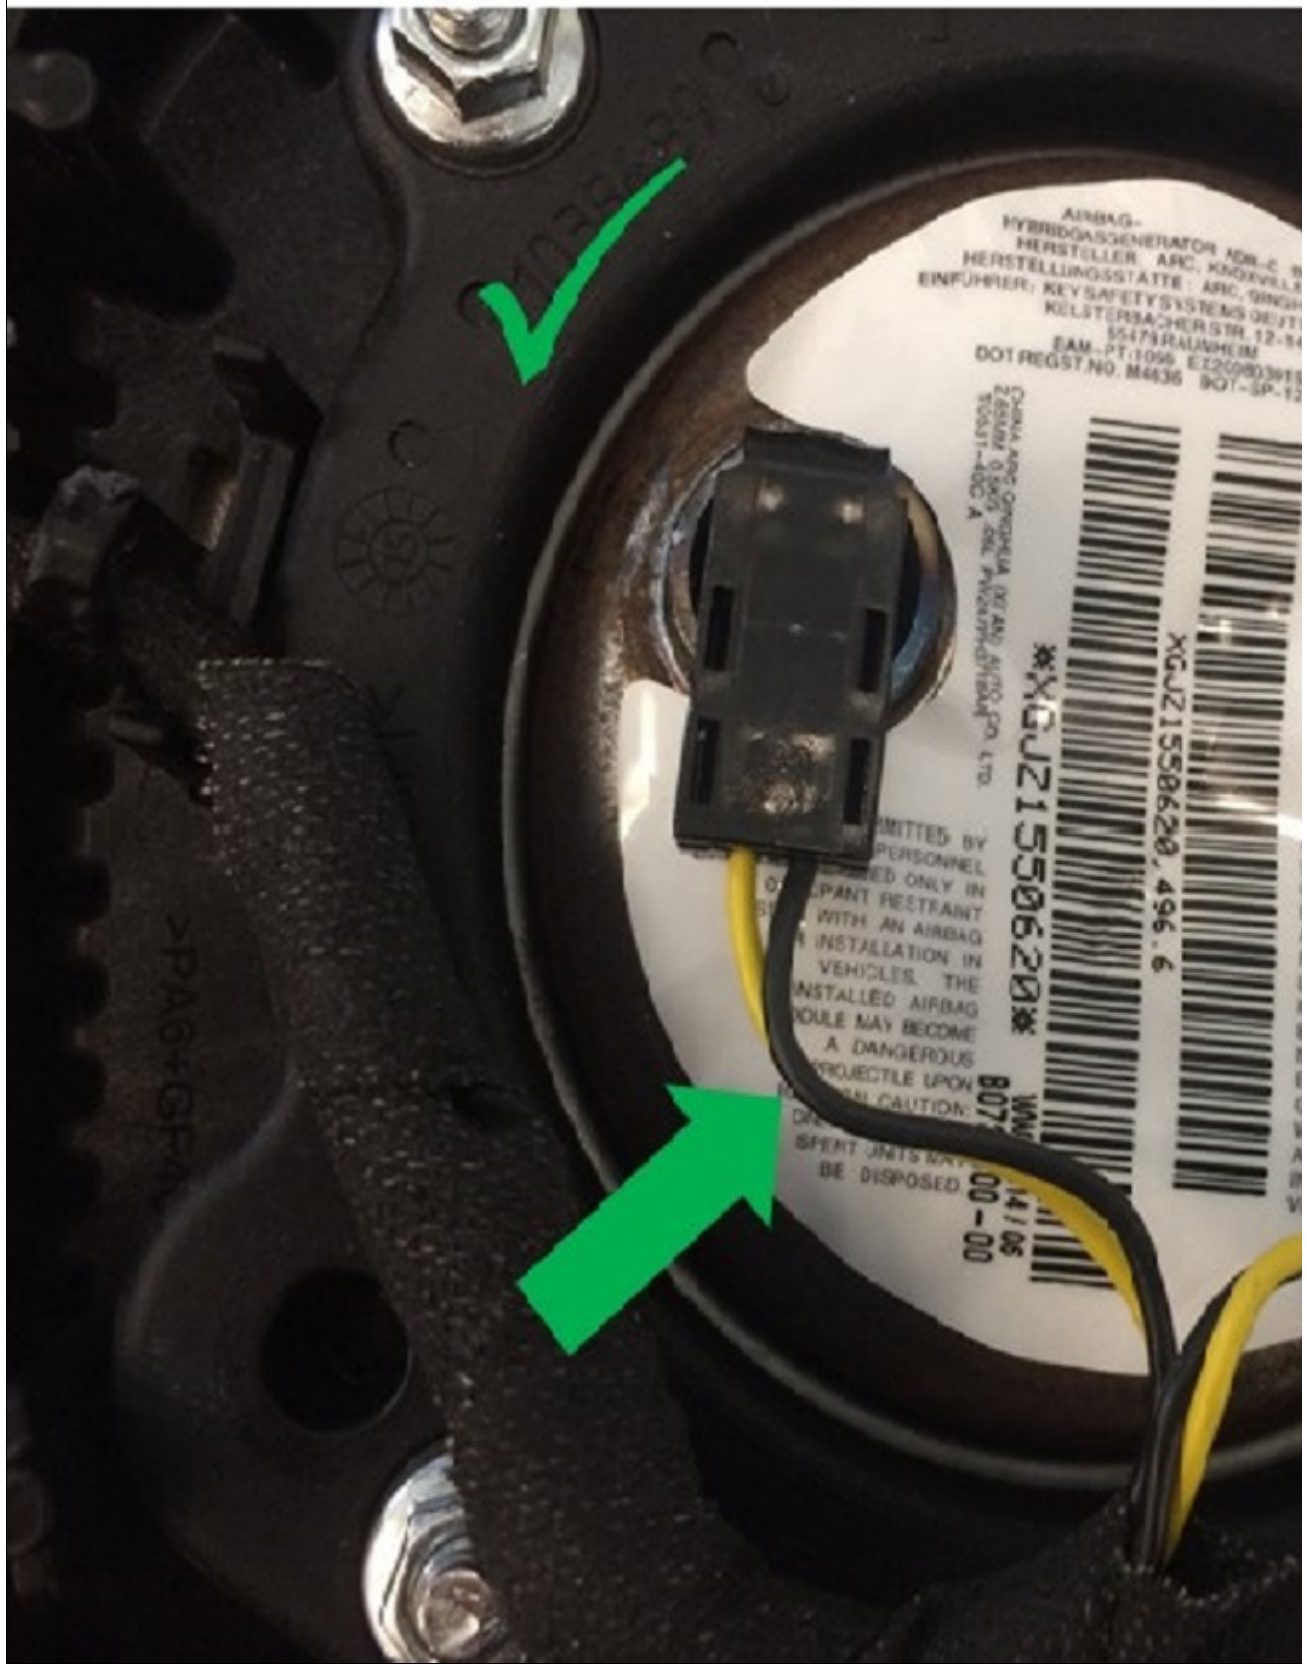
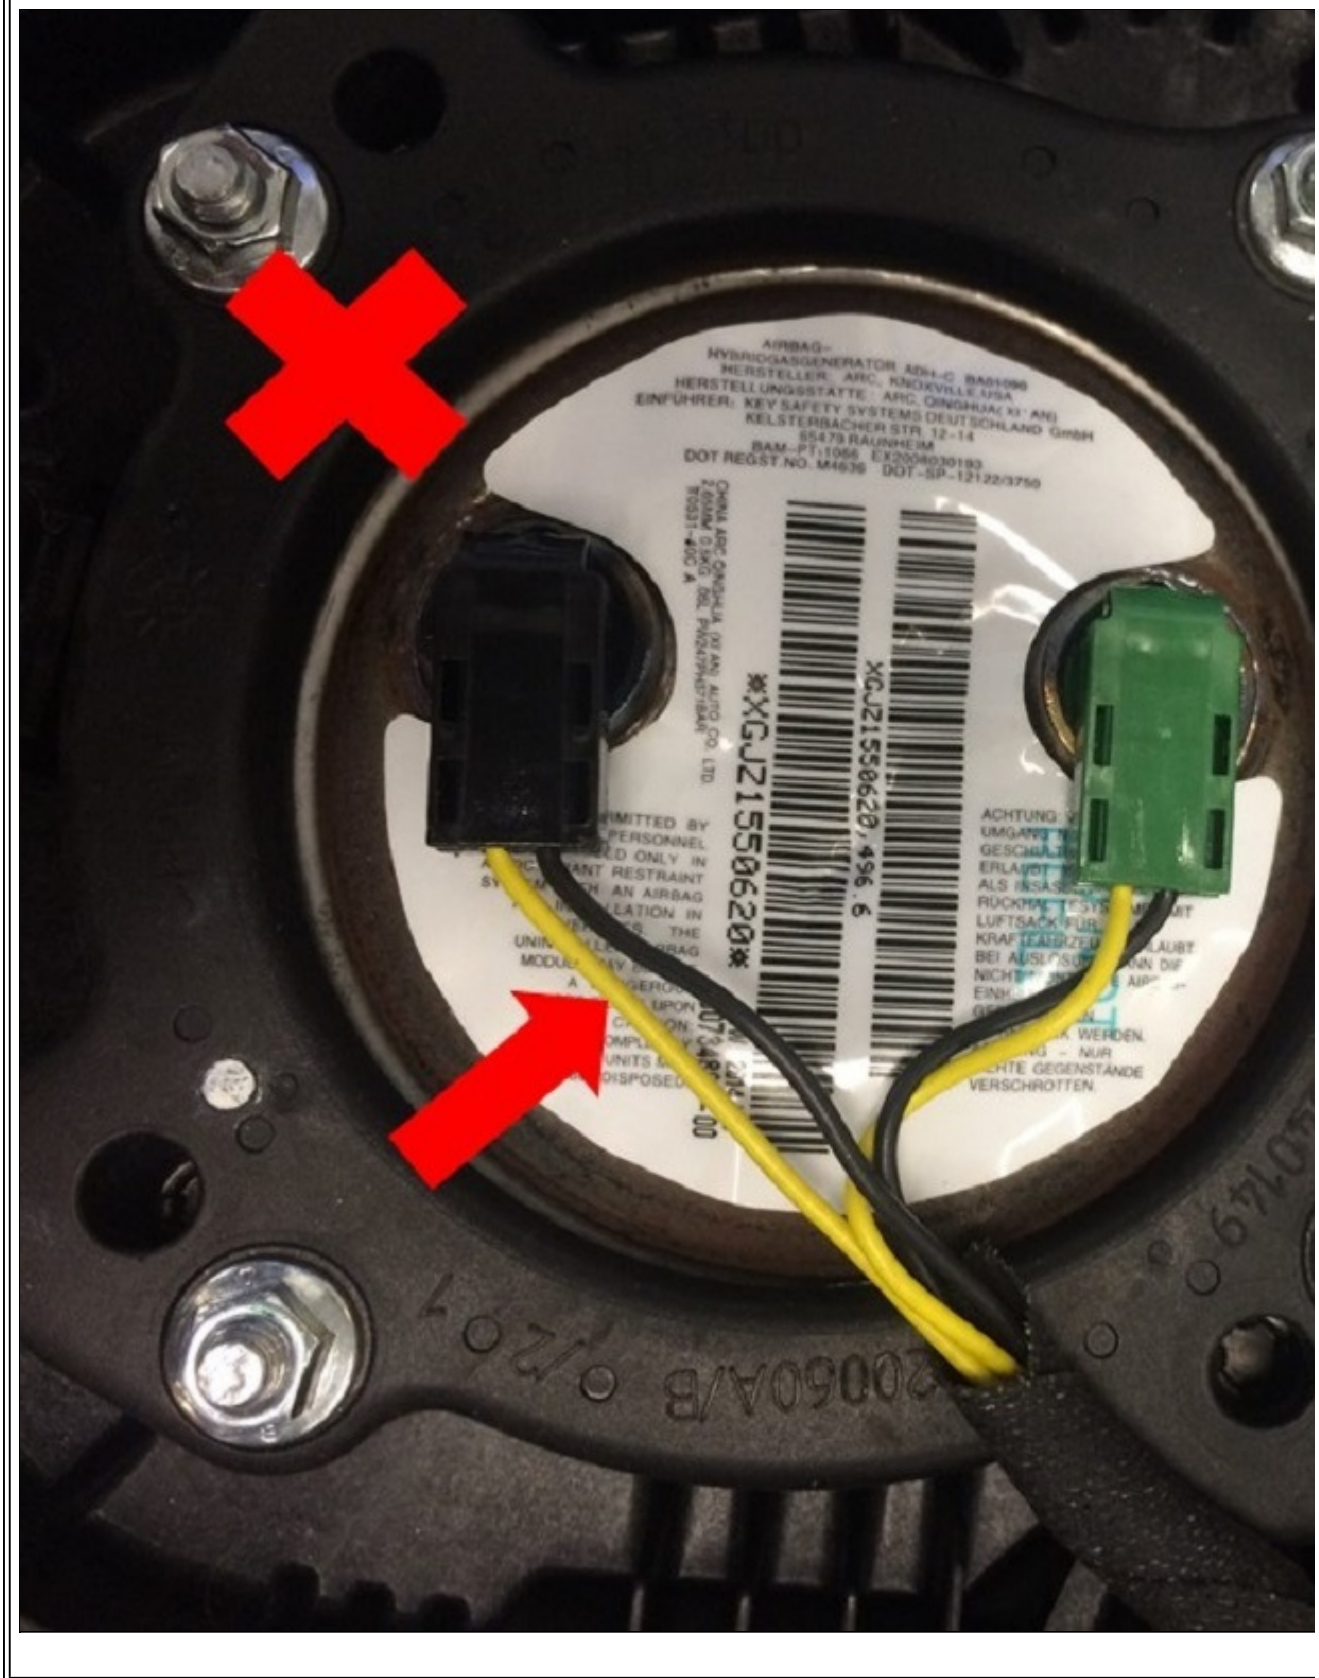
Tension caused by harness cable tie on short jumper harness located between steering column slip ring and driver's airbag creates excess resistance.

Check for tension and tension-free routing of the wiring harness between driver airbag module and the steering column switch cluster (SZL).

Change tension on harness **OR** replace driver's airbag module
