## SQUEAKING NOISE FROM POWER FOLDING EXTERIOR REARVIEW MIRRORS

F54 (Cooper Clubman / Cooper S Clubman)	F55 (Cooper hardtop 4 door / Cooper S hardtop 4 door)	F56 (Cooper hardtop 2 door / Cooper S hardtop 2 door)	F57 (Cooper Convertible) / Cooper S Convertible)
Vehicles with Option Code 313 Power Folding Mirrors			
Produced to April 18, 2016

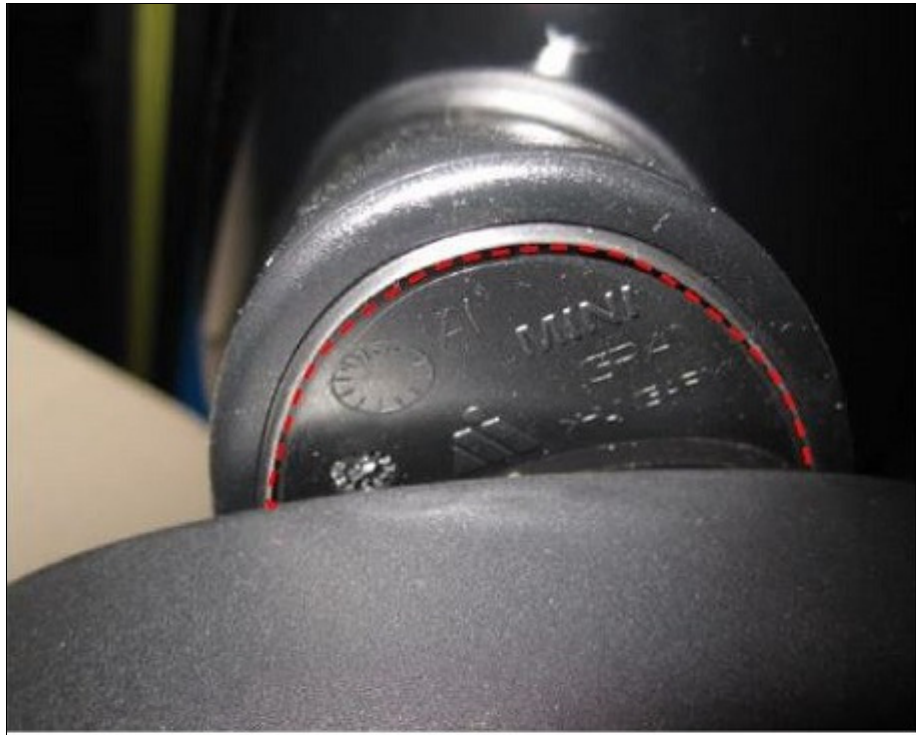
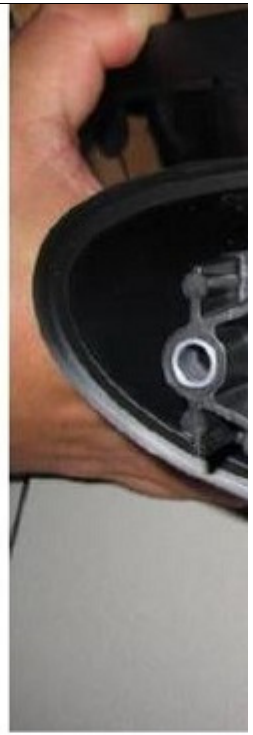
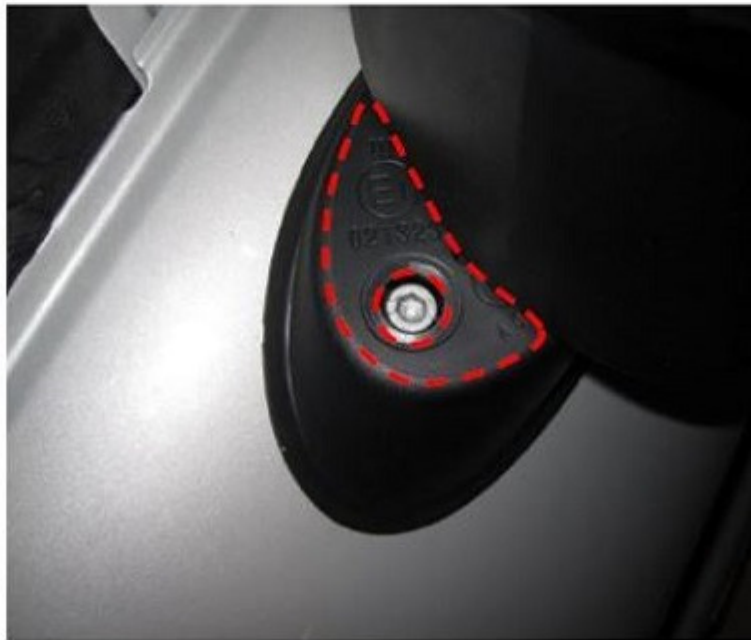
A squeaking noise can be heard when folding the exterior rear view mirrors in or out.

Tolerances in the exterior rear view mirrors

Apply lubricant to the contact surfaces in the exterior rear view housing.
