SI M51 08 16
Body Equipment

WATER INGRESS, FRONT DOOR

R58 Cooper Coupe	R58 Cooper S Coupe	R58 JCW Coupe
------------------	--------------------	---------------

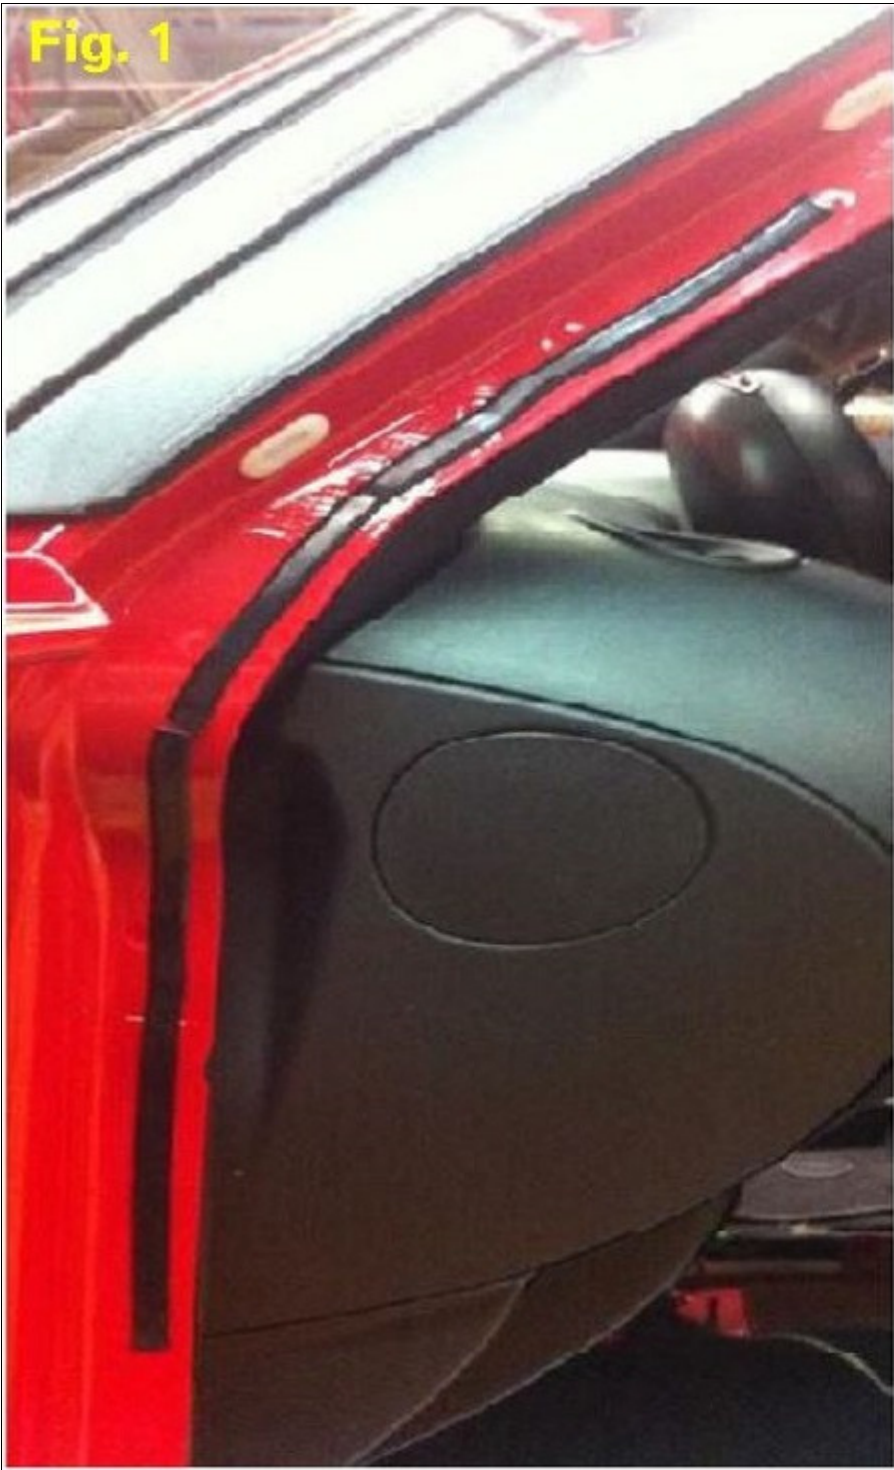
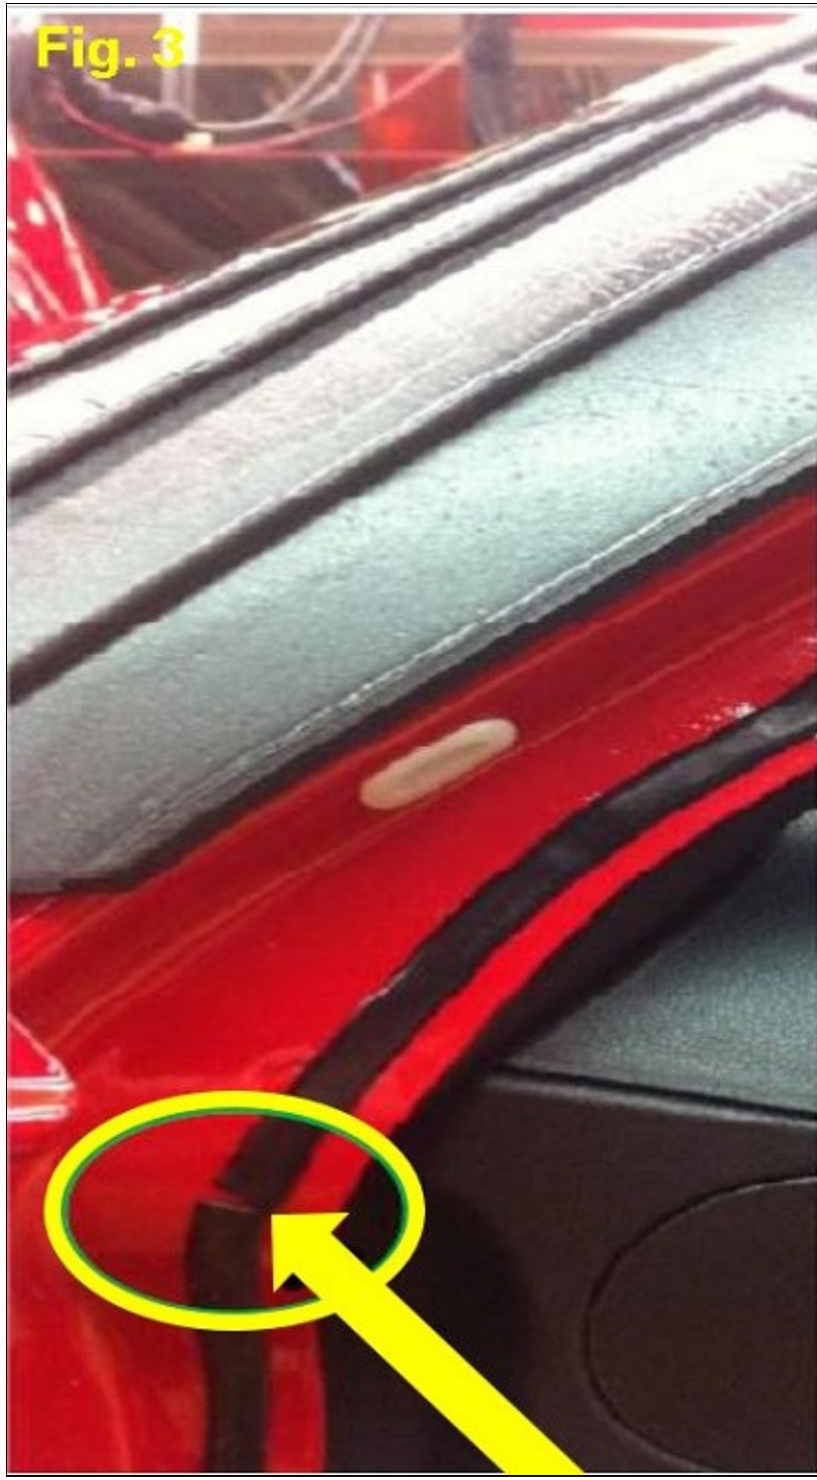
PROCEDURE

Water found on Driver's or Passenger's side front carpet.

Improper sealing of door at A-pillar.

Install butyl rope under door seal and replace door seals.
