SI M62 02 16
Body Equipment

PERCEIVED SCRATCH IN INSTRUMENT CLUSTER

F54 (Clubman)	F55 (Cooper Hardtop 4-Door)
F56 (Cooper Hardtop 2-Door)	F57 (Cooper Convertible)
Vehicles produced from 11/30/2013

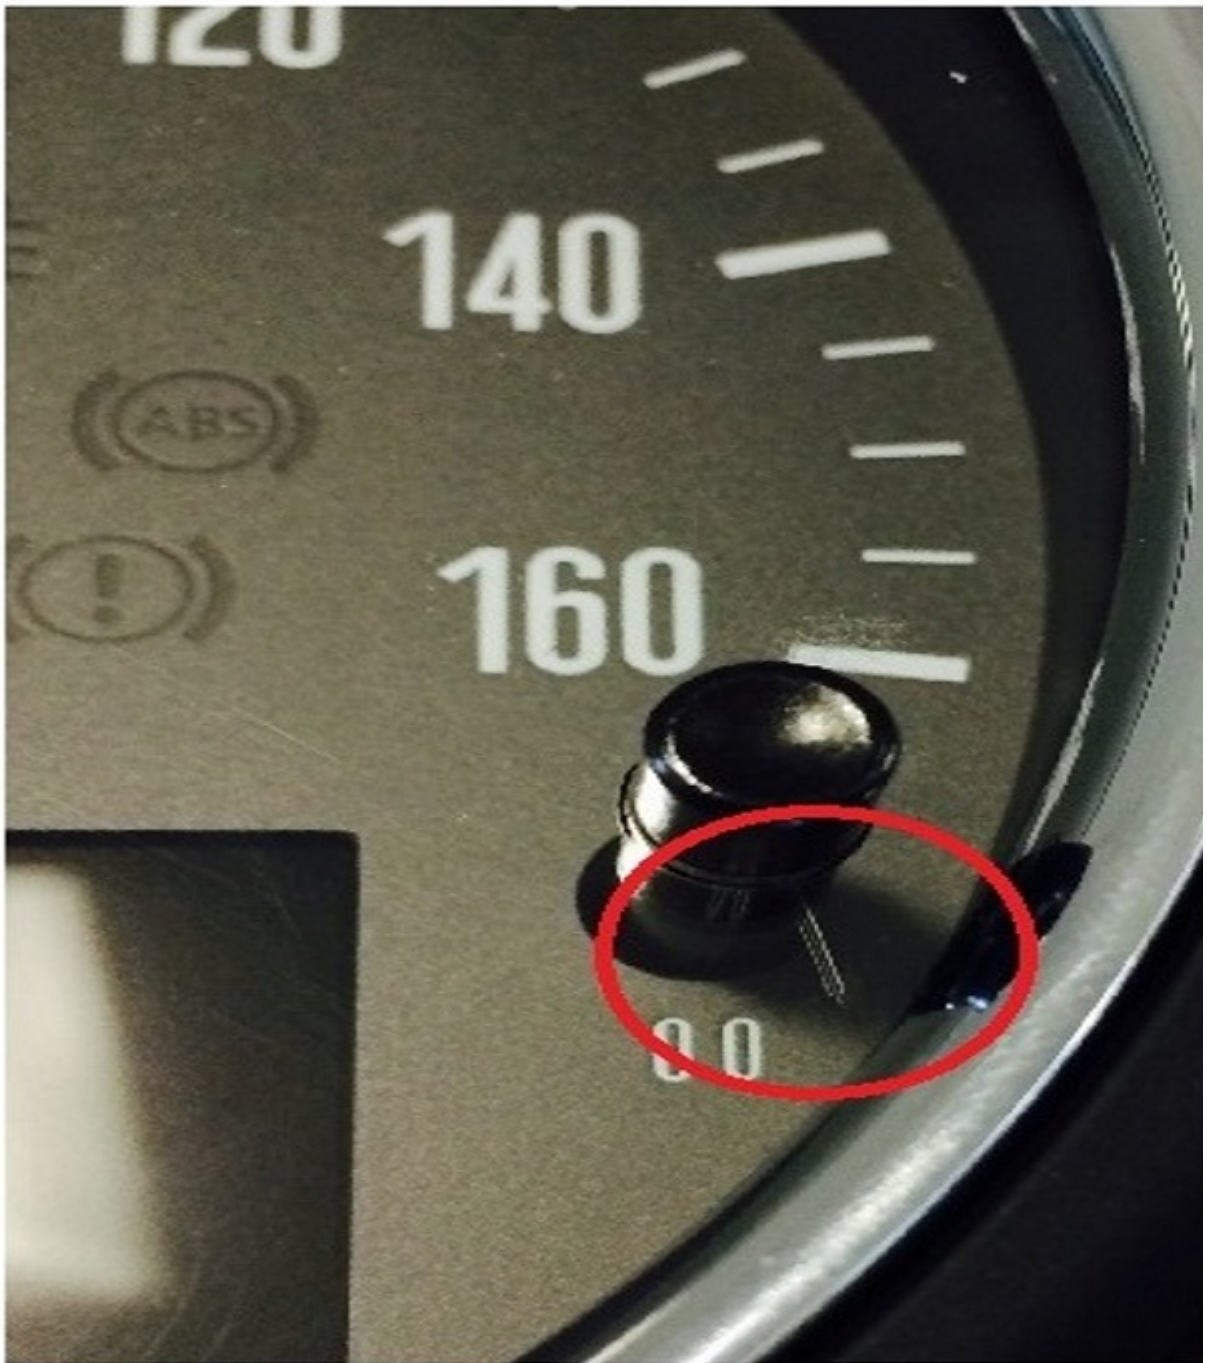
SITUATION

Instrument cluster glass cover manufacturing process creates a flow line where materials are joined together.

Please inform the customer that this is a normal result of the instrument cluster manufacturing process.

Replacing the instrument cluster will NOT provide a solution.
