SI B11 14 15  
Engine

**Service Action: N55 Engine - Inspect and Replace Engine Oil Filter Housing**

F30 (3 Series Sedan)

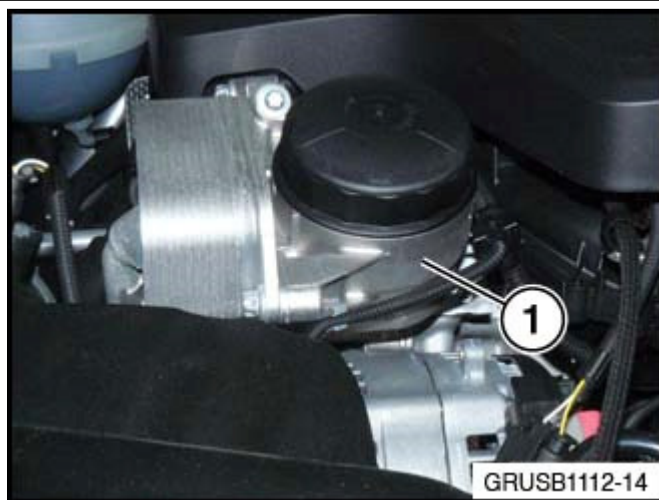
1. Inspect and replace the engine oil filter housing as per the repair instructions.

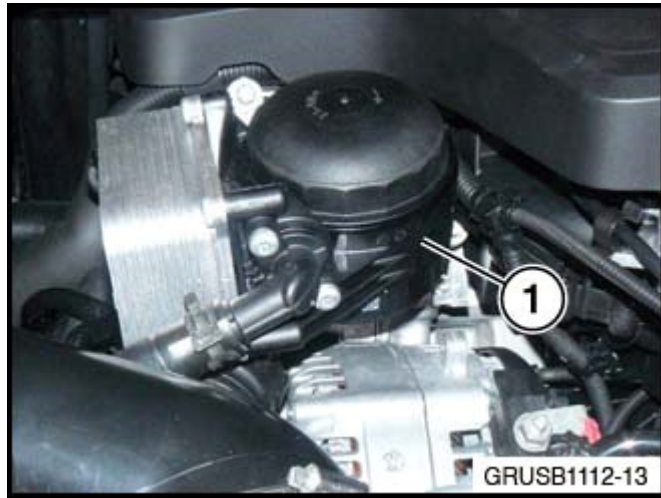
2. If the vehicle is fitted with the aluminum oil filter housing (silver color) then take no further action. Do not replace any parts.

3. If the vehicle is fitted with the plastic engine oil filter housing (black color) then replace the engine oil filter housing as per the attached instructions.
