Service Action: S63 Engine – Check and Replace High-Pressure Injectors

E70 (X5M)

E71 (X6M)

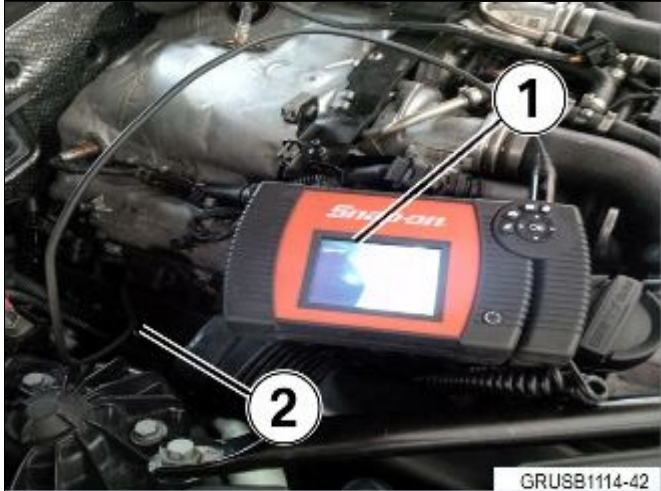
<ol style="list-style-type: none"> 1. Use a bore scope (1) or similar (mirror) to help identify the injector index number on the injector (2). <p>Do not remove the injector to identify the index number.</p>
	<ol style="list-style-type: none"> 2. Perform the injector index number evaluation on both cylinder banks. <p>As of January 2013, an</p>

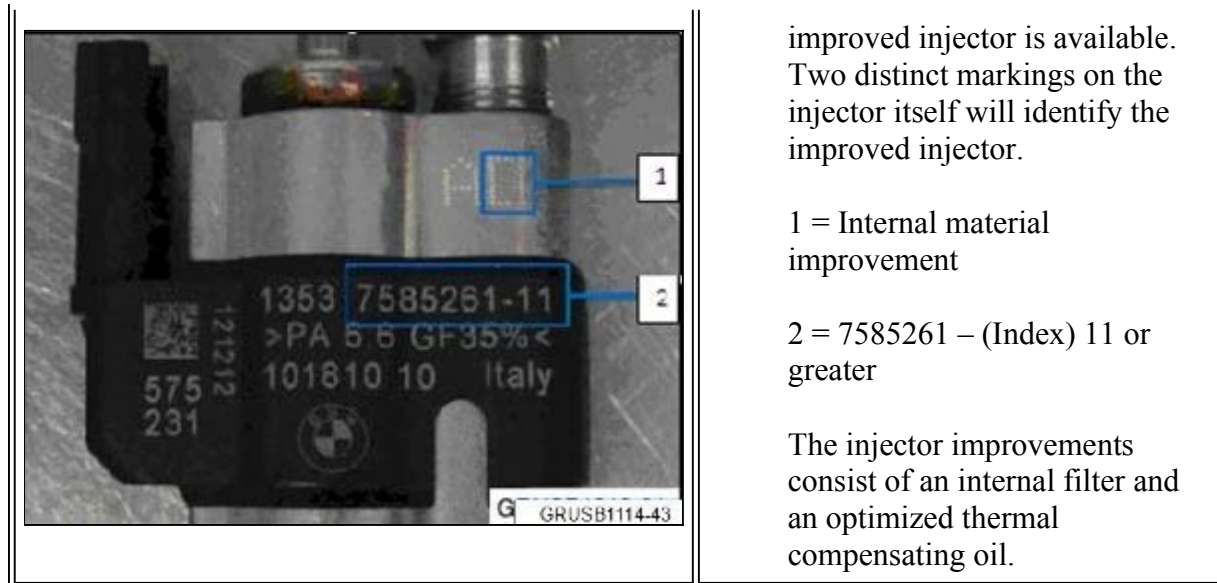
improved injector is available. Two distinct markings on the injector itself will identify the improved injector.

1 = Internal material improvement

2 = 7585261 – (Index) 11 or greater

The injector improvements consist of an internal filter and an optimized thermal compensating oil.

- All injectors that are not index 11 or higher will need to be replaced. Use **P/N 13 53 8 648 937** when replacing the injector(s).

If the injector index number is already 11 or greater, take no further action regarding injector repairs.

IMPORTANT: Injectors with index 11 and higher have a different calibration and construction than injectors with index 10 and lower. Due to this difference, injectors with index 11 and higher and injectors with index 10 and lower cannot be mixed on the same engine bank (i.e., cylinders 1-4 or 5-8).
