Noises when turning the steering wheel

I01 (i3, i3 REx)

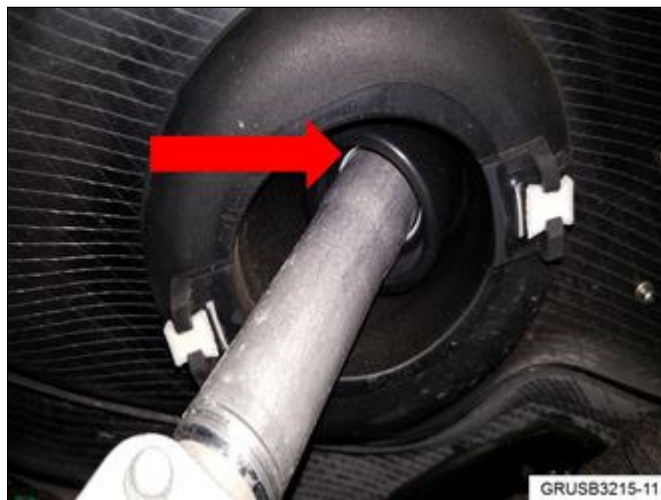
There are squeaking noises from the steering spindle when the steering wheel is turned.

The steering spindle sleeve's plastic bearing is insufficiently lubricated or not lubricated at all.

1. Lubricate the engine compartment side of the steering spindle-
 - a. Refer to REP 51 64 050" Removing and installing/replacing front luggage compartment well" to gain access to the steering shaft bearing.
 - b. Lubricate the plastic ring of the sleeve on the steering shaft with the following agent: Universal plastic lubricant (BMW P/N 81 23 2 327 735).
 - c. To complete, distribute the lubricant by turning the steering left and right, and then repeat this operation three times.
