SI B51 44 15
Body Equipment

January 2016
Technical Service

A Groaning Noise is Heard from the Front Door Trim

F10 (5 Series Sedan)

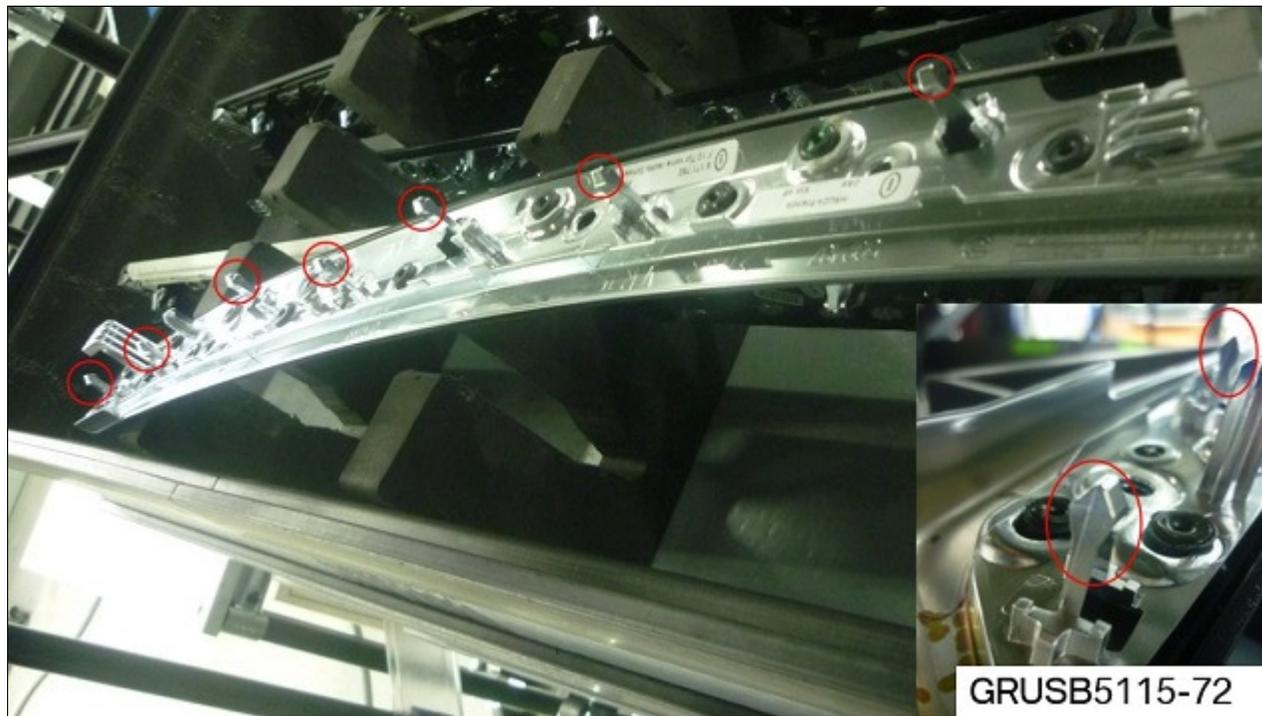
A groaning noise can be heard from one or both of the front door decorative trim pieces while on rough roads.

The chrome plating of the trim mounting pins rubs against the door panel creating a groaning noise.

1. Remove the front door trim for both doors per repair instruction “5141030 Removing and installing decorative strip on left or right door trim panel”.
2. Apply a film of Carbaflo to all the trim mounting points as highlighted below. Allow the Carbaflo to dry for a minute before reassembly.
