SI B51 45 15  
Body Equipment

January 2016  
Technical Service

**A Rattling Noise is heard coming From the Lower Front Door Area**

I12 (I8)

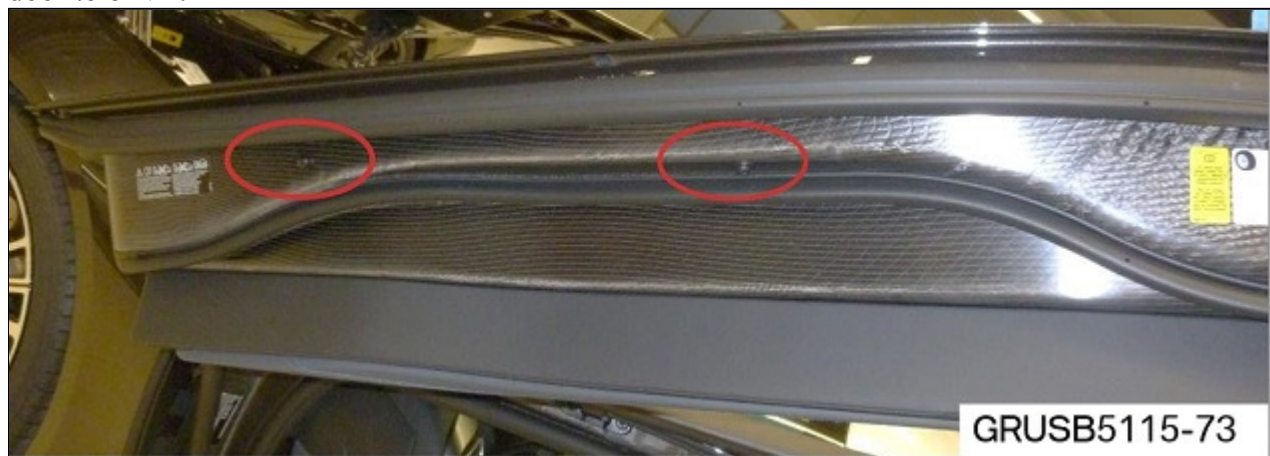
A rattling noise is heard coming from the lower front door area while driving or closing the door.

The lower power window regulator mounting screws have loosened over time.

If the customer reports this issue, check and tighten both lower screws (where shown) on each front door to 8 Nm.
