SUBJECT

Moisture in LED Headlight

NEW F01 (7 Series Sedan)

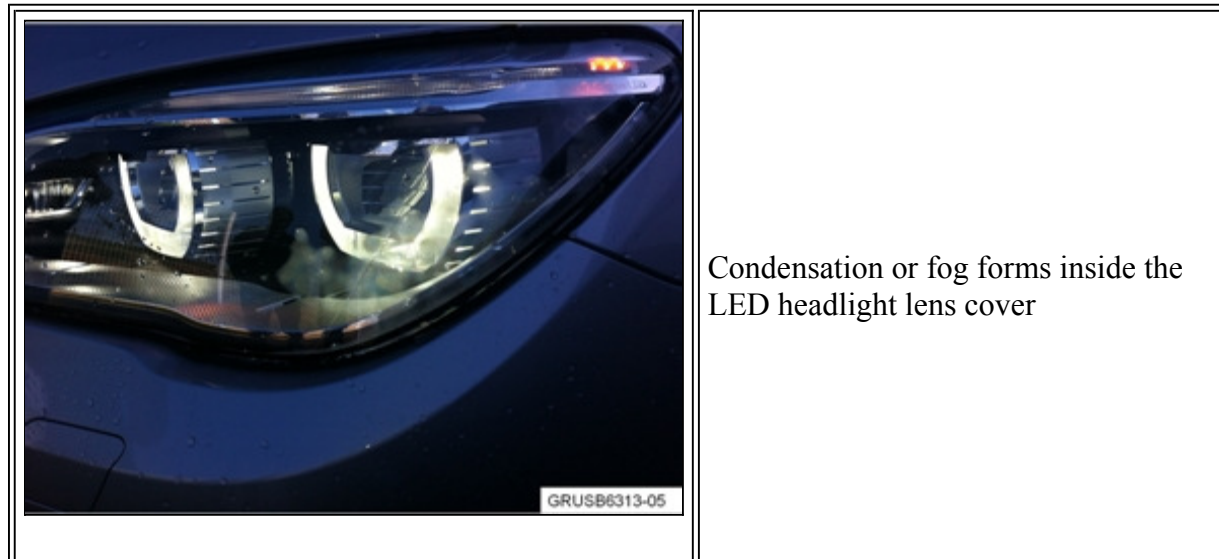
SITUATION

Water enters the headlight from the headlight ventilation filter.

Remove filter from ventilation hole.
