Noise from Steering Column Switch Center when Turning

NEW F54 (Cooper Clubman, Cooper S Clubman)

F55 (Cooper, Cooper S Hardtop 4-door)

F56 (Cooper, Cooper S Hardtop 2-door)

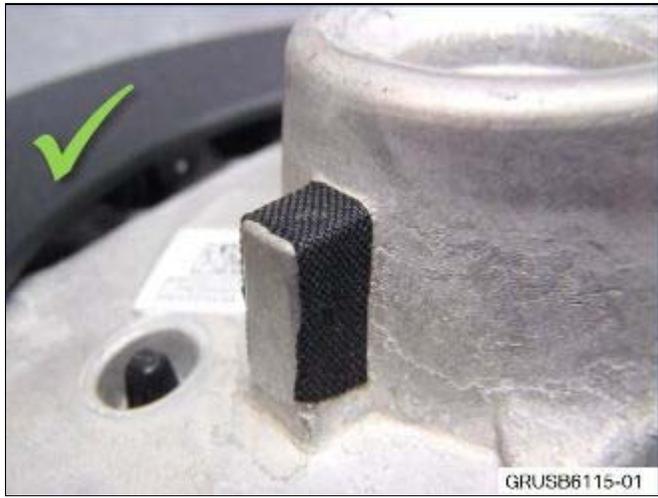
The customer states that there is a grating or scraping noise when the steering wheel is turned. The noise comes from the area of the Steering Column Switch Center (SZL).

When turning the steering wheel, the connection between the steering wheel and the SZL causes torsion stress, creating interference noise.

<ol style="list-style-type: none"> 2. Check the drive flange on the coil spring cassette for adhesive tape, as shown. 3. Install a piece of adhesive tape if it is missing. Cut a piece of adhesive tape from the felt tape set (P/N 51 45 2 353 024) to cover the area shown in the illustration.
---	--
