US 53702534-03

End cap in the cylinder head is leaking oil

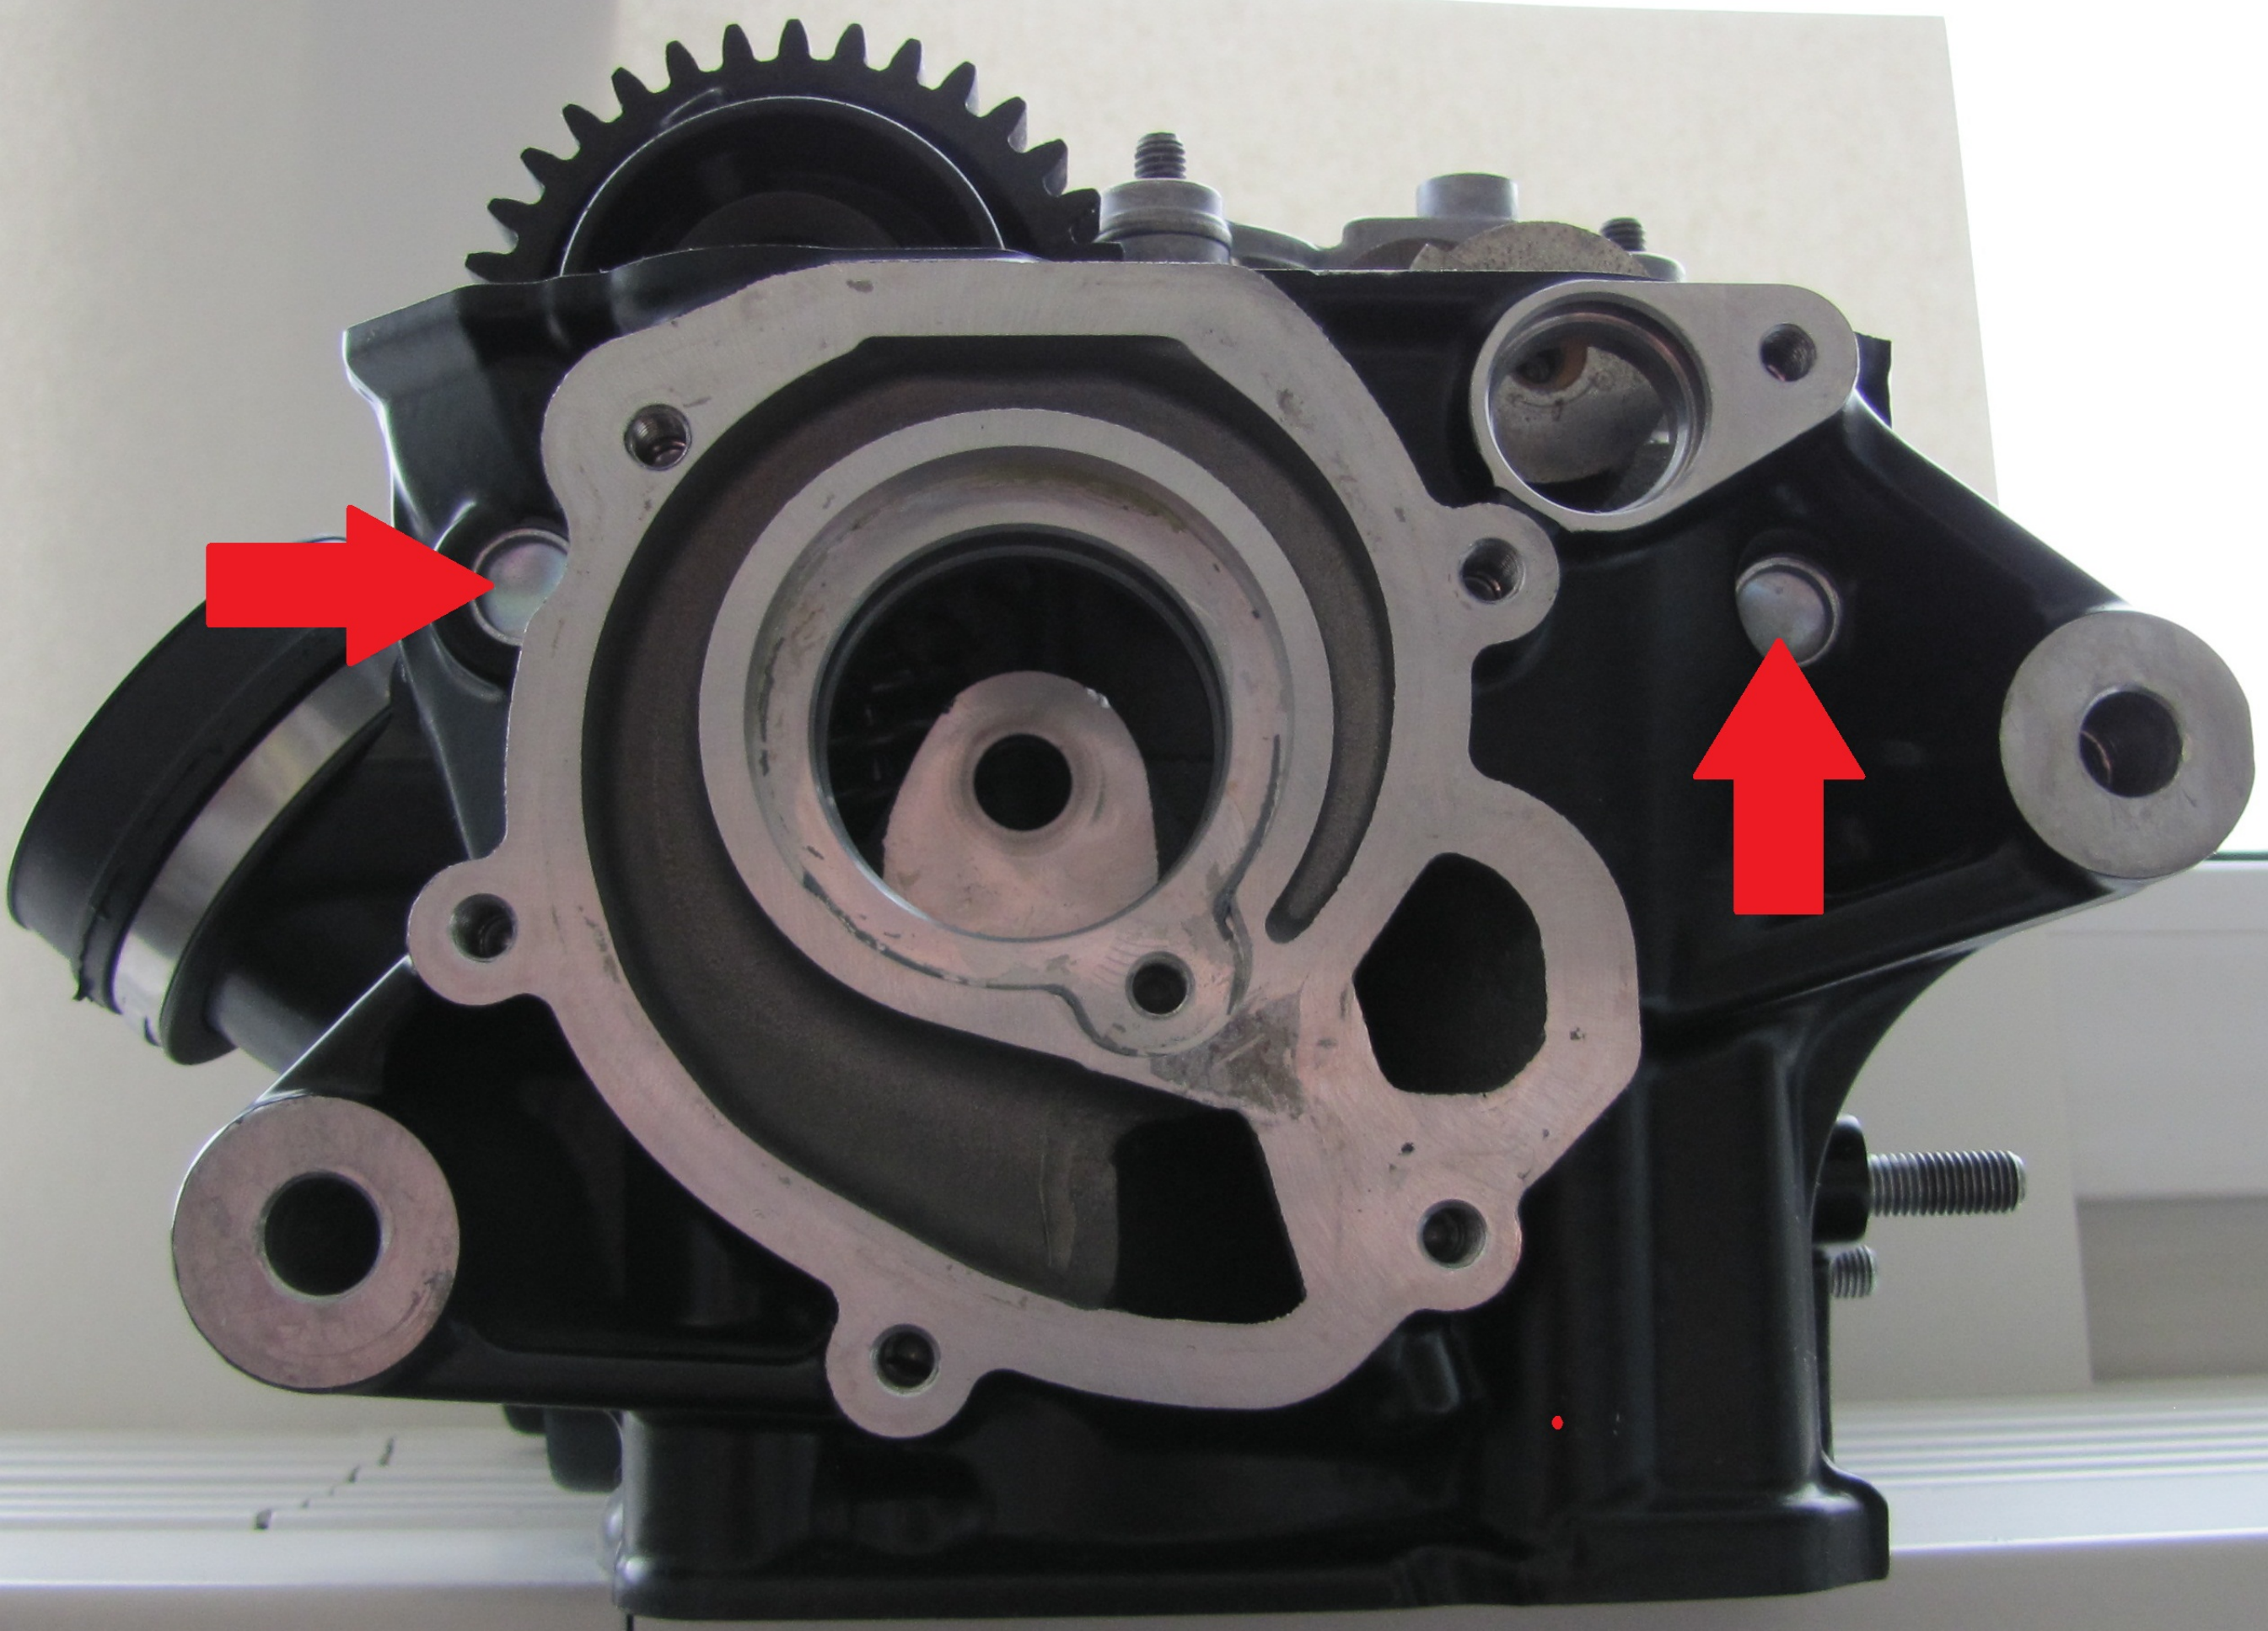
Oil leaking from one of the two end caps of the cylinder head; see attached picture

Installation error

- Mark or measure the installation location of the end cap in order to be able to install the new cap in the same position
- Drill open and remove the end cap
- Clean and lubricate the seat surface in the cylinder head
- Insert a new end cap (part number 07 11 9 906 393) with Loctite 603;

Note: curing time for the Loctite: at least 6 hours
