**SUBJECT****Noise from the Headliner****MODEL**

F31 (3 Series sports Wagon)

Produced to June 23, 2015

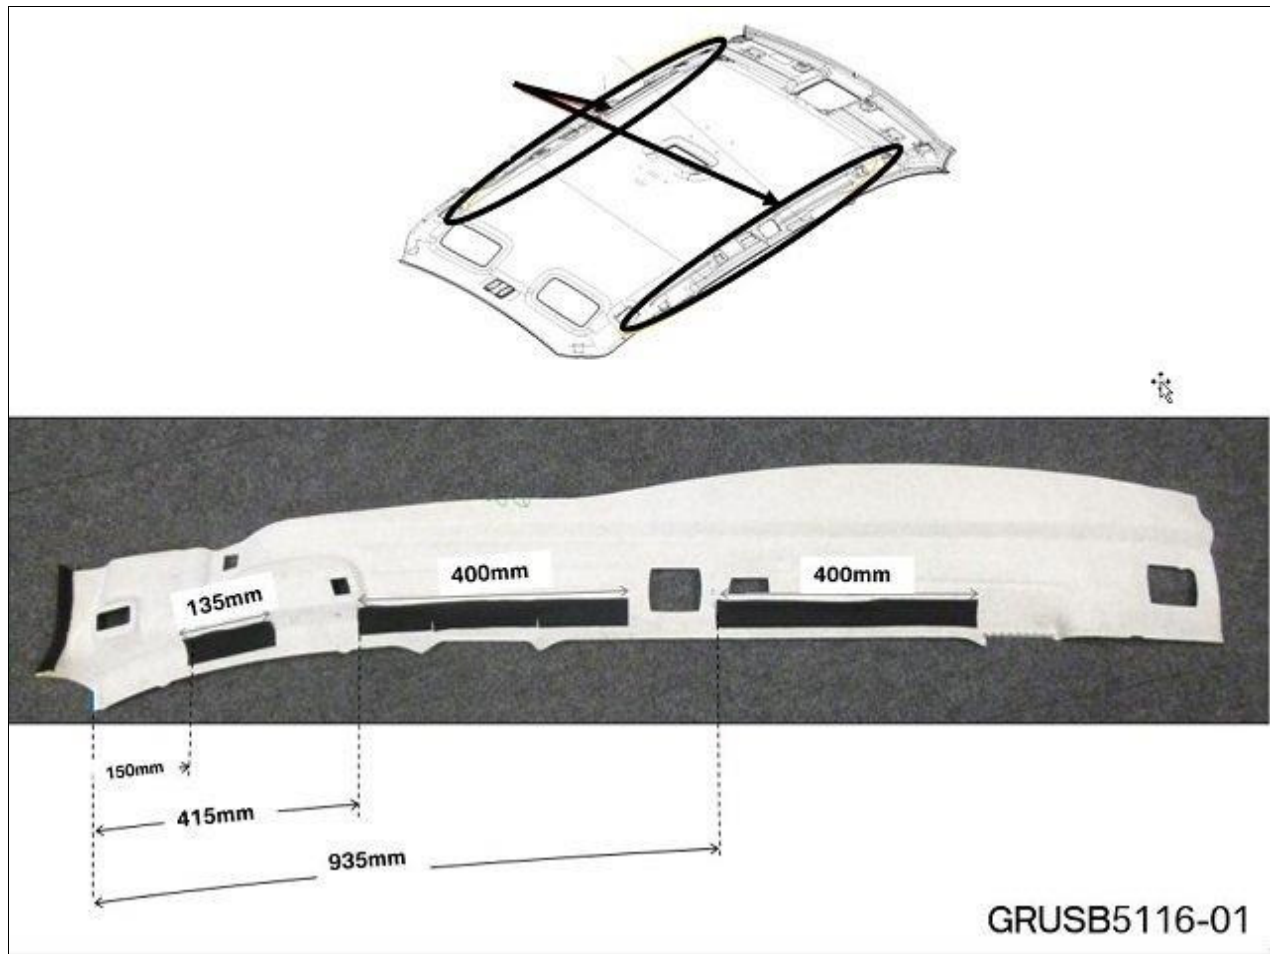
A scraping or groaning noise can be heard from the left or right side of the headliner from the A, B or C-pillar.

The head air bag fabric may rub on the headliner.

Apply self-adhesive felt tape (1mm thick) to eliminate friction between air bag and headliner.

1. Duplicate the area of the noise in the headliner.
2. Lower the headliner in the area of the noise (complete removal of the headliner is not needed).
3. Apply self-adhesive felt tape in the areas shown in the picture below (only one side is shown).

- Review Repair Instruction 51 44 011 and re-mount the affected area of the headliner.
