SI B51 04 16
Body Equipment

Groaning Noise When Adjusting Steering Column

F10 (5 Series Sedan)

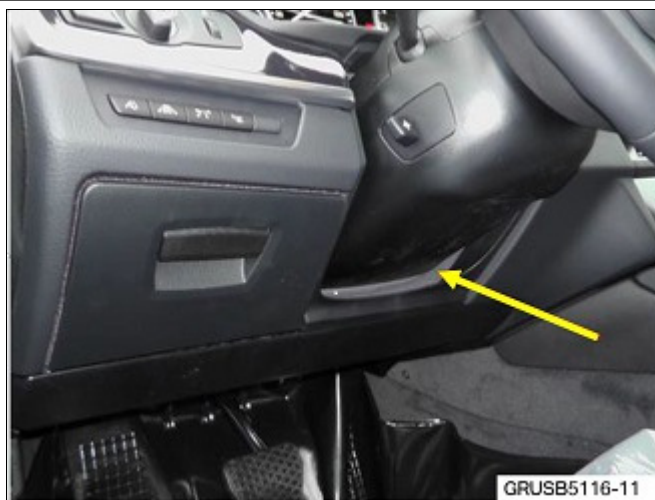
3. Locate the areas of contact near the corners of the lower trim cover.

1. Use Repair Instruction 32 31 003 to remove the upper steering column trim.

2. Use Repair Instruction 32 31 020 to remove the lower steering column trim.
