SI B51 05 16
Body EquipmentBody Equipment

Steering Column Upper Joint Cover Trim Shows Creasing

F48 X1 (xDrive 28i)

Produced to March 30, 2015

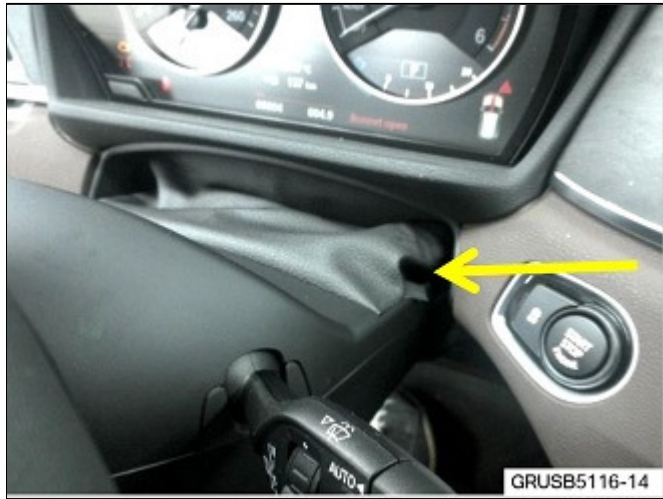
Customer can see a crease in the upper steering column joint trim, especially when moved into the lower position.

Tensioning of the upper steering column joint trim

Replace joint trim.

<ol style="list-style-type: none"> 1. Confirm the upper joint trim is creasing. 2. Use Repair Instruction 32 31 003 to replace the steering column joint trim.
---	--
