SI B51 07 16  
Body Equipment

Noises from B-pillar Trim

F36 (4 Series Coupe)

Produced from February 28, 2015 to October 31, 2015

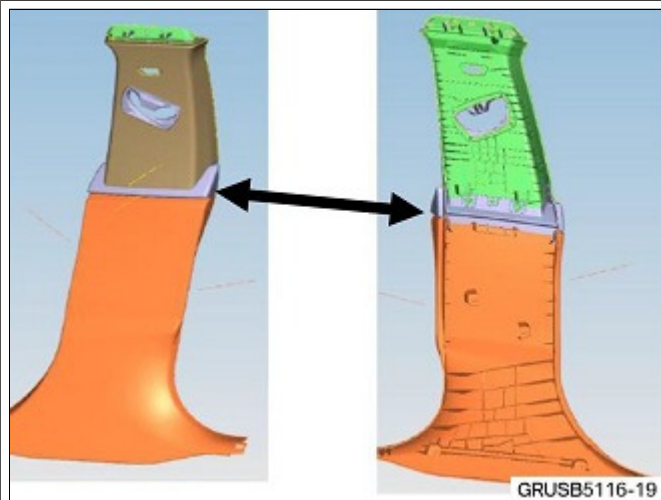
1. Use Repair Instruction 51 43 150 and remove the affected interior lower B-pillar trim.
  - The noise can occur where the upper and lower B-pillar trims meet.

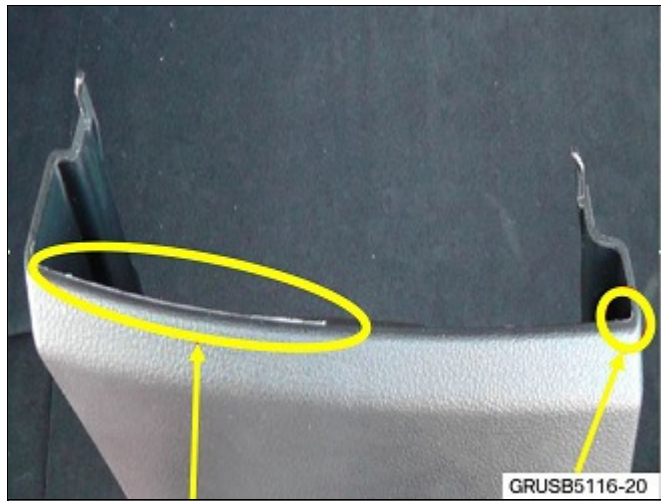
Burred edge on the inside trim of the lower B-pillar

2. Remove the burr from the lower trim with appropriate tool such as grinder, file, sandpaper or

knife.

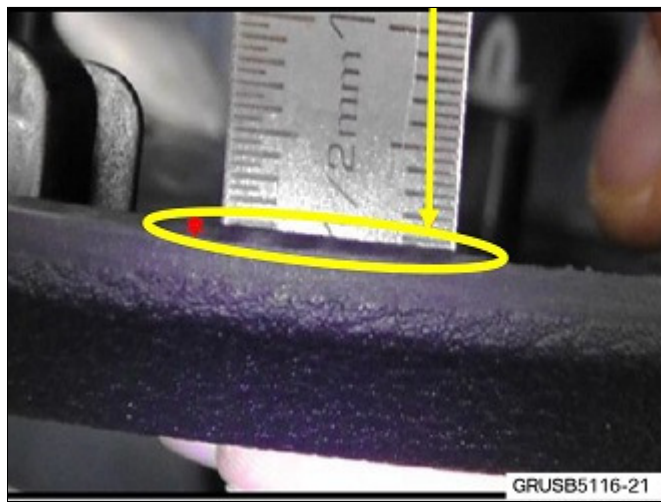
3. This is a closer look at the raised burr that needs to be removed.

Grind off raised burr of the interior lower B-pillar trim.
