**SUBJECT****A Groaning Noise from the Rear Center Console Is Heard****MODEL**

F06 (6 Series Gran Coupe)

Vehicles produced up to November 29, 2015

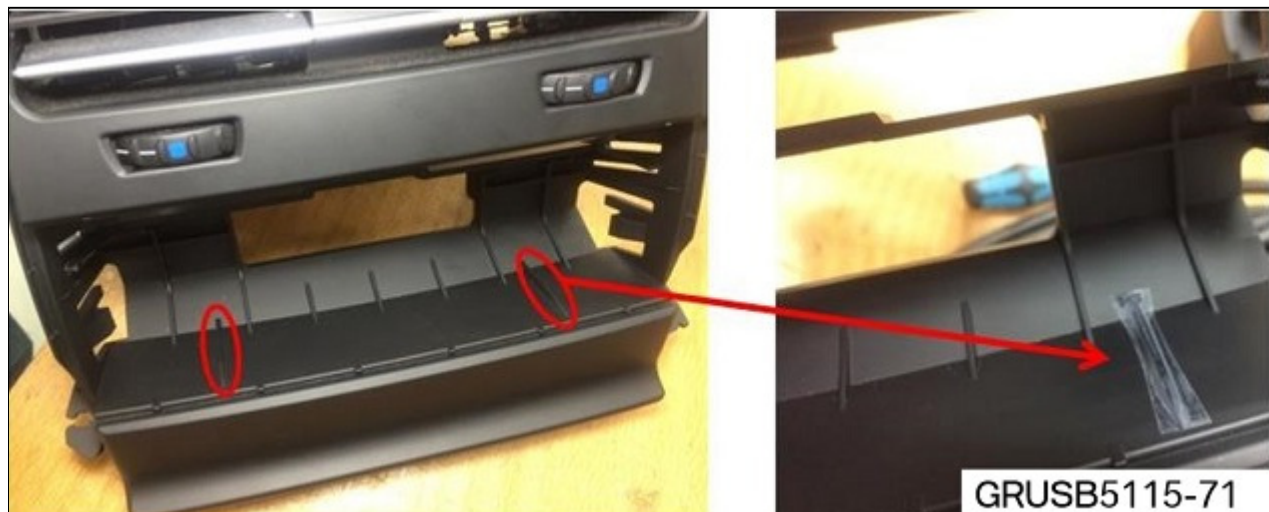
The support ribs of the rear passenger compartment air conditioning control panel rub against the left and right center console trim causing a groaning noise.

1. Remove the control panel of the rear passenger compartment air conditioning per repair instructions “64 11 395 Removing and installing control panel for rear cabin air conditioning”.
2. Bond a strip of transparent tape onto the left and right support ribs of the center console trim as shown below.
