SI B52 10 15  
Seats

### The Front Seat Ventilation Fan Makes a Grinding Noise

G12 (7 Series)

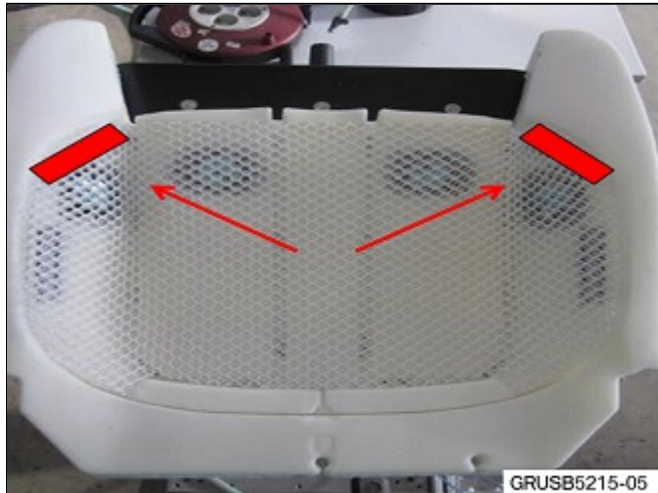
3. Inspect the adhesive attachment to the foam, as shown, for both left and right corner fan.

| <p>GRUSB5215-05</p> | <p><b>Is the adhesive improperly attached to the foam and the grill cover, interfering with the fan?</b></p> <p>YES - glue the grille cover with double-sided adhesive tape in the area shown, then go to step 4.<br/>Caution: do not glue in the area of the fans.</p> <p>NO – go to step 4.</p> |
