**SUBJECT****Head-Up Display Does not Work After Programming****MODEL**

G12 (7 Series Sedan)

Production up to June 29, 2016

With option code SA 6WB “Multifunctional instrument display”

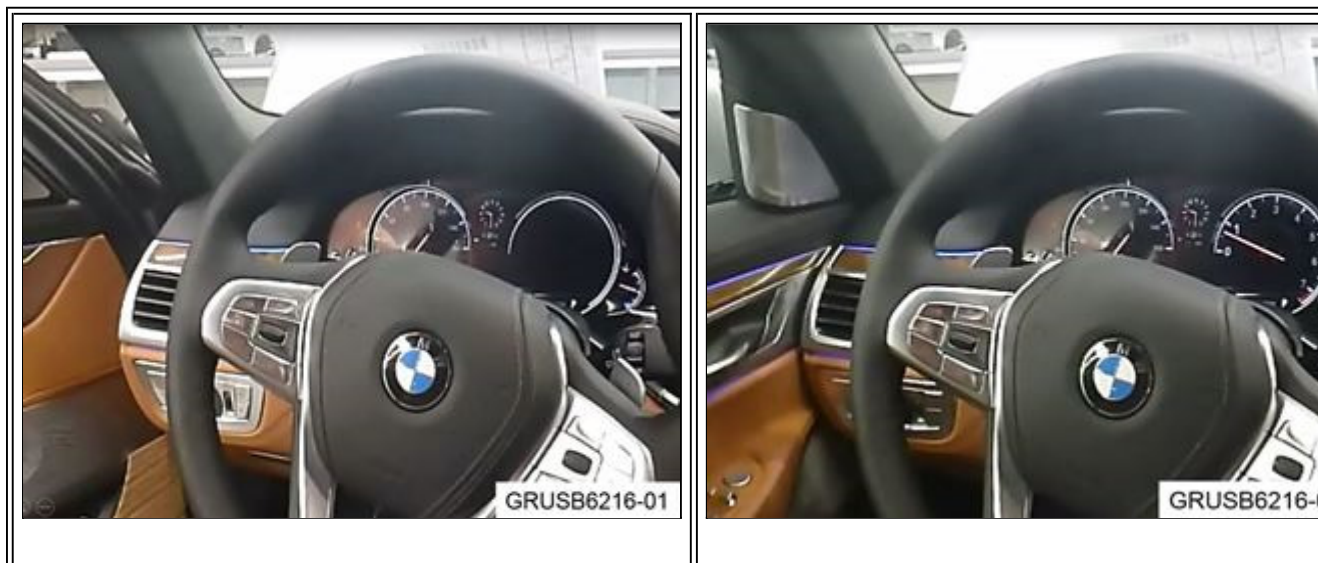
- The LED display of the tachometer in the instrument cluster is blacked out when door is opened and engine is running (shown below, left).
- After closing the door, tachometer will display again (shown below, right).
- The Check Control message is not displayed.
- HUD (Head-Up Display) does not work.
- No fault memory is displayed in the final report from ISTA/P or during PDI.

A programming abort occurred during programming of the instrument cluster causing a software error in the instrument cluster.

Manually reprogram the instrument cluster (KOMBI) control unit.

1. After confirming at least one of the situation conditions exists, start a new session with ISTA/P.
2. Manually select the KOMBI from the control unit list. Select programming and coding.
3. After programming is complete, recheck operation and function.
