Automatic Trunk Does Not Open Fully

F10 (5 Series Sedan) with option code (SA316)

Produced October 9, 2014 to April 1, 2016

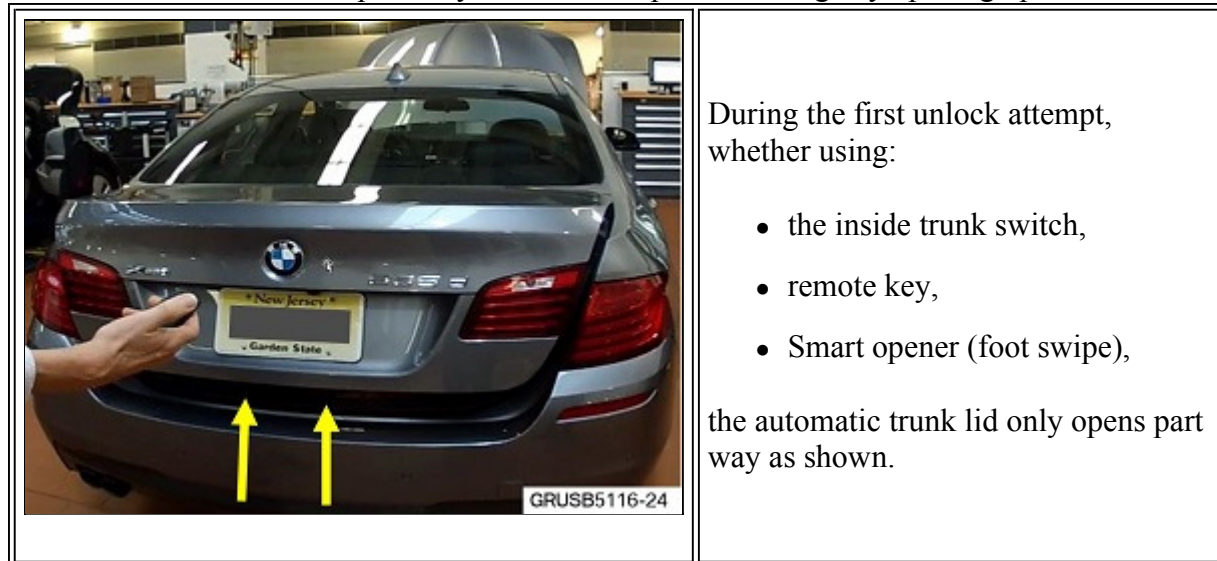
Automatic trunk does not open fully on first attempt when using any opening options.

During the first unlock attempt, whether using:

- the inside trunk switch,
- remote key,
- Smart opener (foot swipe),

the automatic trunk lid only opens part way as shown.

HKL software and trunk latch adjustment issue.

Adjust trunk lid then reprogram and code vehicle.

1. Use Repair Instruction 51 24 004 and check or adjust the trunk lid.
2. Perform diagnosis with ISTA/D and troubleshoot any related faults.
3. Program the vehicle using ISTA/P 3.58.1 or higher (integration level F010-16-03-502 or higher).
4. Activate trunk opening to make sure it operates properly.
