Service Action: Repair Roof Side Frame Paint

F82 (M4 Coupe)

Produced from January 13, 2015 to April 1, 2015

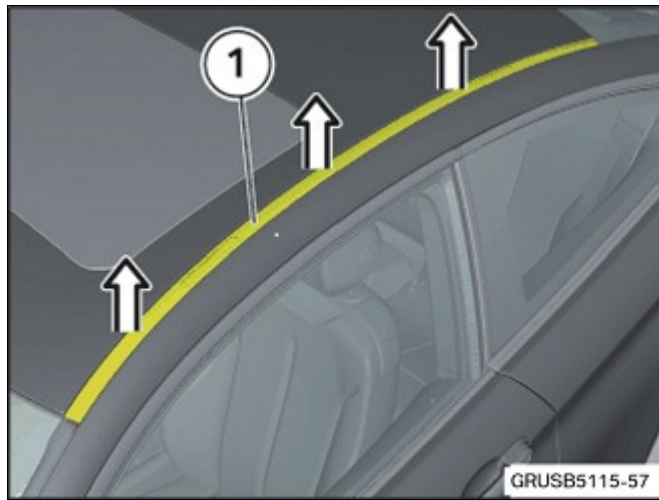
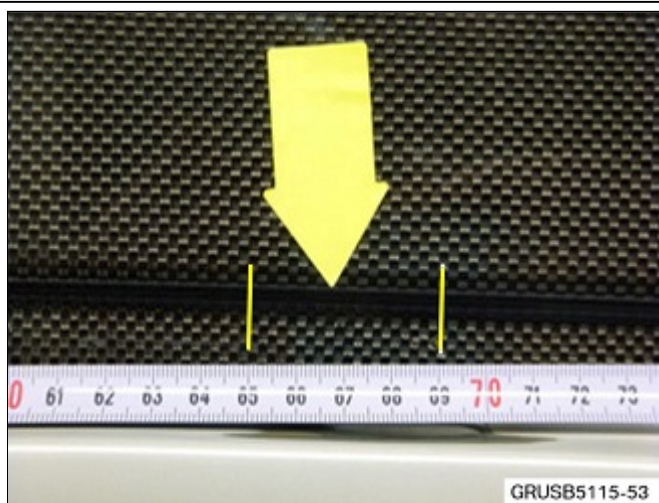
| | <ol style="list-style-type: none"> 1. Use Repair Instructions RA 51 13 280 "Remove and install or replace the trim strip on the roof frame on the left or right side" to remove the left roof side trim. |

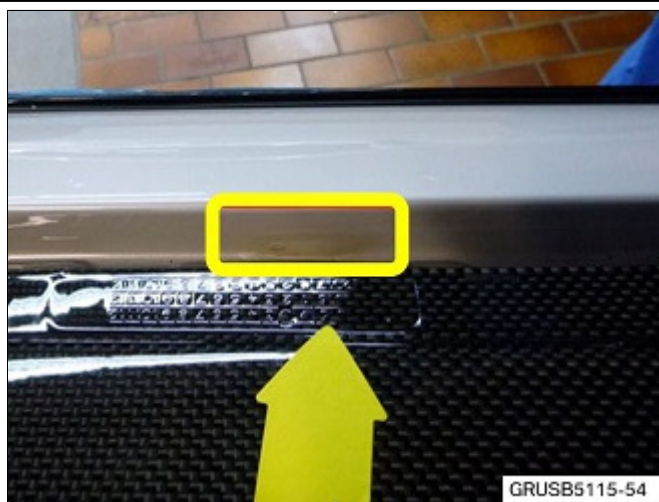
2. Locate the area by the carbon fiber roof panel. The area to be inspected is on the left side approximately 65 to 69 cm from the front edge.
3. **NEW** The area that may be affected is approximately 3 -5 cm in size and is located on the inside edge.
