SI M51 04 16
Roofliner Makes Rattle Noise Near B-pillar

March 2016
Technical Service

F54 (Cooper Clubman, Cooper S Clubman)

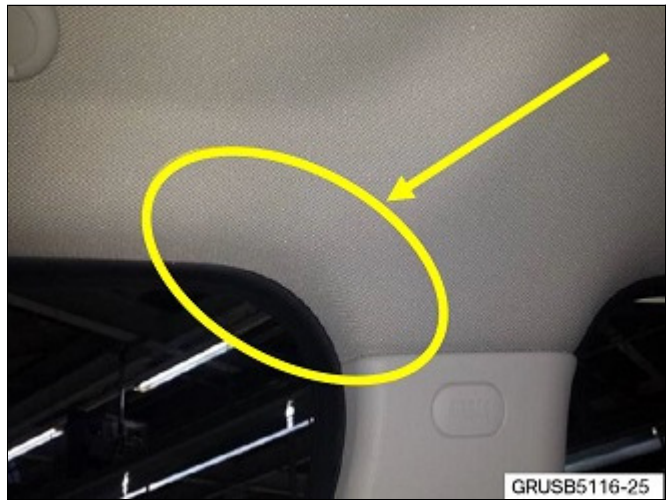
Roofliner makes rattle/groaning noise near B-pillar when driving on rough roads.

Friction between body components where the center and side frames converge

<ol style="list-style-type: none"> 1. Inspect the B-pillar area which produces the noise.
	<ol style="list-style-type: none"> 2. Remove the B-pillar trim of the affected side.

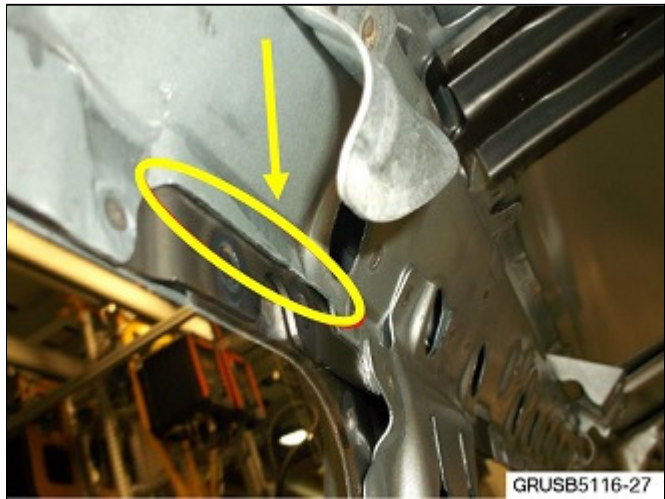
<p>3. Locate the affected area.</p> <p>Use your hand to feel where the noise is generated. Apply varying pressure to the area to confirm that the noise changes.</p>
