US 61479140-02

Float in the handbrake fitting

Vehicles affected**E series**

K49

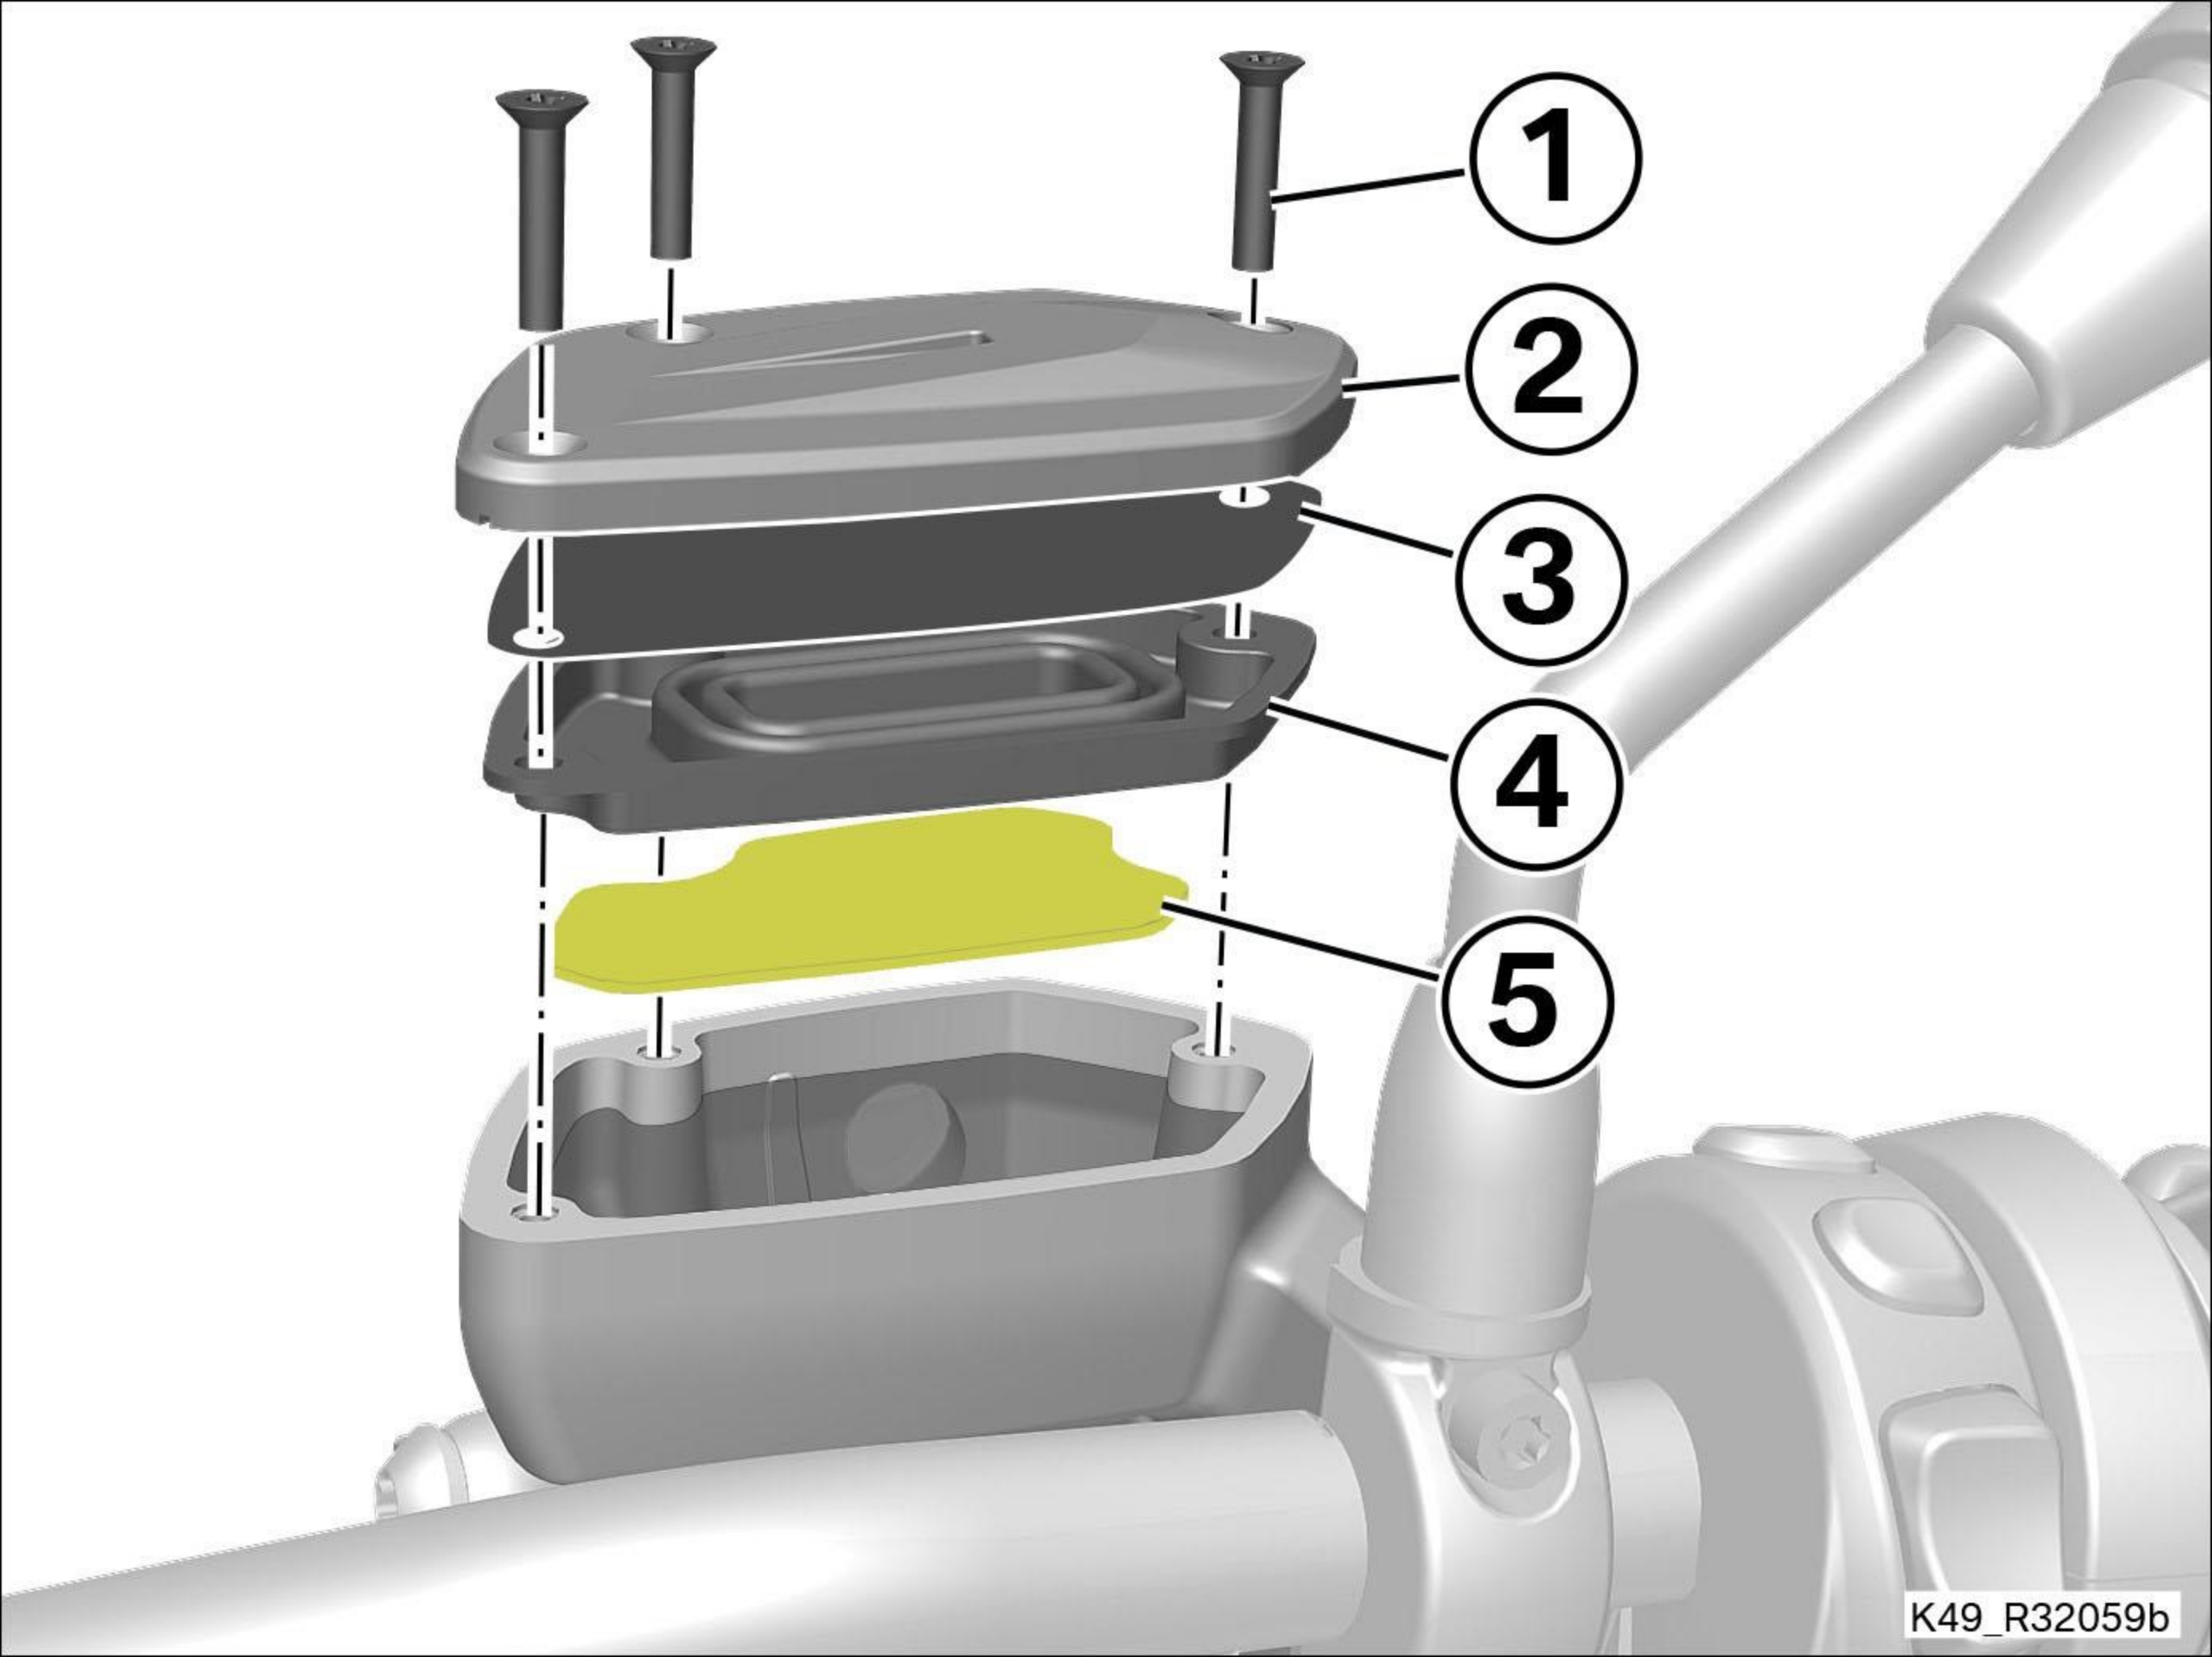
Figure 1:

When the brake system is filled with fluid for the first time in the assembly plant, a float is installed in the fluid reservoir of the handbrake fitting (see illustration 1 and 2 in the attachment). This is only required for the assembly plant filling.

If a float remains installed, it is not possible to clearly read the brake fluid level. To improve the readability, the float must be removed before the vehicle is handed over to the customer.

Components of the expansion tank

- Screws (1)
- Reservoir cap (2)
- Support plate (3)
- Gaiter (4)

- Float (5)

On all vehicles concerned, the float (5, fig. 1) must be removed from the handbrake fitting's expansion tank before the delivery to the customer. You must then check and, if required, correct the brake fluid level.

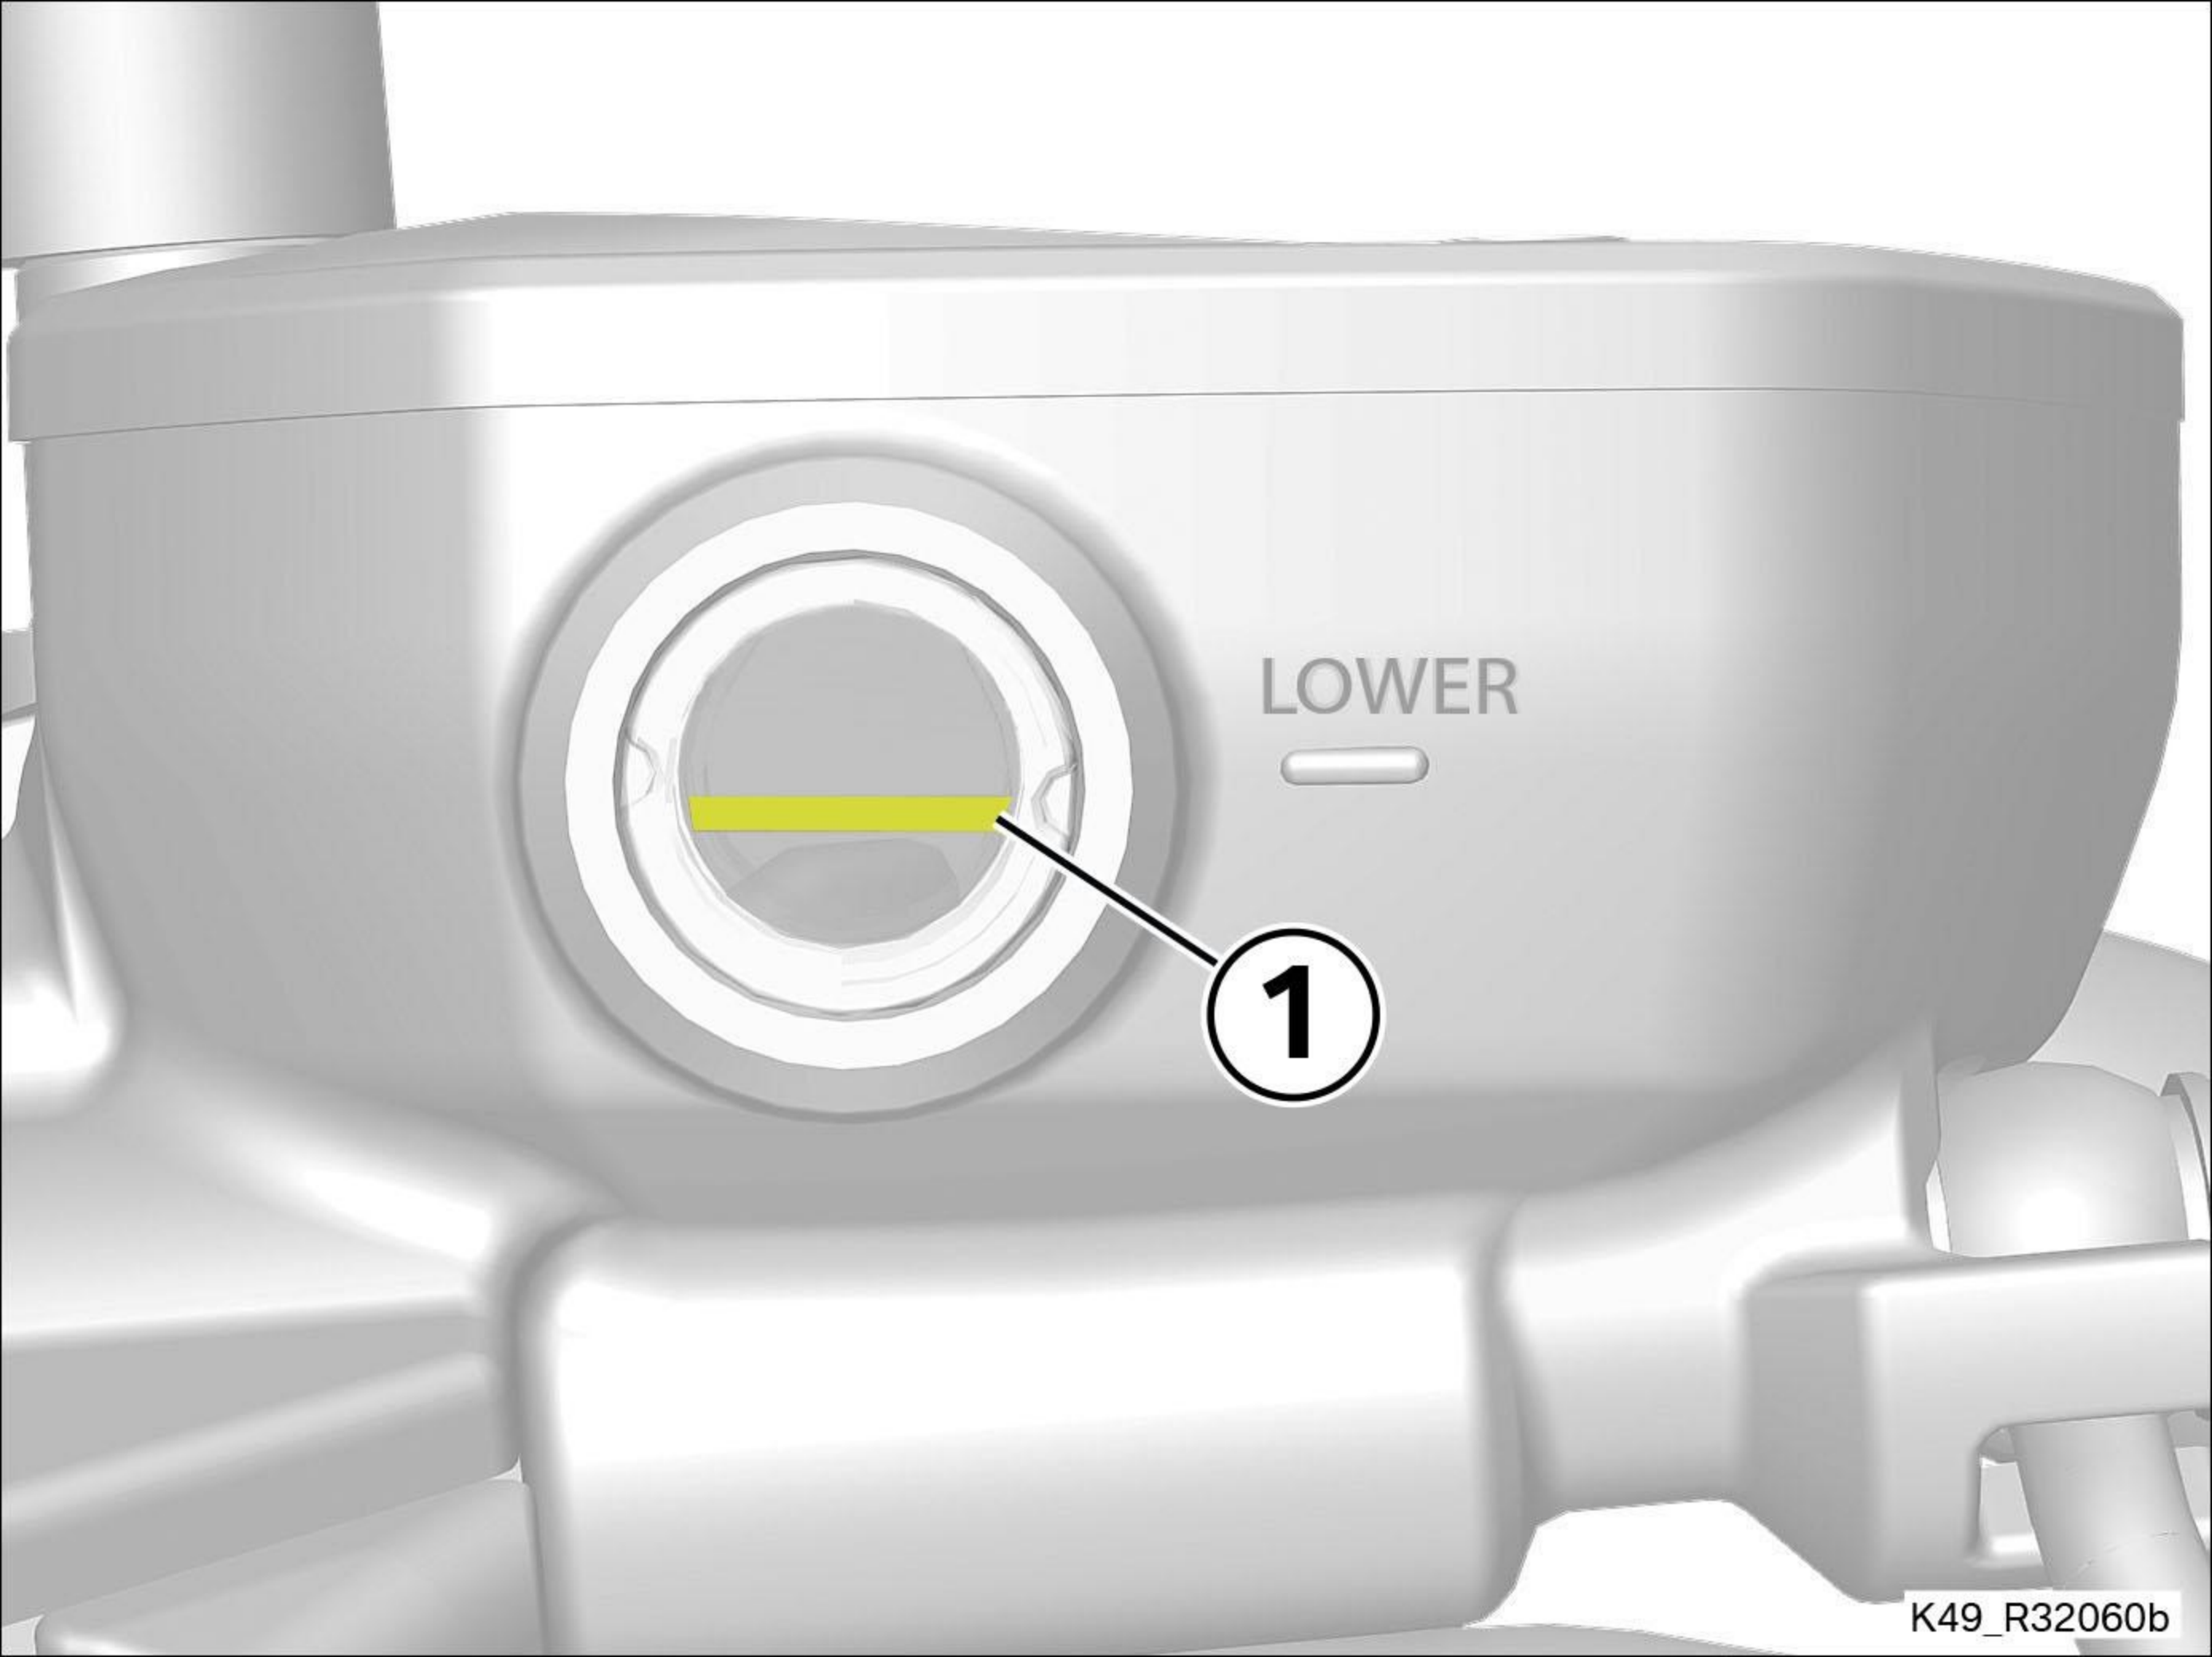
Figure 2:

Difficult to see the brake fluid level.

Expansion tank sight glass

- Float (1) (yellow)
