SI B11 08 15  
Engine

March 2016  
Technical Service

**N63 and S63 Engine: Valve Seal Replacement**

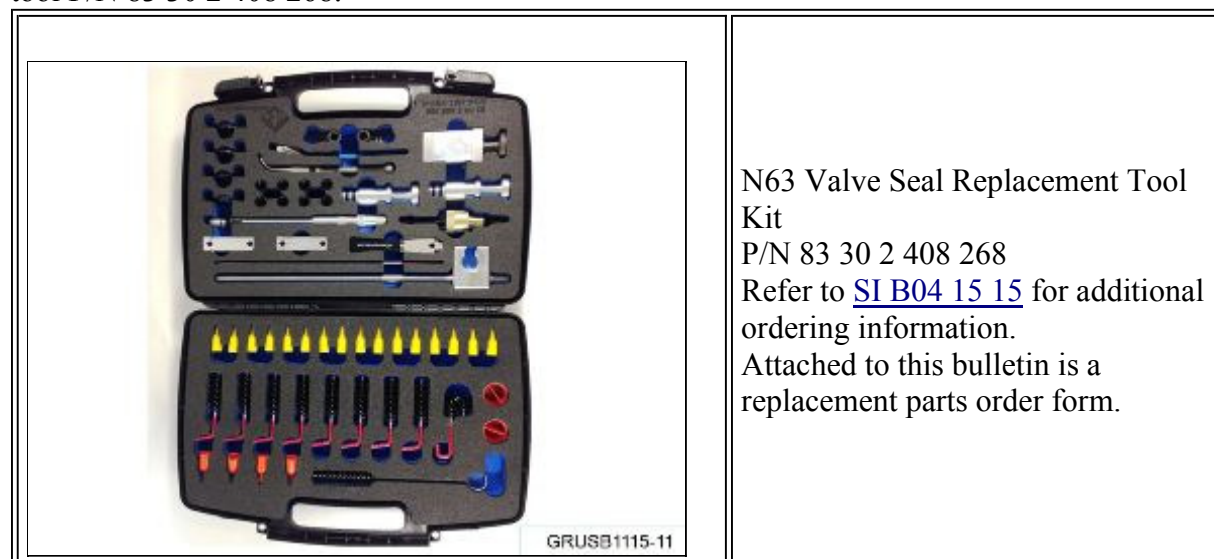
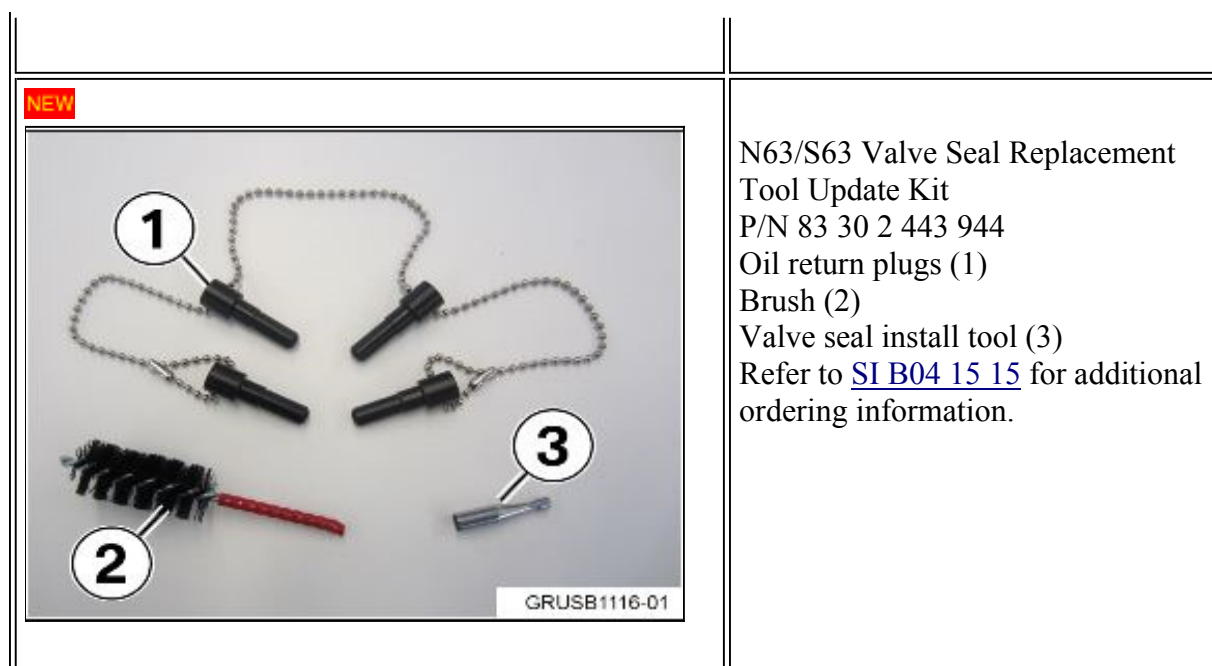
If the valve seals are leaking, one of the following will help determine if the seals should be replaced.

- Smoke from the tailpipe when starting or aggressively accelerating and decelerating the engine
- Excessive engine oil consumption
- Spark plugs fouled with engine oil

If one of these conditions is verified, replace the intake and exhaust valve stem seals using special tool P/N 83 30 2 408 268.
