### Groaning Noise from Doors over Rough Roads

F30 (3-Series Sedan)

F31 (3 Series Sports Wagon)

F80 (M3 Sedan)

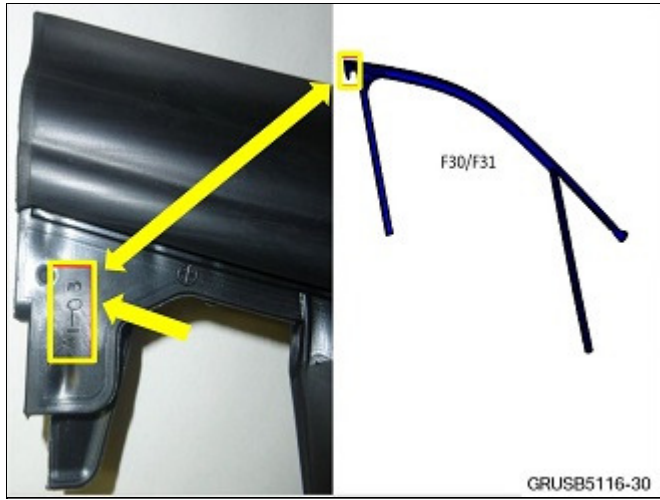
window guides.

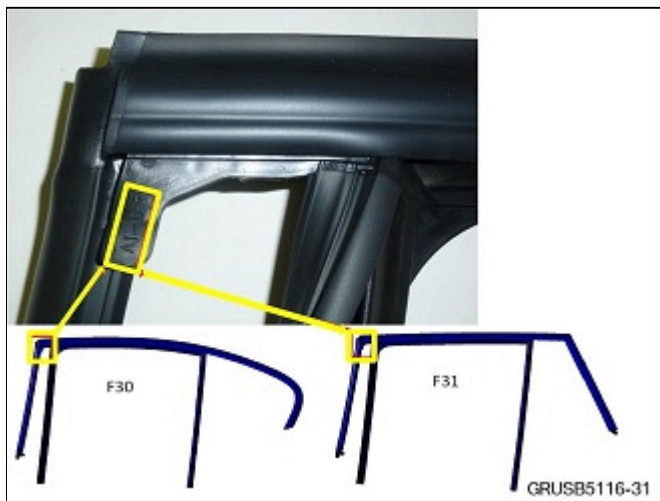
Location of revision index on the rear window guides.

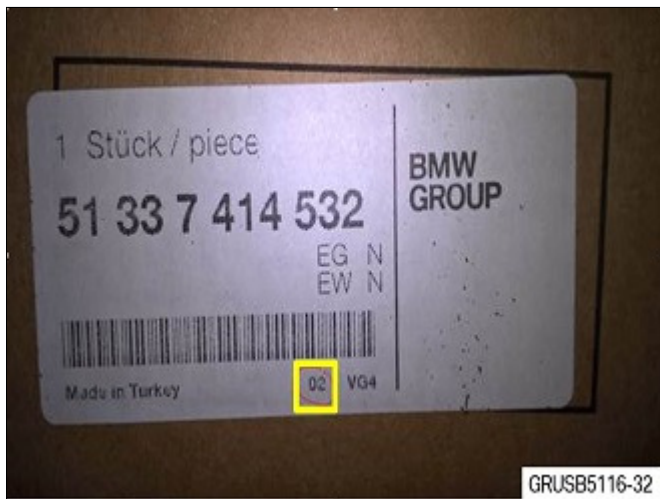
Location of revision index on shipping carton label (Note: version shown is old version "02")
