SUBJECT**Various Check Control Messages Caused by Shorted K-CAN****MODEL**

F22 (2 Series Coupe)

NEW F30 (3 Series Sedan)

F32 (4 Series Coupe)

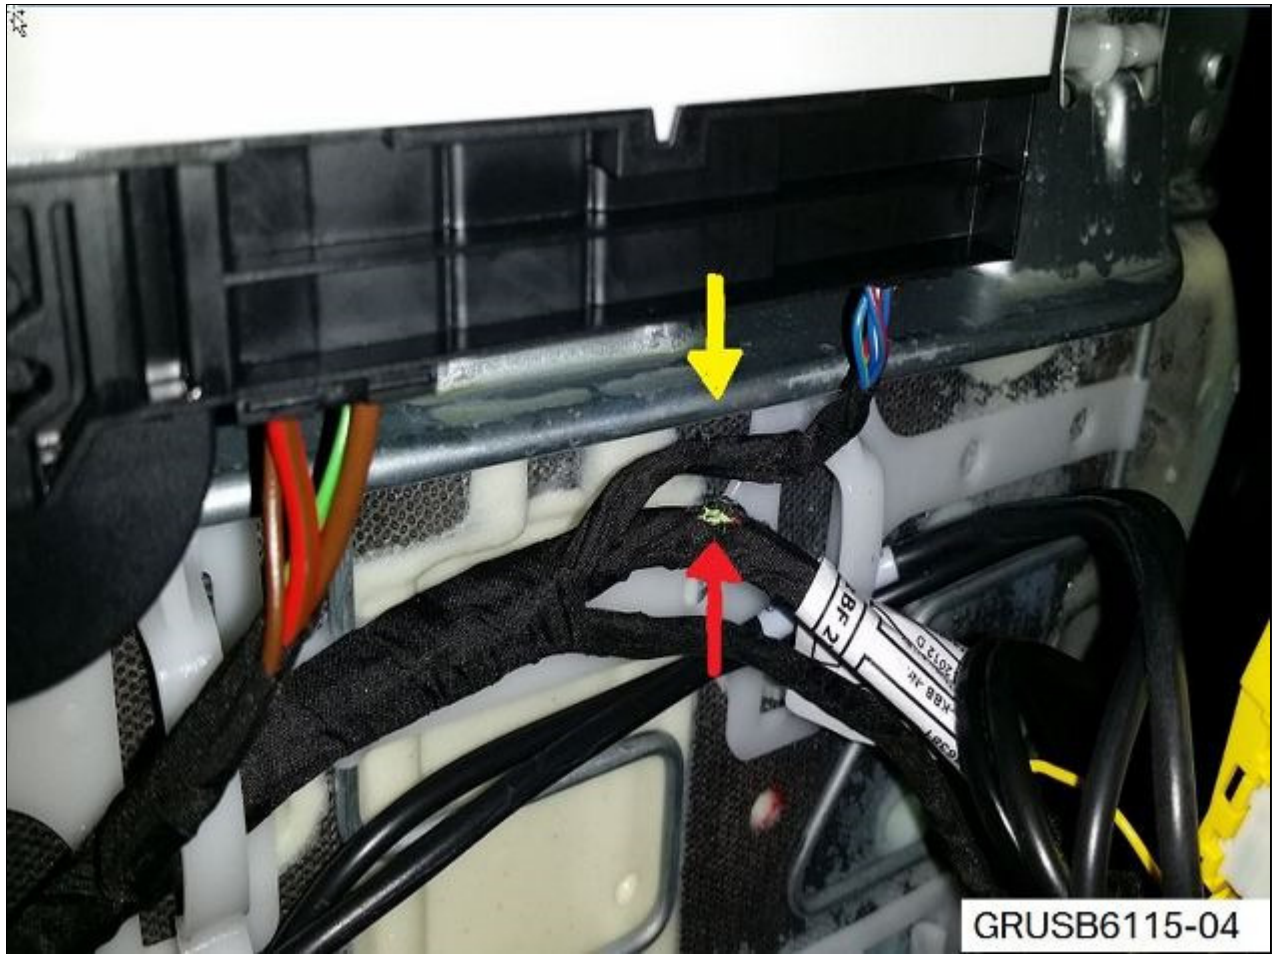
- A. Under driver or passenger front seat.

2. Repair short.
3. Reinstall all components, ensuring routing prevents future wire damage.

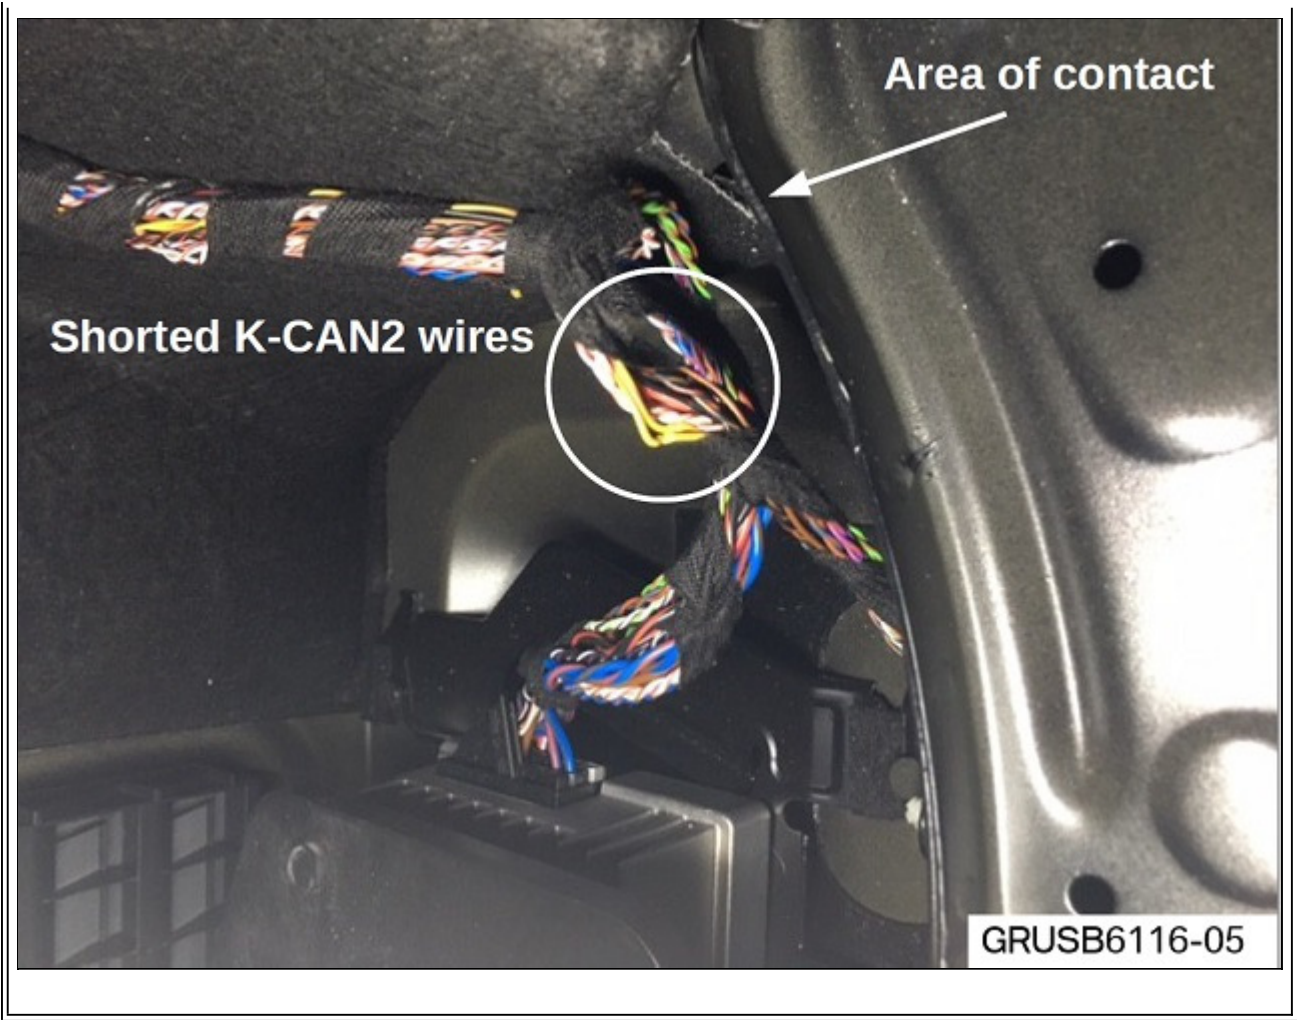
B. Between the left side trunk trim panel and the body

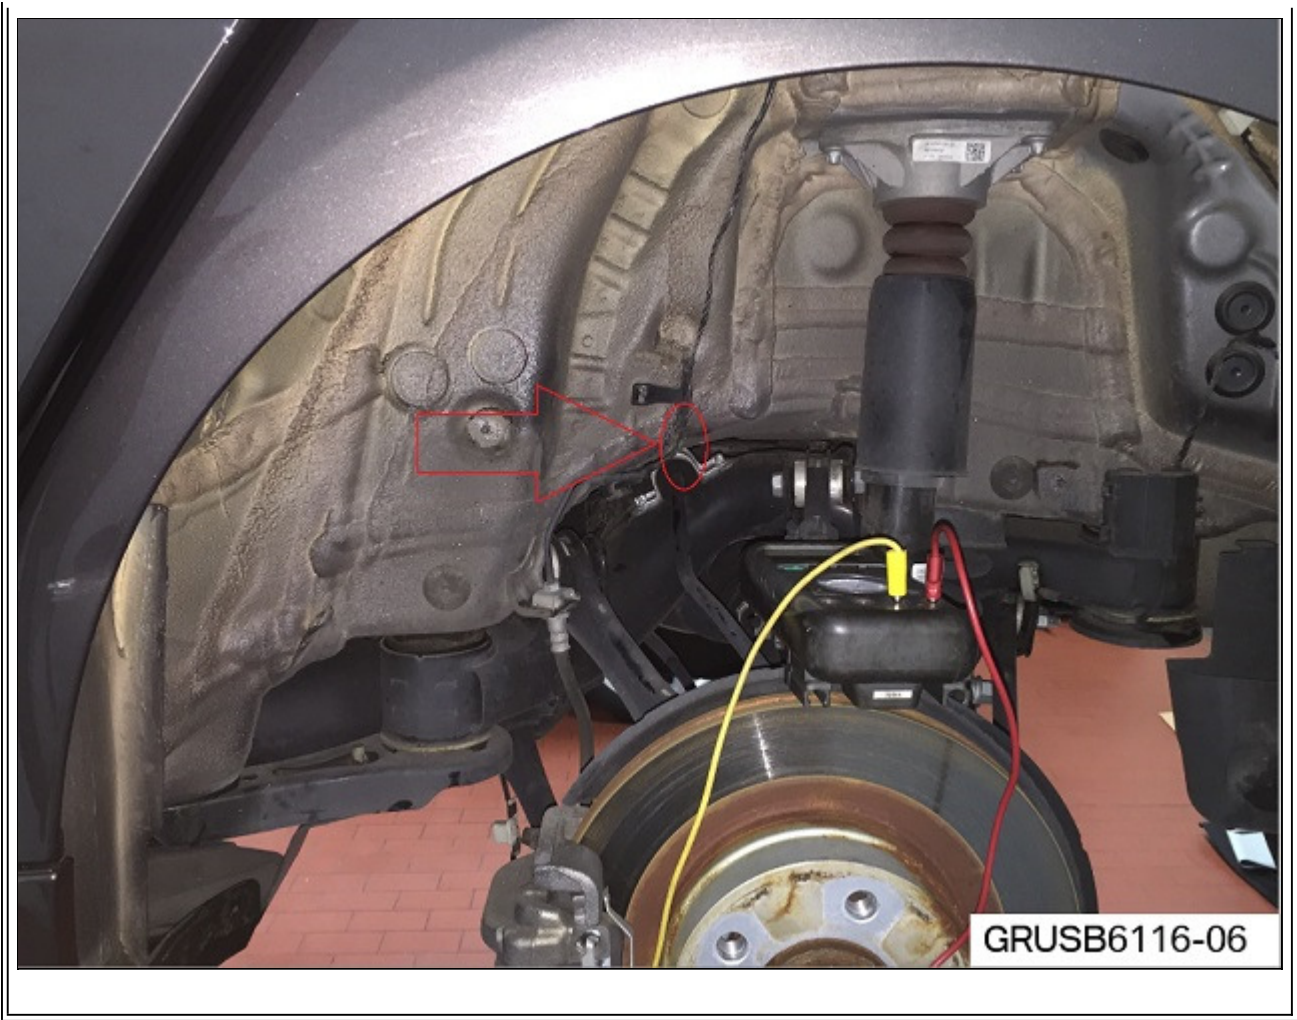
C. On the body in the left rear wheel well area

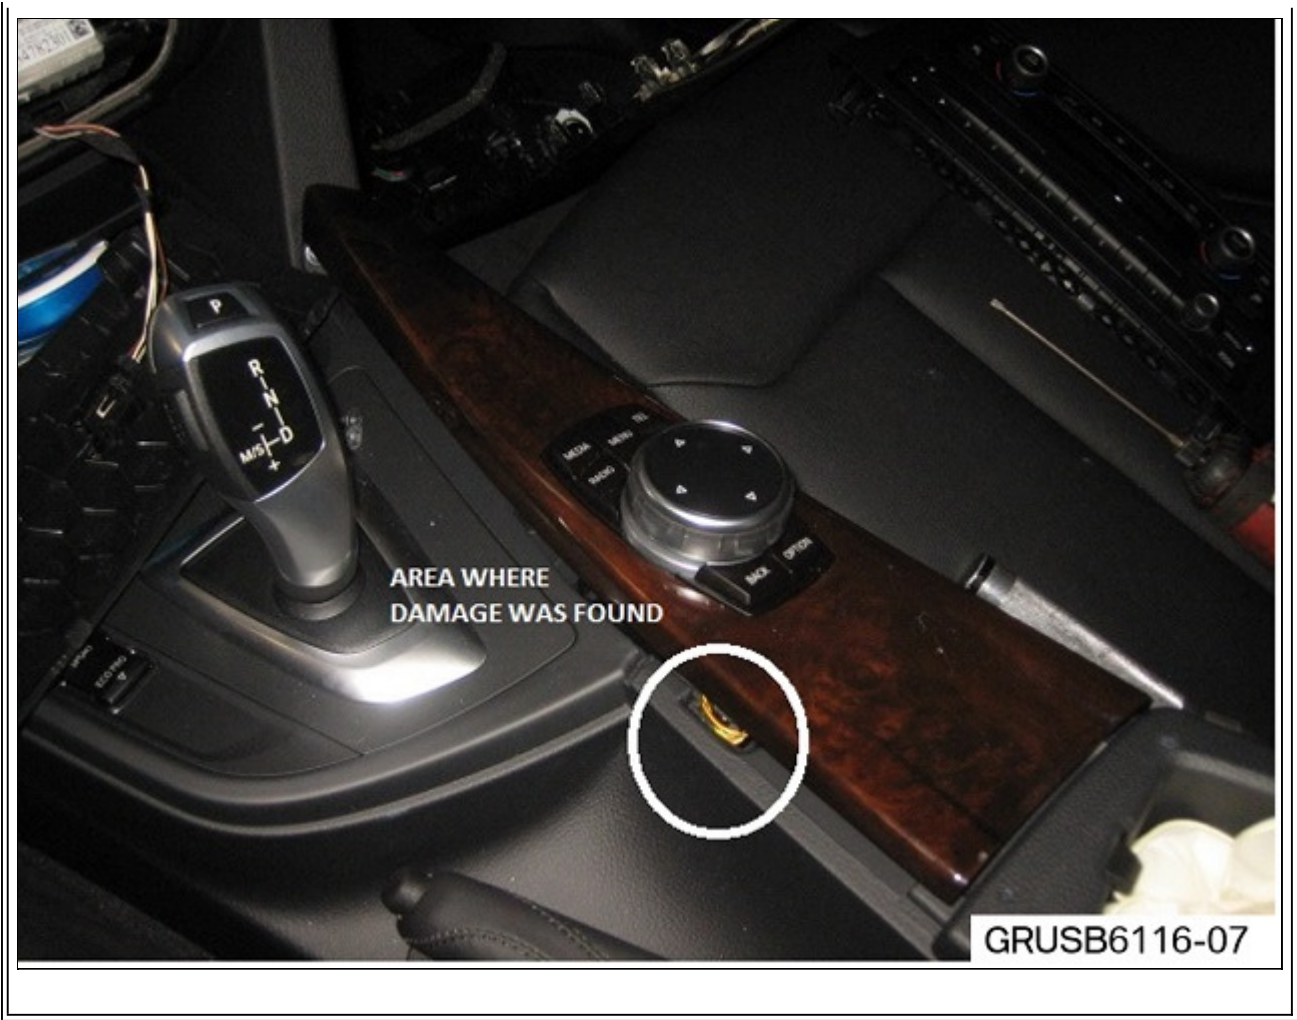
D. Under the center console trim (also check near controller)

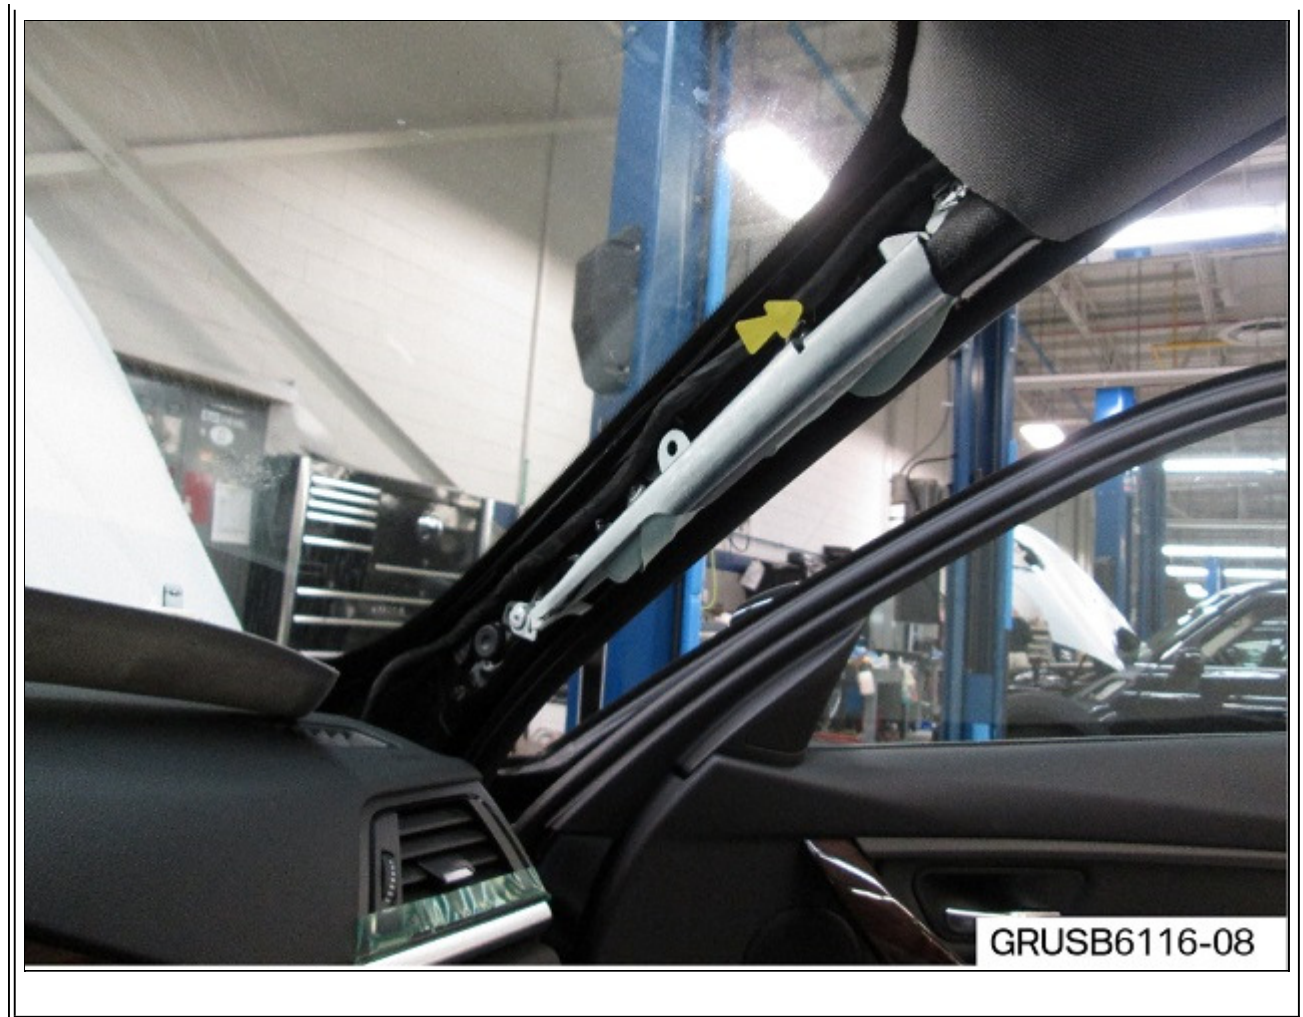
E. Short in A-Pillar behind trim (clip pinching harness)
