SI B11 09 16
Engine

N63, N63TU, S63 and S63TU Engines: Oil Leak from the Rear of the Engine and Transmission Bell Housing

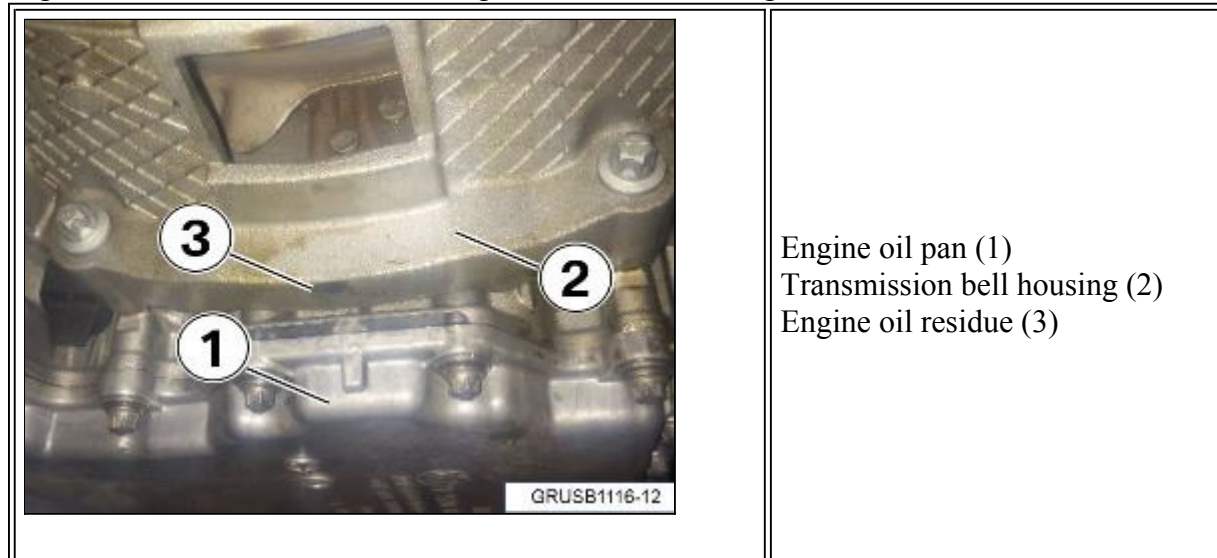
Customer complains that engine oil is leaking from the center of the vehicle. When verified, the engine oil residue can be seen leaking from between the engine and the transmission bell housing.

If the engine oil leak diagnosis described in the attachment supports the removal of the transmission, replacement of the end cover, rear and the crankshaft seal.
