Delivery Stop – Transmission Oil Cooler Lines Incorrectly Routed

F15 (X5)	F16 (X6)
----------	----------

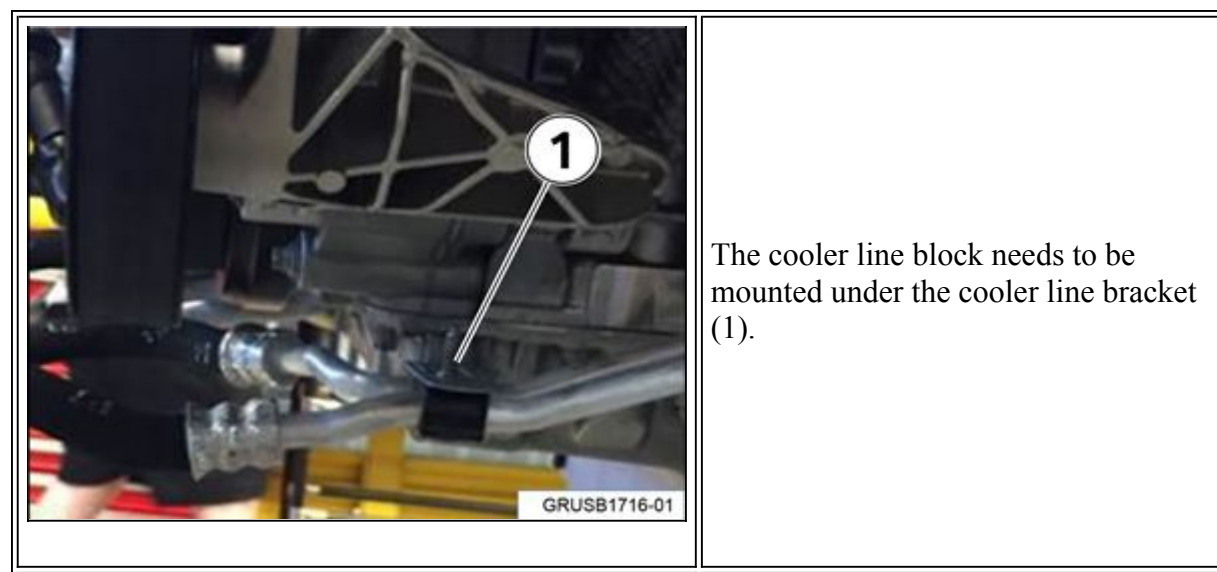
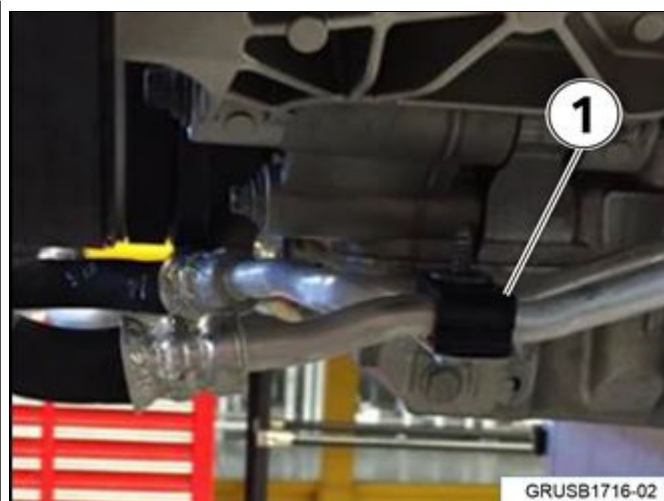
Check the mounting of the plastic retainer block for the cooler lines at the front of the engine oil pan.

The cooler line block **should not** be mounted over the cooler line bracket (1). Relocate the plastic block under the bracket (tighten bolt to 10Nm).

If the plastic block is mounted above the bracket the cooler feed line needs to be checked at the crankshaft vibration damper for abrasions. If there are any signs of rubbing on the cooler line the cooler line will need to be replaced. Follow Repair Instruction RA 22 11 110 Replace the left-hand engine carrier arm (N63) to properly replace the transmission cooler line.
