SI B31 06 14  
Front Axle

## Front Axle Noise when Turning at Low Ambient Temperatures

I01 (i3 and i3 REx)

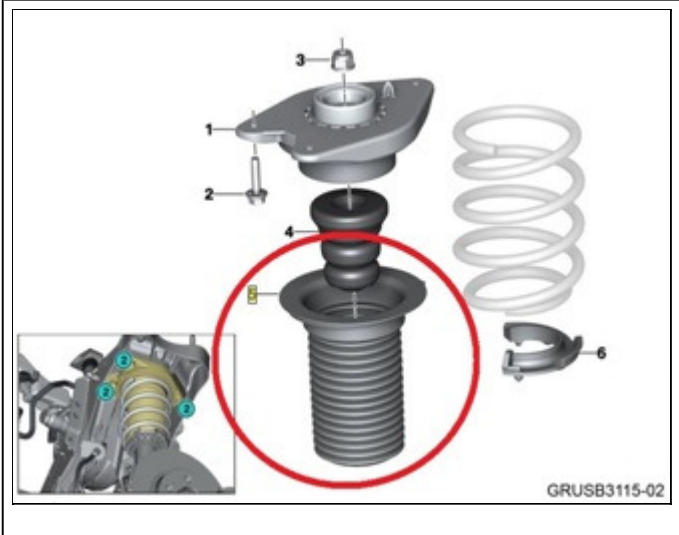
A grating and/or squeaking noise from the front axle occurs when turning at low speeds or idle.

Friction between the spring pad and the strut upper support bearing is causing the noise.

<p>Replace both upper spring pads with guard tube of the front spring struts. Refer to repair manual REP 31 31 031. The improved upper spring pads can be identified by an index 03 following the part number. <b>P/N 31 33 6 852 223-03</b></p>
---	--
