“Collision Warning Failed” or “Pedestrian Warning Failed” CCM Display
MODEL

F06 – 6 Series Grand Coupe	F07 – 5 Series Grand Turismo	F10 – 5 Series Sedan	F12 – 6 Series Coupe
F13 – 6 Series Convertible	F15 – X5	F16 – X6	F22 – 2 Series Coupe
F23 – 2 Series Convertible	F25 – X3	F26 – X4	F30 – 3 Series Sedan
F31 – 3 Series Sports Wagon	F32 – 4 Series Coupe	F33 – 4 Series Convertible	F34 – 3 Series Grand Turismo
F36 – 4 Series Grand Coupe	F48 – X1	F80 – M3	F82 – M4 Coupe
F83 – M4 Convertible	F85 – X5 M	F86 – X6 M	I01 – i3 BEv
I01 – i3 Rex	With option:	5AS – Driving Assistant	Or
5AT – Driving Assistant Plus

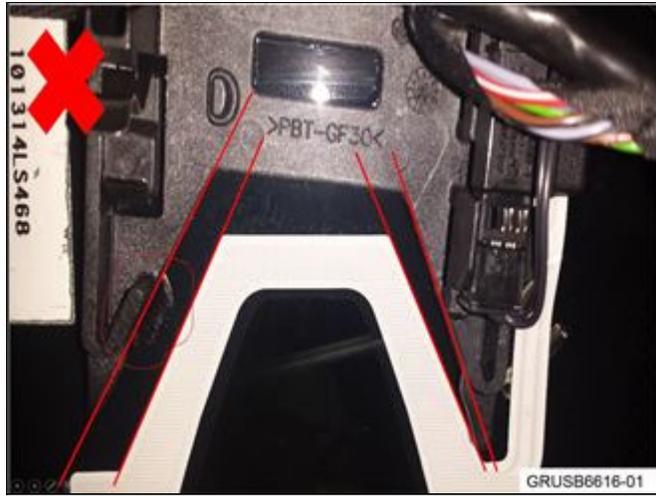
- KAFAS camera mounting bracket not secured correctly to the windshield. Notice the spacing between the white outline and the bracket.

YES – Replace the windshield. Refer to repair instructions 51 31 011 – Replace windscreen and continue from step 6.

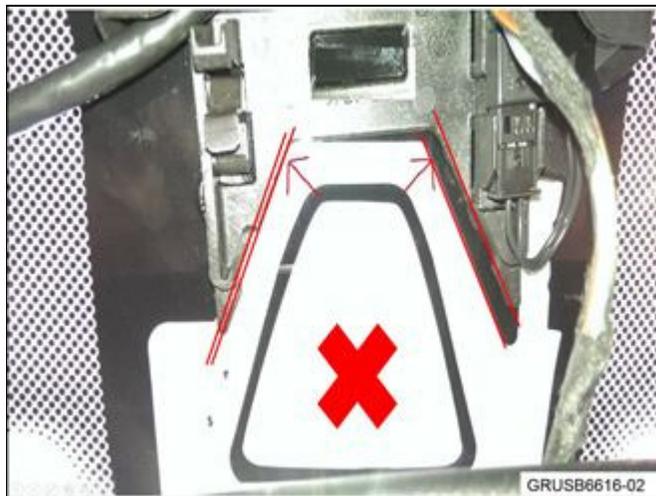
- Here is another example of KAFAS camera bracket improperly secured to the windshield.

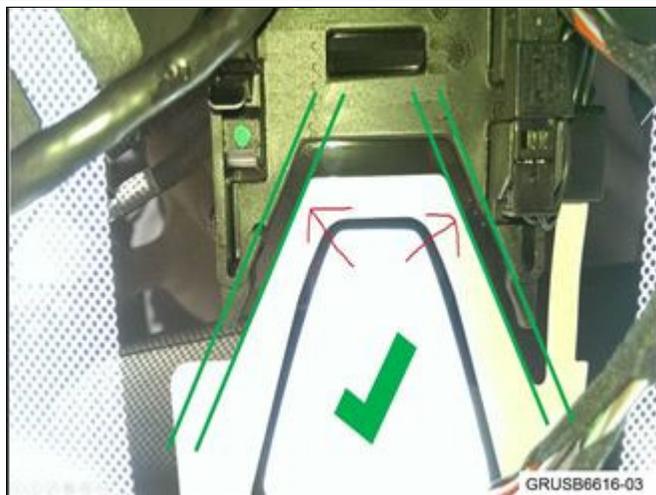
- This picture shows the KAFAS camera bracket properly secured to the windshield. Notice the spacing between the white outline and the bracket.

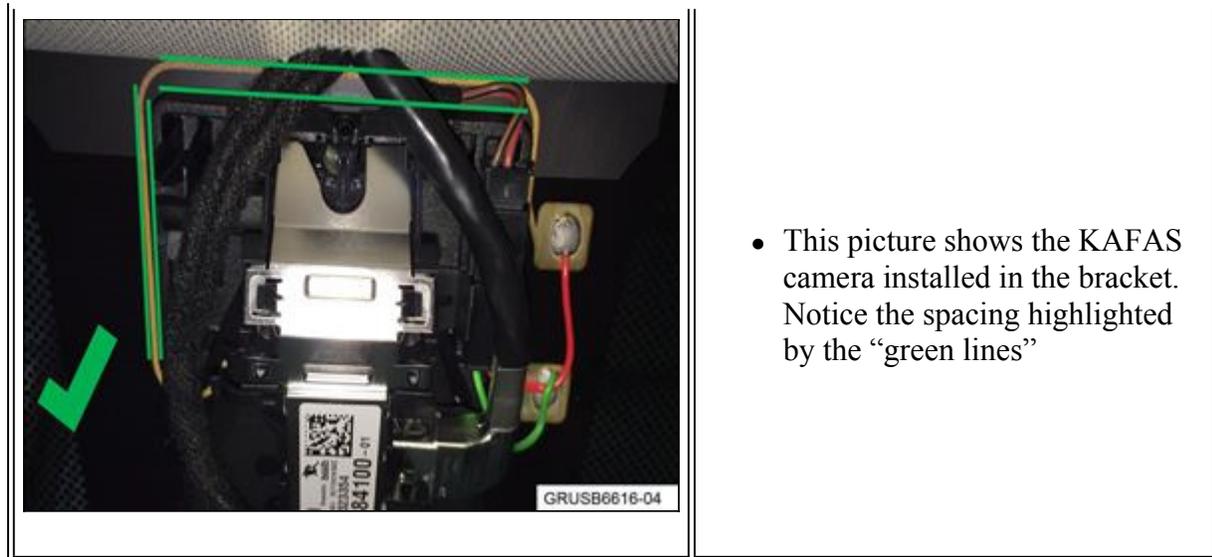
- This picture shows the KAFAS camera installed in the bracket. Notice the spacing highlighted by the “green lines”
