SI M11 03 15  
Engine

### B38 Engine: Mixture Faults Stored in DME and Cylinder Head Cover Leaking Engine Oil

| F55 (Cooper Hardtop) | F56 (Cooper) | With the B38 engine |

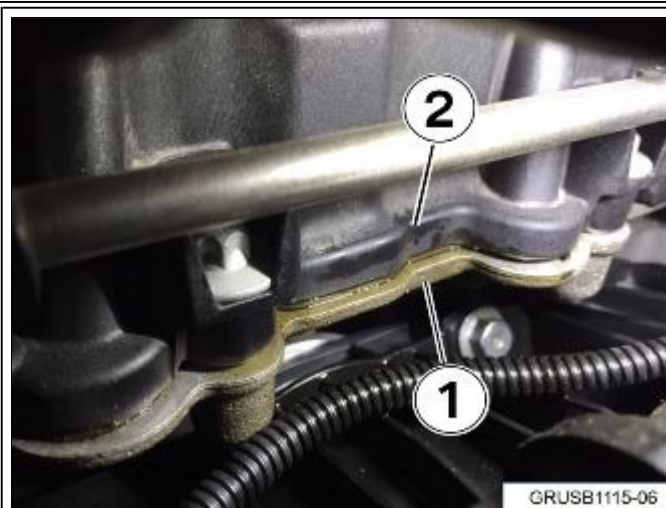
Engine oil leak (1) at the front edge of the cylinder head cover where it meets the cylinder head (2).

In some cases the cylinder head cover gasket material may be bulging out from between the cylinder head cover and cylinder head mating surfaces.

1. Replace the cylinder head cover P/N 11 12 7 611 277 that includes the cylinder head cover gasket and profile gasket for the HPP pump.

Refer to Repair Instruction 11 12 000 “Removing and installing/sealing cylinder head cover.”

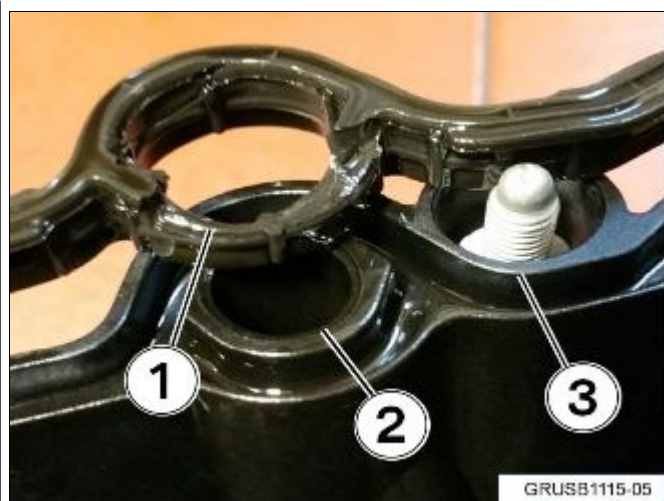
When the cylinder head cover is removed, the cylinder head cover gasket material is damaged (1) near the crankcase ventilation drains (2) or the bolt holes (3).
