Collision warning and Pedestrian Warning Failed

F54 (Cooper, Cooper S, Clubman)	F55 (Cooper, Cooper S, Hardtop 4DR)	F56 (Cooper, Cooper S, Hardtop 2DR)	F57 (Cooper, Cooper S, Convertible)
With Option 5AS - Driving Assistant

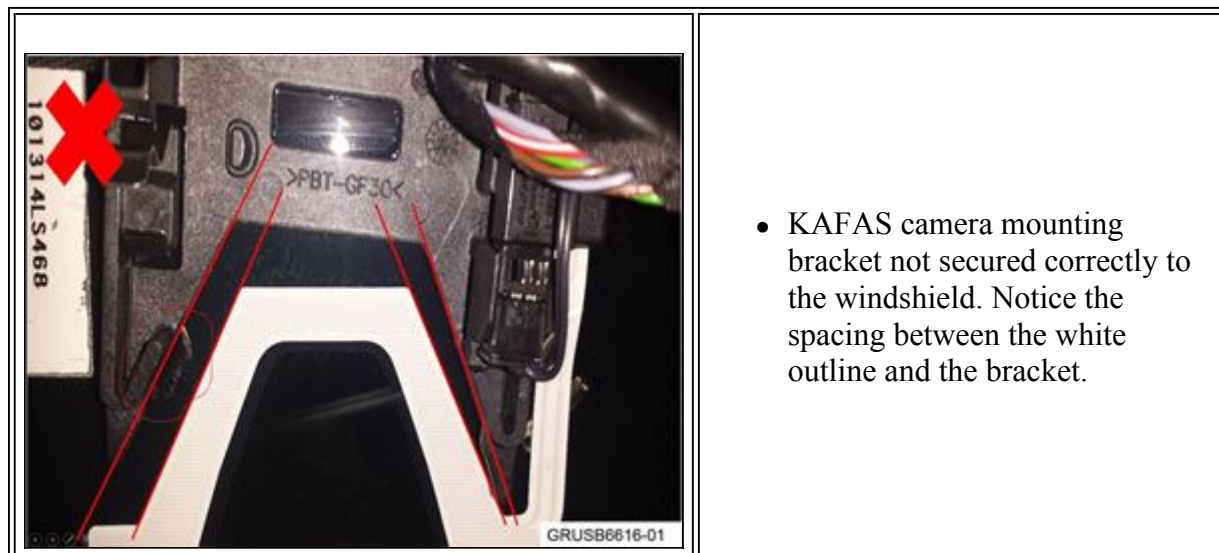
The KAFAS camera is not properly mounted and secured to the mounting bracket on the windshield,

The mounting bracket glued to the windshield is not installed correctly. The pictures below show both incorrect and correct installation.

- Verify the KAFAS camera is installed (seated) properly in its bracket
- Replace the KAFAS camera
- Replace the windshield

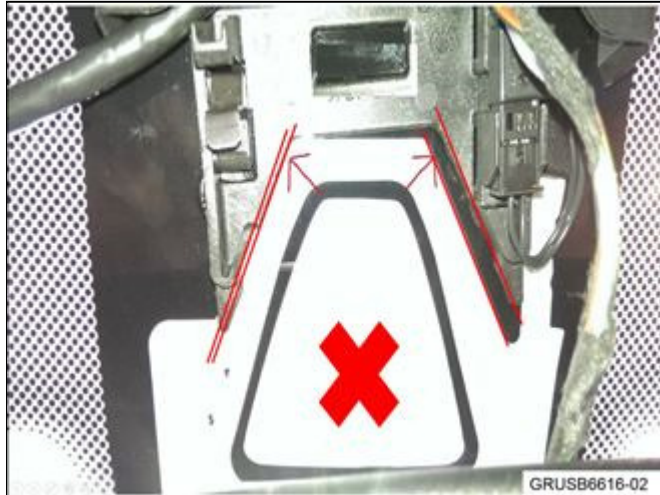
- Here is another example of KAFAS camera bracket improperly secured to the windshield.

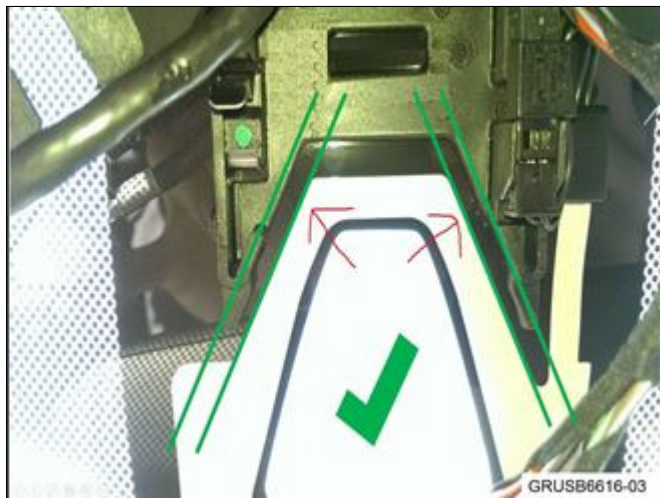
- This picture shows the KAFAS camera bracket properly secured to the windshield. Notice the spacing between the white outline and the bracket.

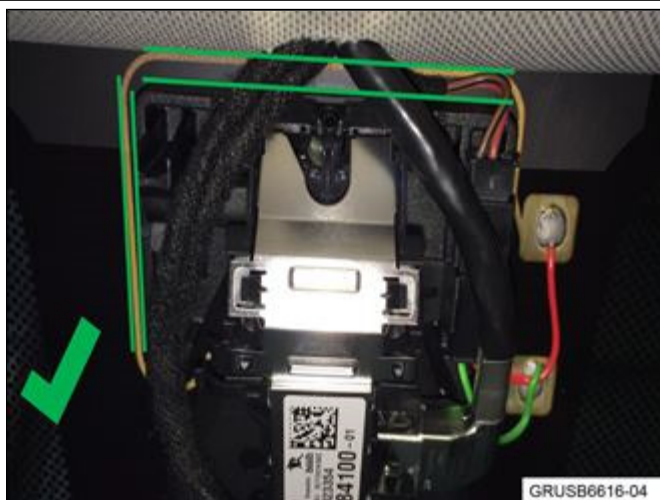
- This picture shows the KAFAS camera installed in the bracket. Notice the spacing highlighted by the “green lines”
