### Service Action: Replace the Motor Mount Screws

I01 (i3 and i3 REx)
---------------------

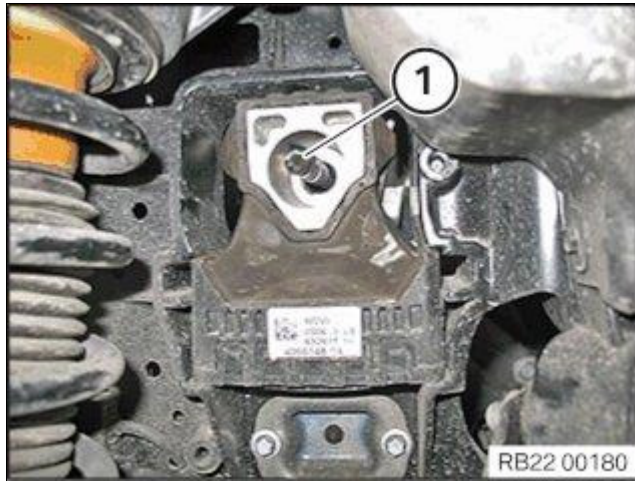
Important! During installation, the bore holes of support bearing and transmission mounting bracket must absolutely fall in line precisely. For alignment of bore holes use a suitable tool (1), for example, a drill bit with 11 mm diameter shank.
