SI B51 14 16  
Body Equipment

## Rear Spoiler Screw Connection Corroded

F34 (4 Series GT)

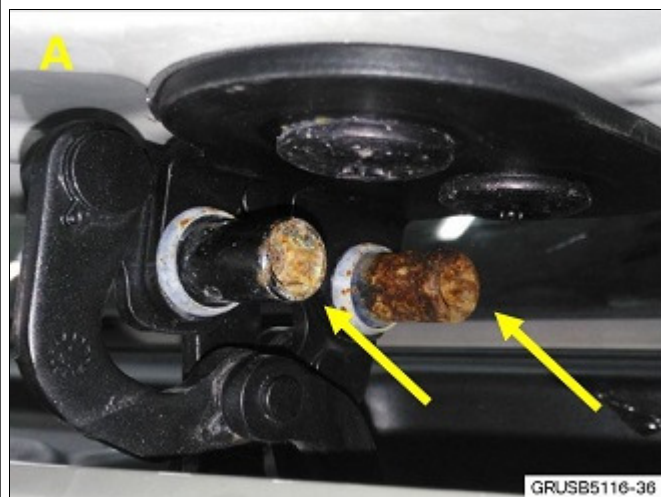
**Is corrosion present on flange nuts?**

YES – Replace flange nuts (4).

**Note: Replace flange nuts one at a time to avoid disturbing rear spoiler adjustment.**

**Tightening torque: 8 Nm.**
