SI B51 19 16
Body Equipment

STEERING COLUMN STALK SWITCH STICKING

| i12 (i8) |

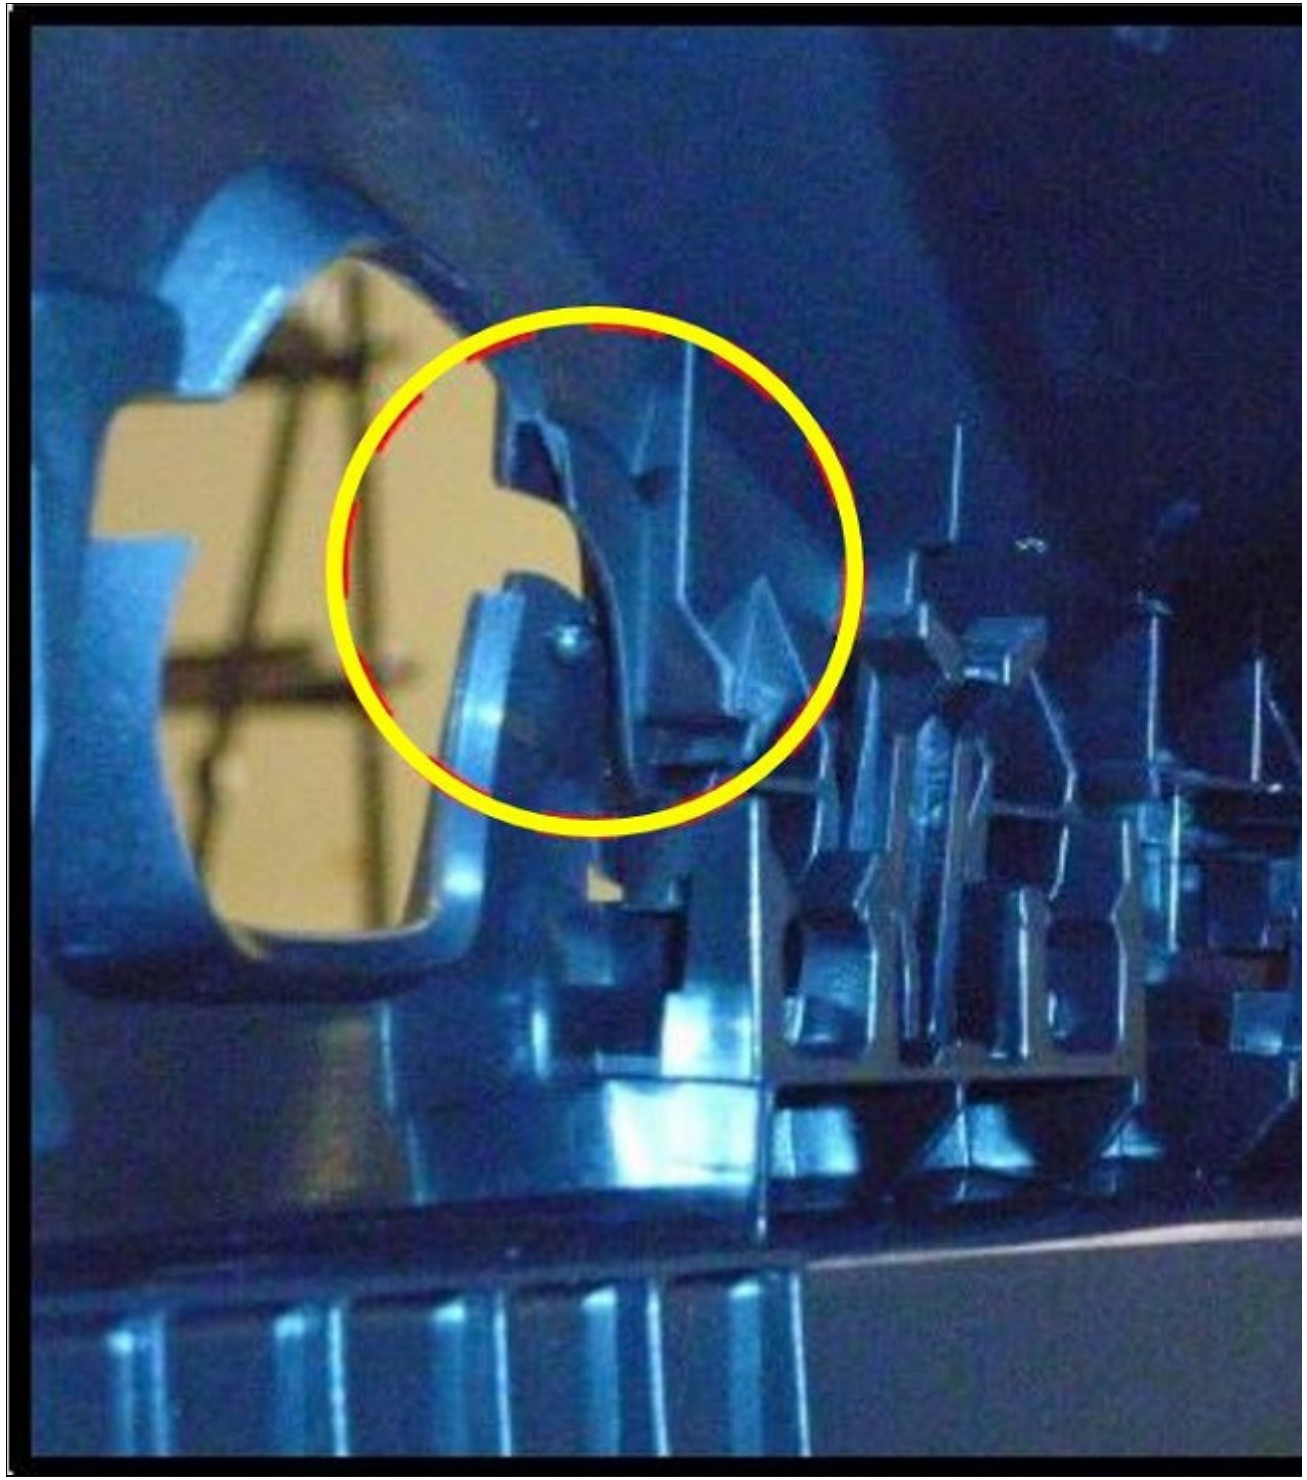
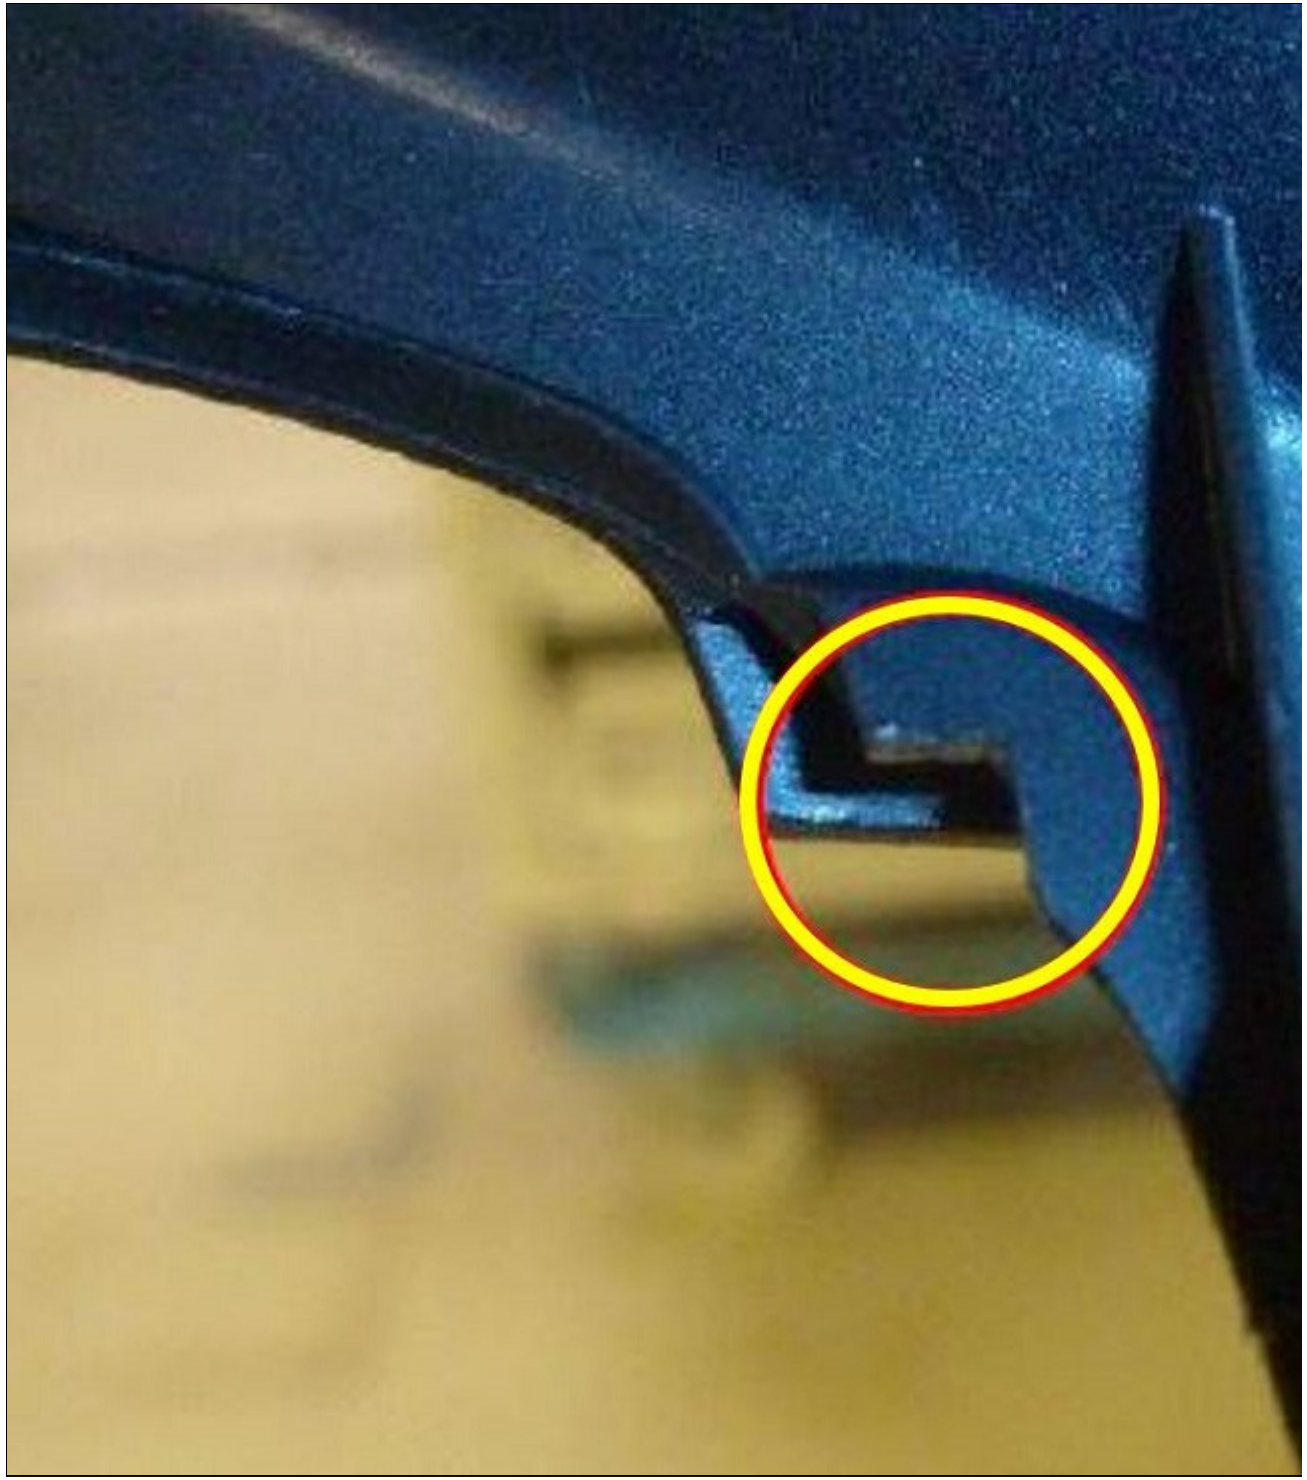
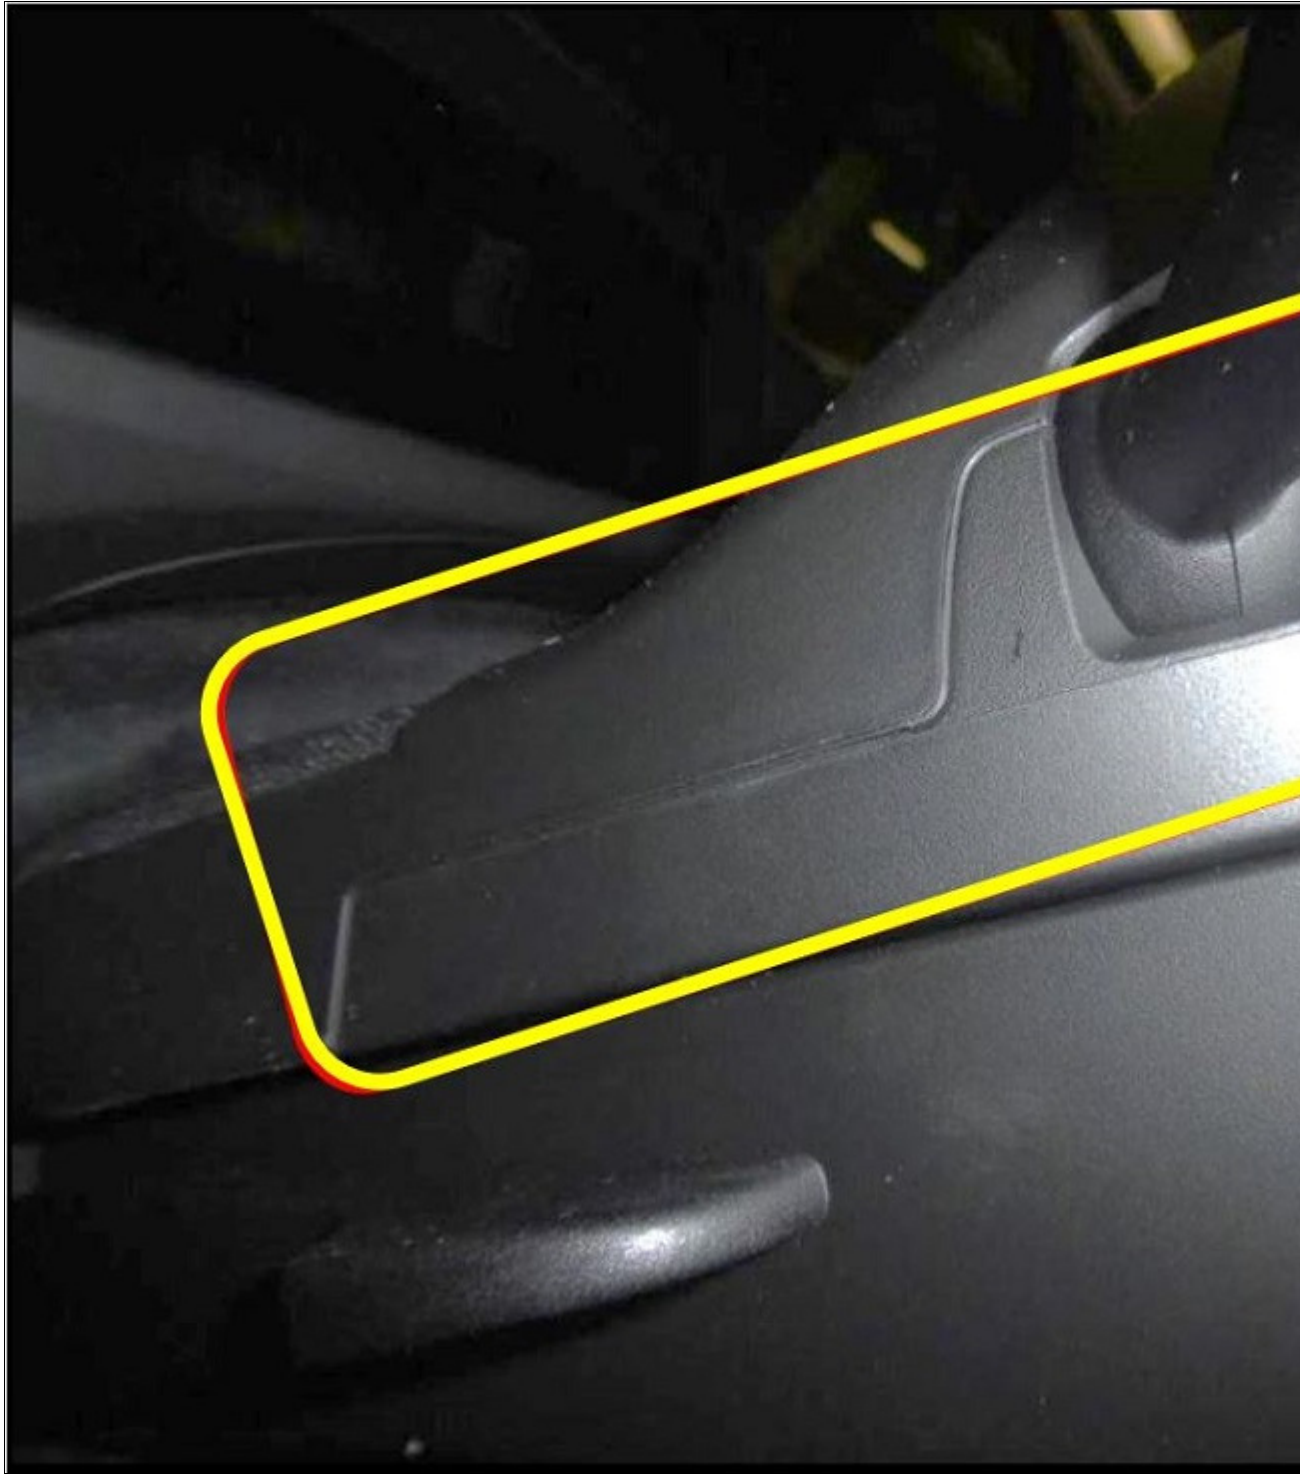
The steering column stalk switch for the turn signal sticks when actuating “headlight flasher” mode.

Interference fit between stalk switch and upper steering column shroud.

Modify steering column shroud.
