Various Check Control Messages Caused by Shorted K-CAN

This Service Information bulletin supersedes SI B61 03 15 **dated April 2016**.

F22 (2 Series Coupe)	F30 (3 Series Sedan)	F32 (4 Series Coupe)	F34 (3 Series Gran Turismo)

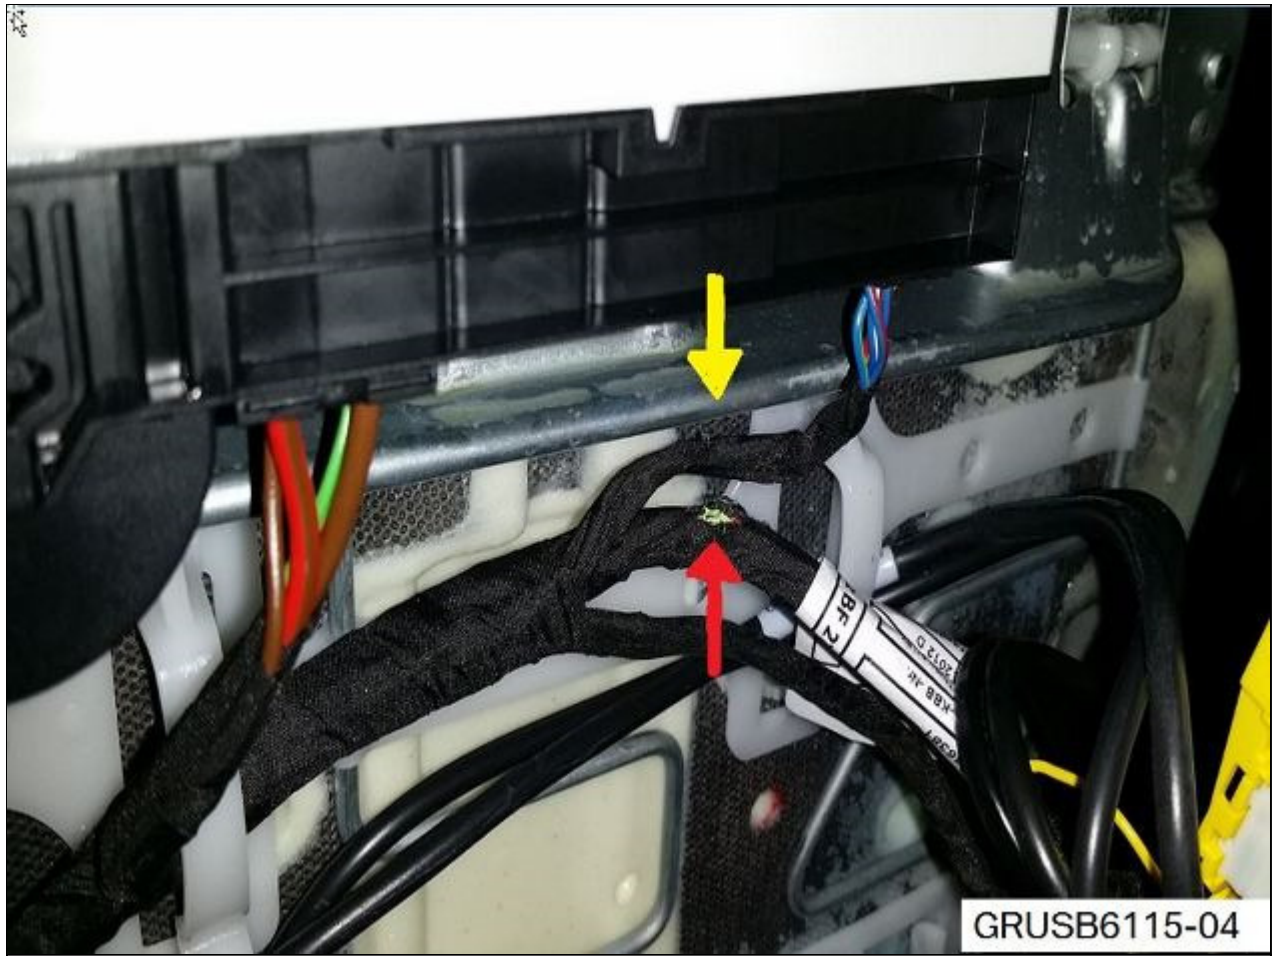
- A. Under driver or passenger front seat.

2. Repair short.
3. Reinstall all components, ensuring routing prevents future wire damage.

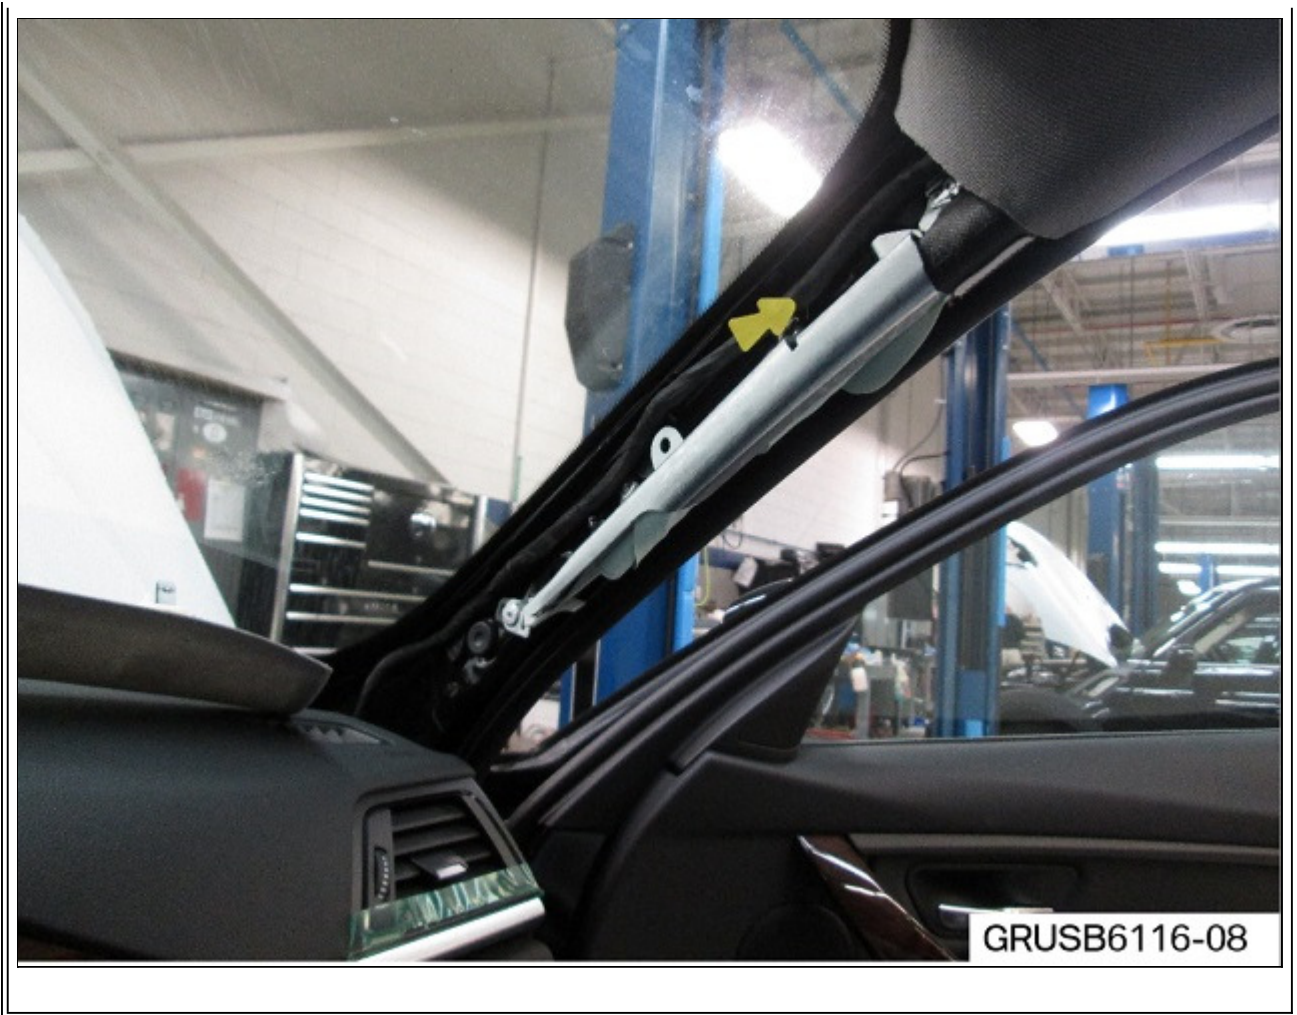
E. Short in A-Pillar behind trim (clip pinching harness)
