SIL 01-TR-16  
March, 2016  
Page 1 of 5

**SUBJECT:** Re-calibrating MY2016 Vehicles with TCM CAN1 Network Speed set to 500 kbps Baud Rate

**MODELS AFFECTED:** All 1000, 2000, 3000, 4000 Series Product Families, and TC10™ Transmissions

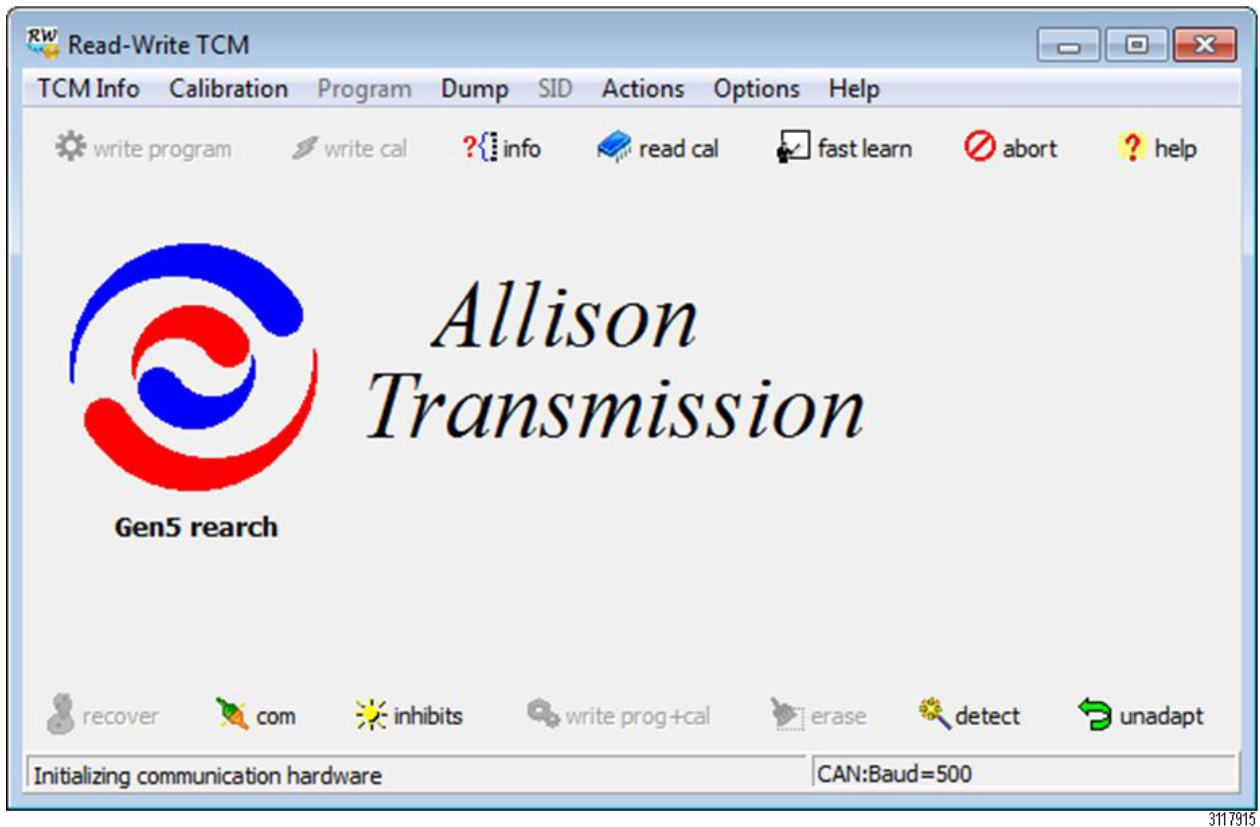
**Figure 3. Read/Write Display with Network Speed**

4. Update software and calibration of a TCM already programmed to 500 kBaud on CAN1 as follows:
  - a. Disconnect the TCM from the vehicle.
  - b. Use TCM Reflash harness (J47276) and WTEC Load box (J42455A) for bench recalibration.
  - c. Use a supported RP1210B compliant adapter such as the Noregon Wireless/USB, Nexiq USB-Link™, Nexiq USB-Link™ 2, or DG Technologies DPA 4 Plus or DPA 5 adapter.
  - d. Launch Allison TCM Reflash™ and download the 5th Generation Controls calibration file.
  - e. Connect to the TCM, select the desired calibration file, and click the load button.
  - f. Complete the Load Report form and click OK.
  - g. TCM Reflash and the Allison Read / Write application will detect the communication speed of the TCM, and the programming will occur at 500 kBaud as indicated in the lower right-hand corner of the following display.

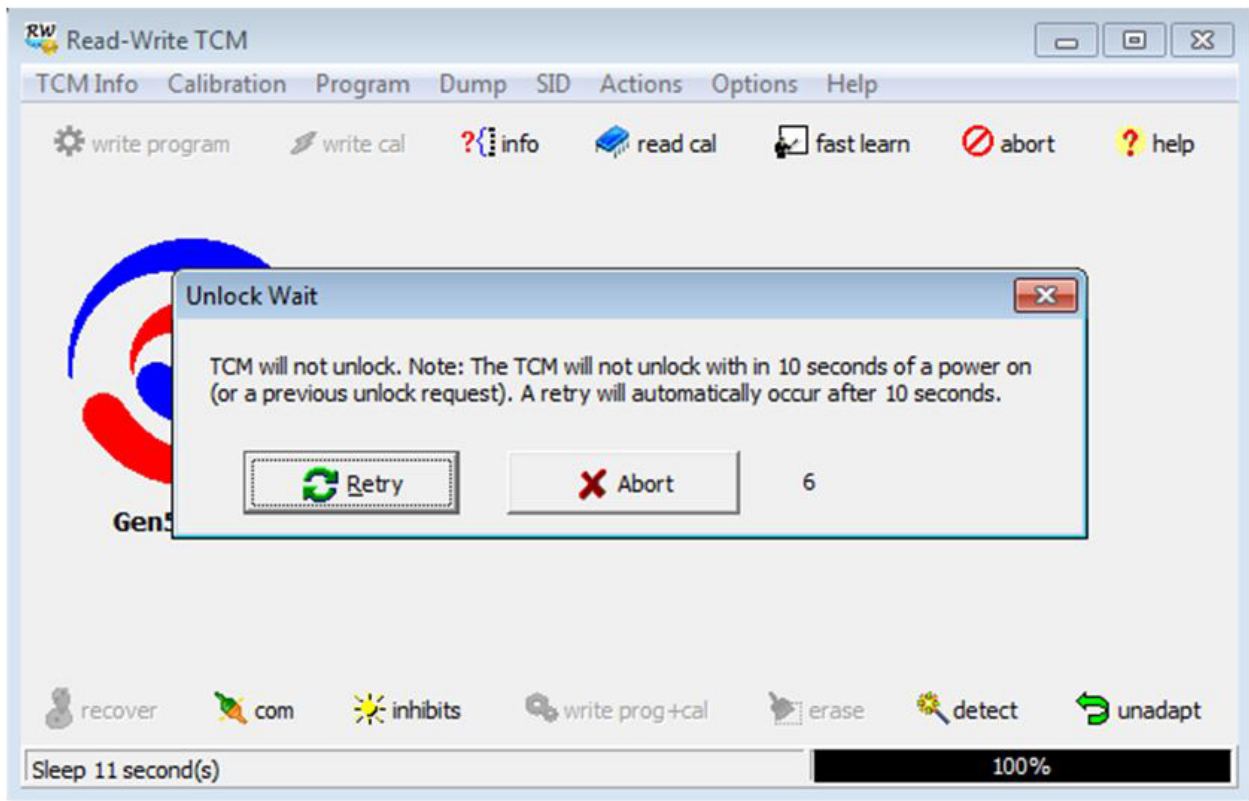
**Figure 4. Unlock Error Message**

- h. TCM Reflash will load the software then calibration.
- i. After the calibration is loaded, the TCM will 'wake up' at 250 kBaud and communications with TCM Reflash will then be lost. The following error message will be displayed:

- j. Click the Abort button. TCM Reflash will display the following message.
