SIL 2-EP-16, Rev. A  
April, 2016  
Page 1 of 16

SUBJECT: Replacing BCA (Bias-Control Assembly) Cards Inside of the Dual Power Inverter Module 2 (DPIM2)

MODELS AFFECTED: H 40/50 EP™ System Equipped with DPIM2

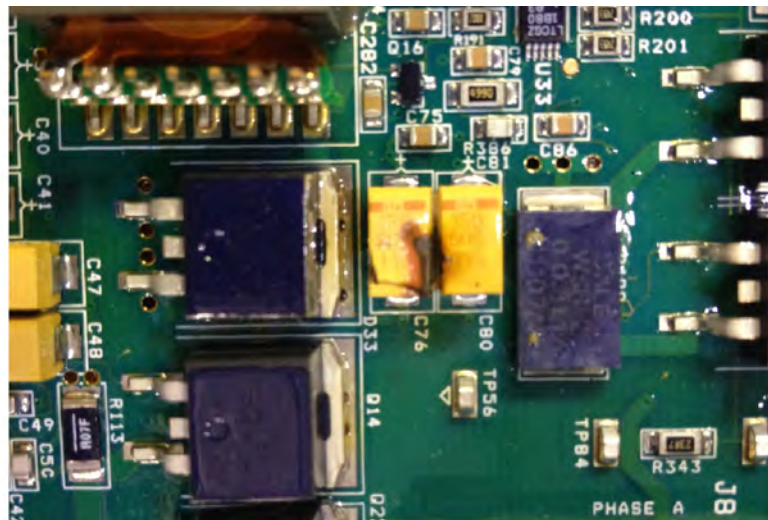
**Figure 4. Damaged BCA Card**

Condition: Fuse (10-40A) for 12V DPIM power or fuse (10A) for 12V DPIM wakeup fails whenever the DPIM 24-way connector is plugged in.

1. Check for smoke damage.
2. Inspect the BCA cards for damaged components (refer to [Figure 4](#)). Replace BCA card if damage is discovered and verify the repair. If damage is NOT found, continue troubleshooting per the below steps until the failed component is identified.
