Bulletin No.: 20760
Date: February 2016

Recall Bulletin

PRODUCT SAFETY RECALL

SUBJECT: Brake Pedal Pivot Nut/Bolt Loose
MODELS: 2015 – 2016 Chevrolet Silverado HD
2015 – 2016 Chevrolet Tahoe PPV (RPO 9C1)
2015 – 2016 GMC Sierra HD

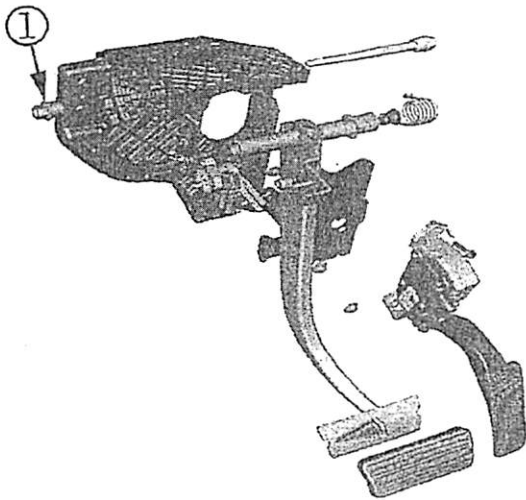
4404307

- If the brake pedal pivot nut (1) is on the outboard side of the vehicle, proceed to step 2.

- Using an inspection mirror, determine if the brake pedal pivot nut is on the outboard side of the vehicle.

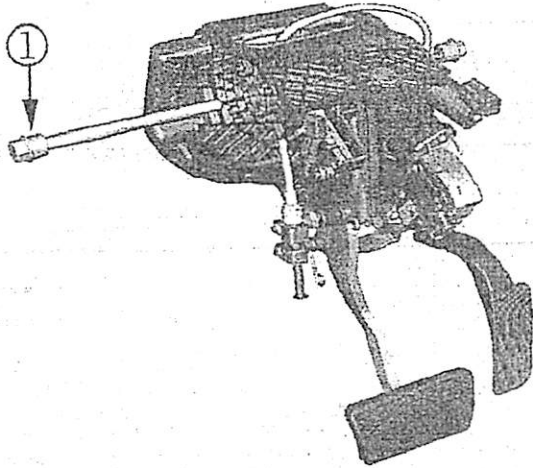
4404296

- If the brake pedal pivot bolt (1) is on the outboard side of the vehicle (nut on the inboard side), no further action is required.
2. Remove the Instrument Panel Knee Bolster. Refer to *Instrument Panel Knee Bolster Replacement* in SI.
 3. Remove the Floor Front Air Outlet Duct Replacement - Left Side. Refer to *Floor Front Air Outlet Duct Replacement - Left Side* in SI.
